VLBA Antenna Memo Series #25

**North Liberty Maintenance Visit**  
April 14<sup>th</sup> through 19<sup>th</sup>, 2000  
Trip Report

Jim Ruff  
05/17/2000

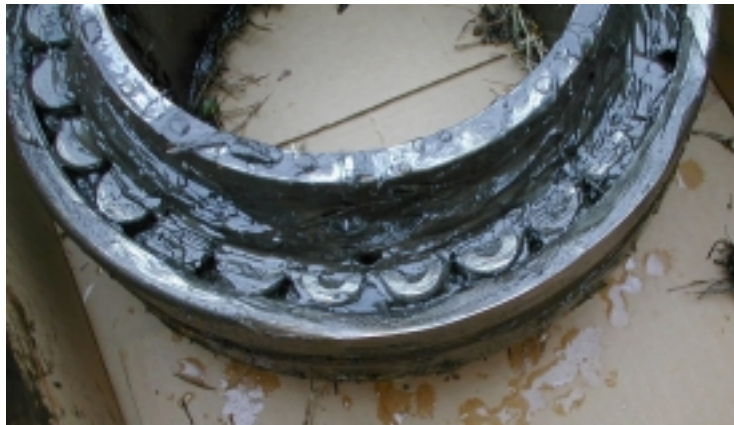
**Figure 1: Failed Azimuth Bearing**

Two azimuth bearings were replaced: Outer drive #1 And outer idler #2. The drive bearing showed severe thrust failure. (Figure 1) The idler bearing had pitting in its outer race. The outer races of the remaining azimuth bearings were rotated 180°. There were outer ring spacers in all eight azimuth pillowblocks. We left the spacers out of the pillowblocks in which bearings were replaced.

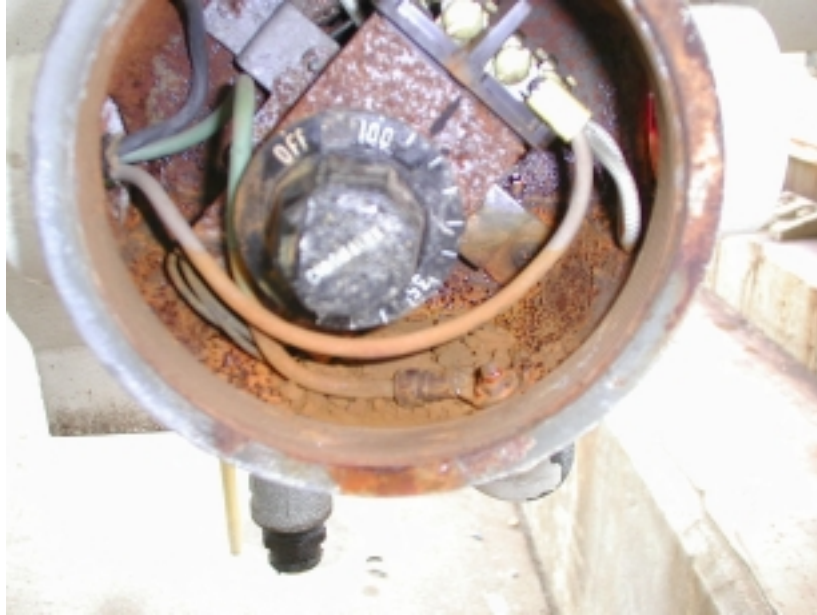
**Figure 2: Gearbox Heater**

The gearbox heaters were inspected. Three of the enclosure covers were very hard to remove, the fourth (inside elevation) could not be removed at all. The three thermostats we were able to inspect were severely corroded but appeared to function properly. (Figure 2) Weep holes were drilled in the three enclosures we opened. Three new heater assemblies (all that were available) were left at the site for replacement during the next gearbox oil change. In the future, we will drill weep holes in these enclosures and apply Nevr-Seez to the cover threads. Note that the Chromalox thermostat, costing \$180, can be replaced with Grainger #2E552 for \$30. A spare thermostat has been added to the container.

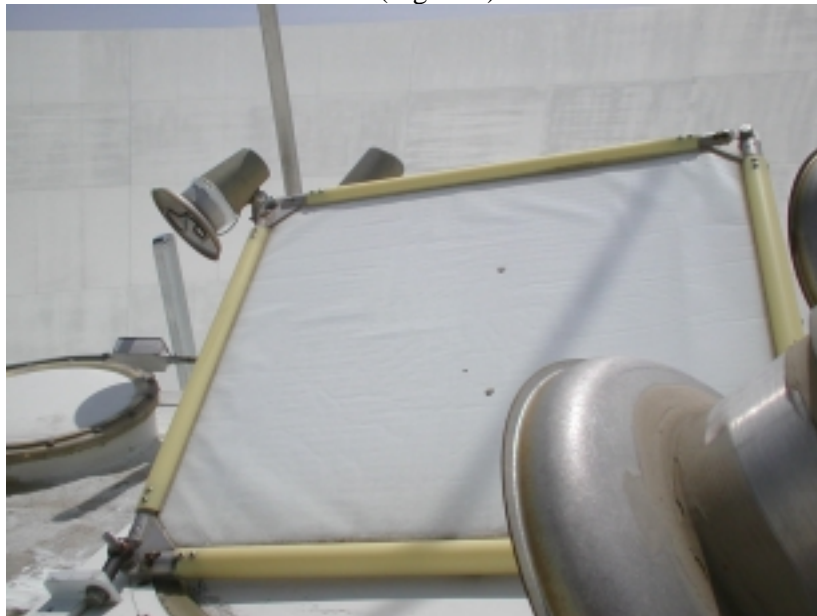
**Figure 3: Dichroic Panel**

The dichroic panel is delaminated in the corners. (Figure 3)

9. The Dichroic Panel appears 50% delaminated, although no problems have been seen by Operations. Peggy Perley is aware of the condition. No action is required at this time.

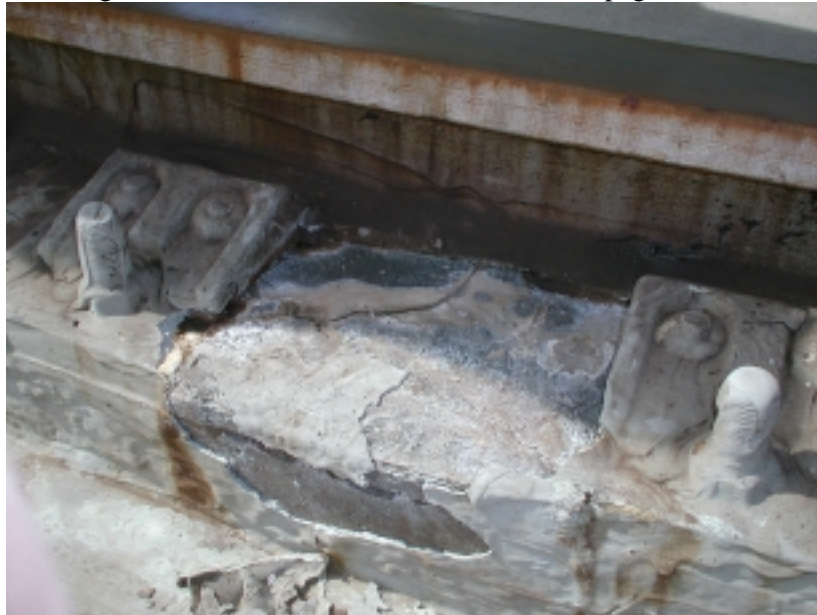
**Figure 4: Grout Failure**

The azimuth rail grout is failing in an area on the southwest side. (Figure 4) This should be monitored and repaired on the next tiger team visit, or sooner if warranted. See page 6 for more on the azimuth rail.

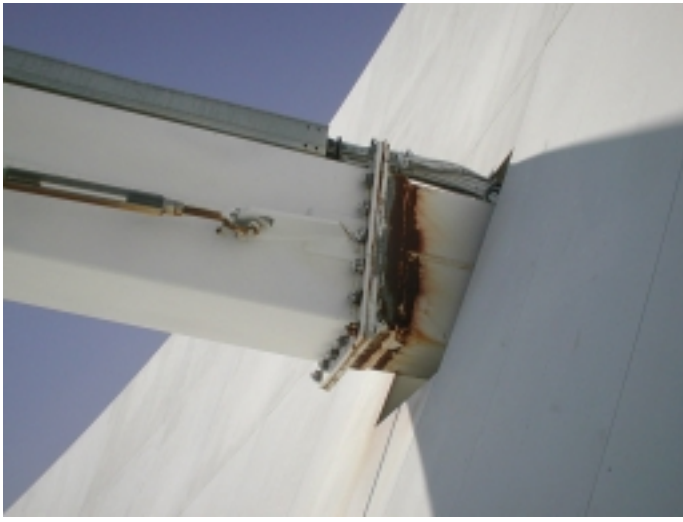
**Figure 5: Quad Leg**

The antenna structure paint was in good overall condition, but had flaked off in several areas. (Figures 5-11) The subreflector, feed cone, and main dish panels were stained black. (Figures 12-15)

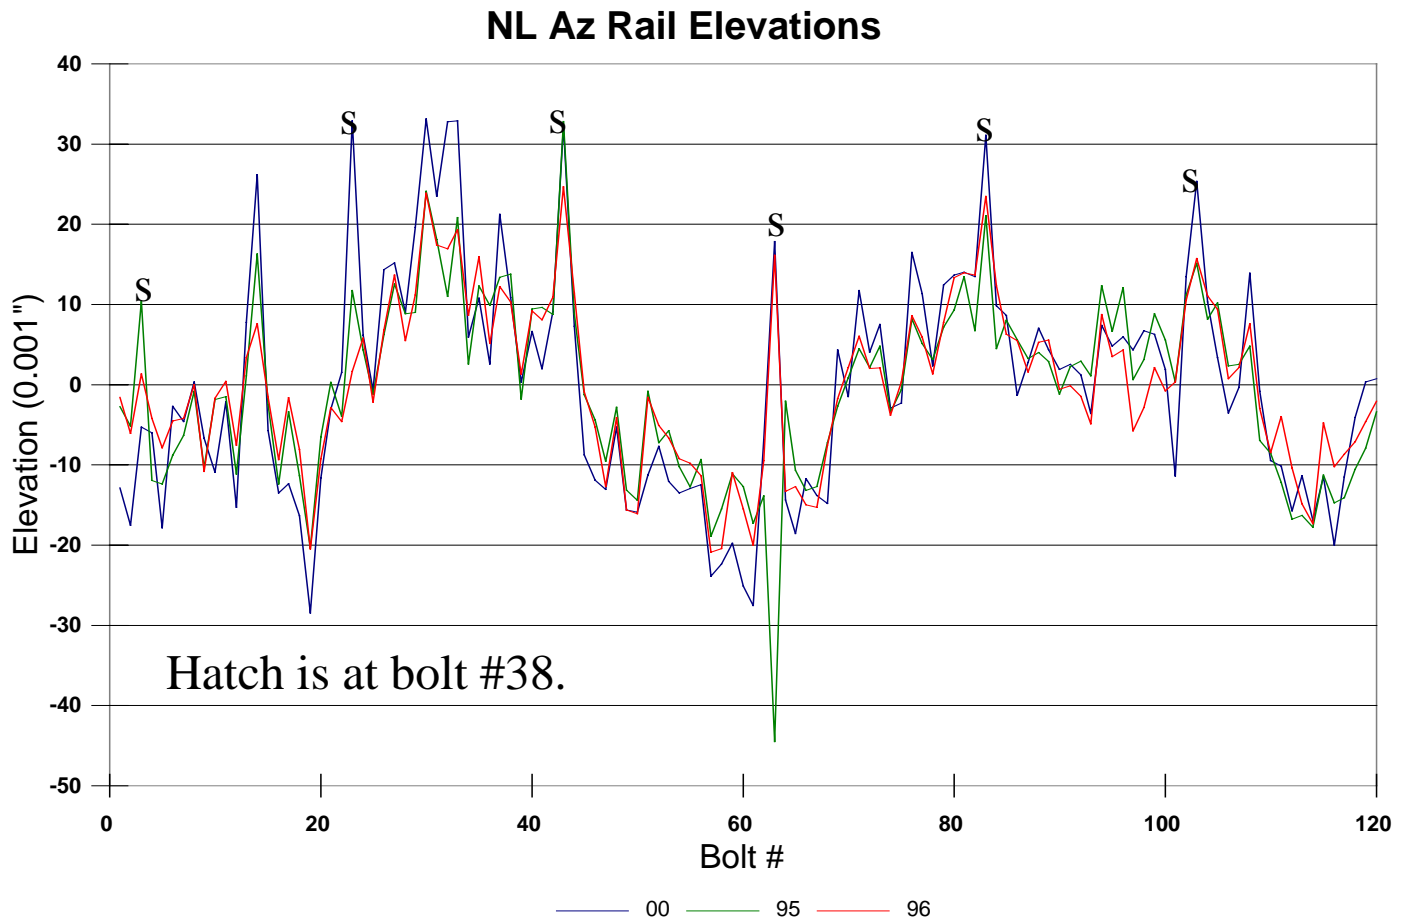
Note apparent grout failure at bolt #15. The splice at bolt #23 may also be failing. Other spots to check are bolts 30-35 and splices at 83 and 103.
