National Radio Astronomy Observatory
Socorro, NM

VLBA Antenna Memo Series #34

Brewster Maintenance Visit
July 23rd through 30th, 2001

Jim Ruff
8/2/01

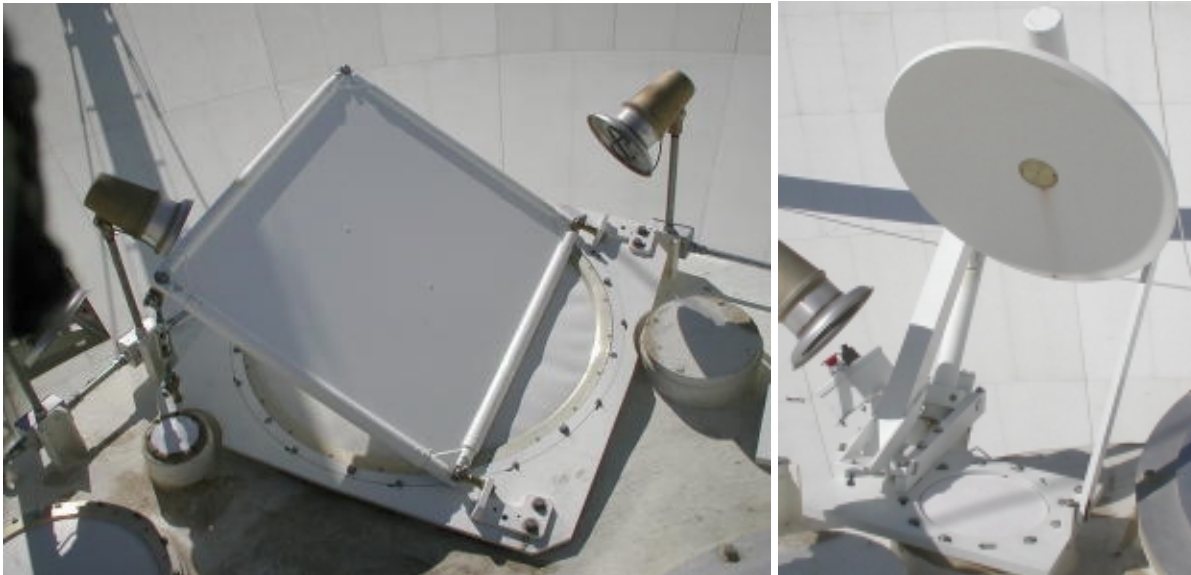
Note the four arcmin vertical error on D1. This is twice the amount allowed by the spec. We loosened the bolts in the rigid coupling and found a 4.2 arcmin tilt in the same direction as the shaft misalignment. This can not be corrected without replacing the wheel assembly, as there is no shim under the pillowblocks. Since the wheel has been like that for about 10 years, with no popping or wheel/axle sliding, I recommend leaving it alone.

Drive Wheel Alignment			
Wheel #	Horizontal Error	Vertical Error	Radius Error
D1	0° 0' 30"	0° 3' 59" (too flat)	0.134" (out)
D2	Not checked

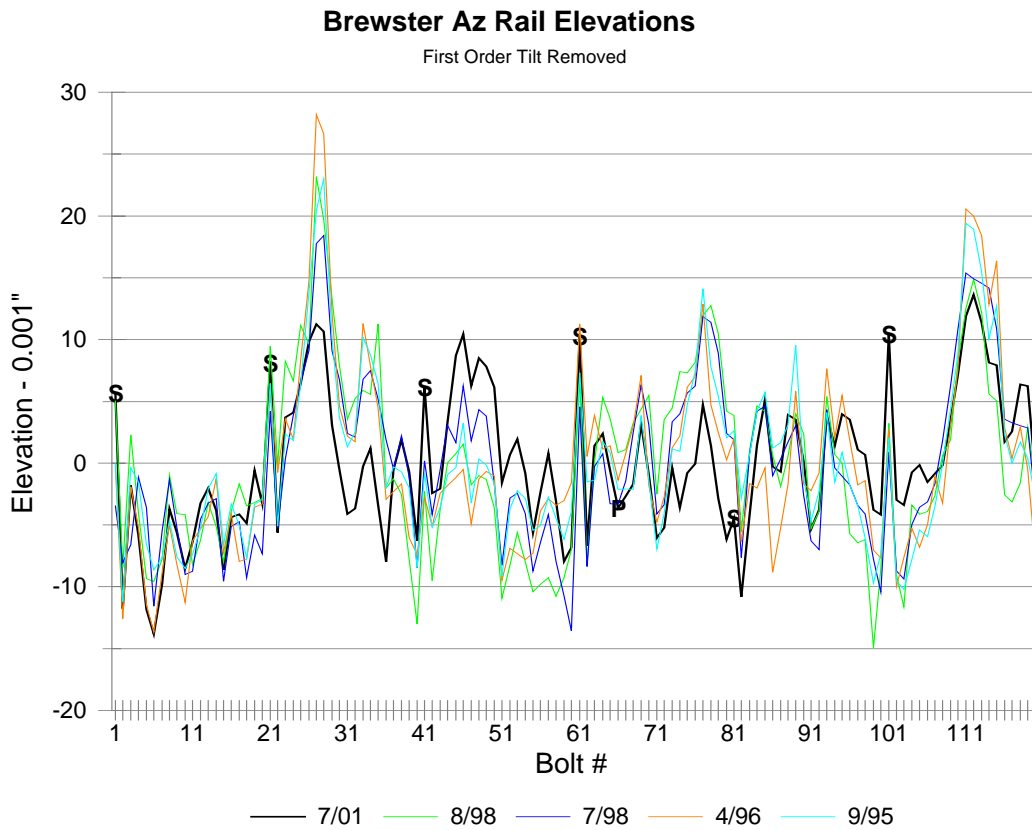
The azimuth rail grout and Vulkem are in good condition, but the grout is crumbling in a few areas.

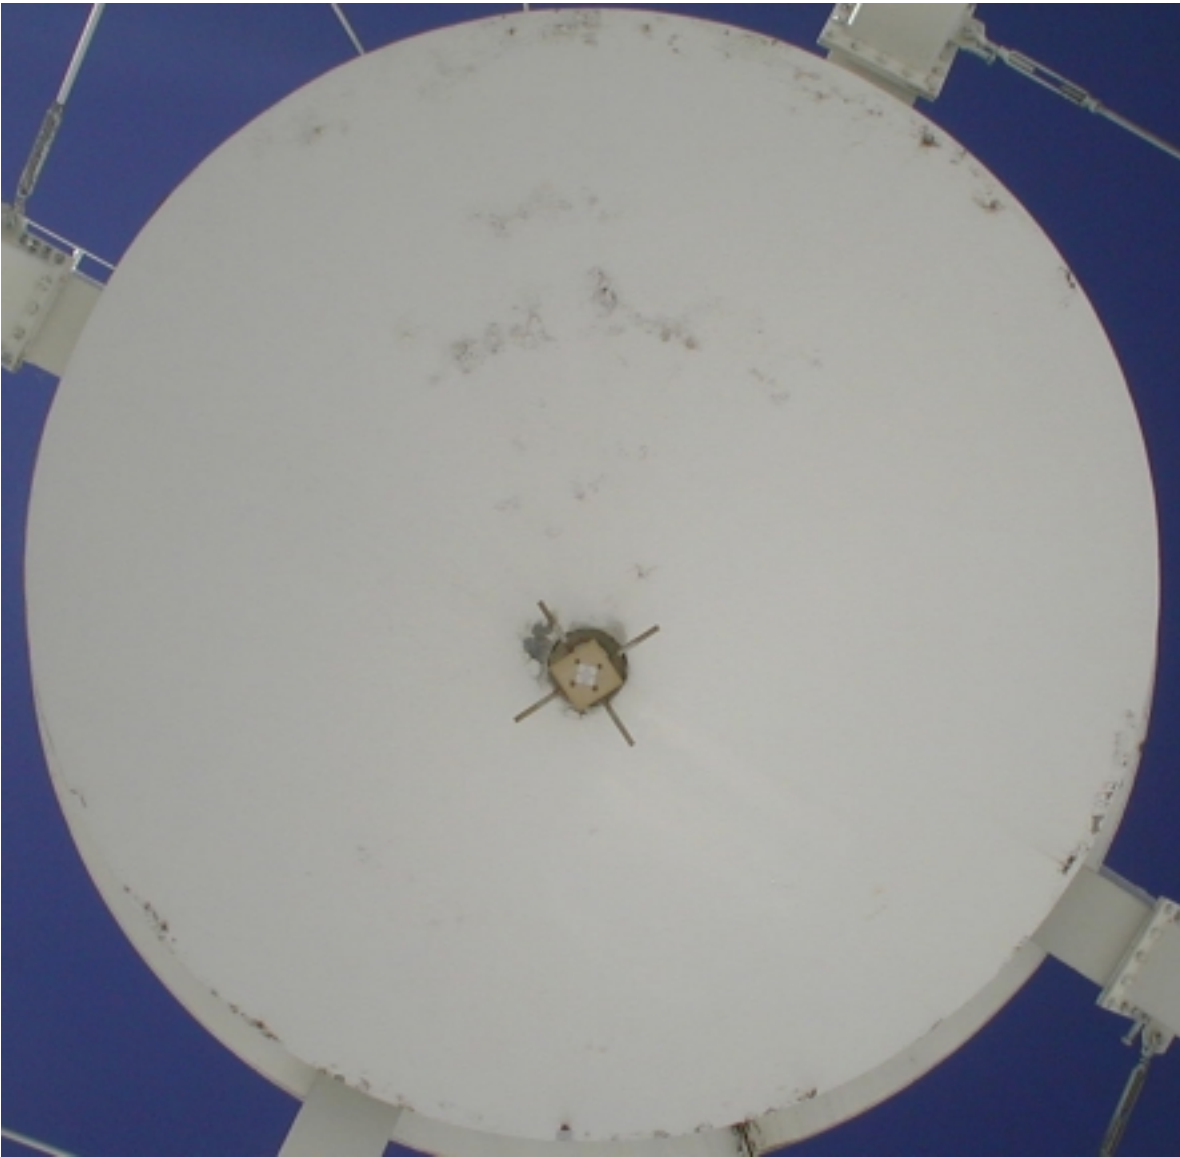
The paint on this antenna is in excellent condition.

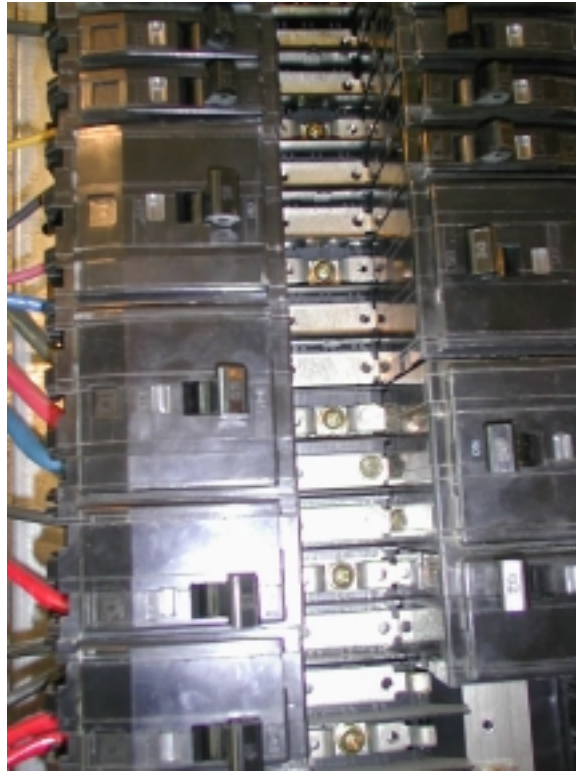
Ped Room Breakers

Also while I was doing the IR. Thermometer checks in the ped. Room electrical panels, Steve Troy noticed that the buss for the breakers is a screw in type and the breakers themselves are not the screw in type. So the breakers will pop out if the panel cover is off. Steve Troy notified Tom Baldwin of the problem and Tom will follow up on it.
