## NATIONAL RADIO ASTRONOMY OBSERVATORY

VLBA Antenna Memo Series No. 44

Los Alamos Rail Repair

J. E. Thunborg August 21, 2002

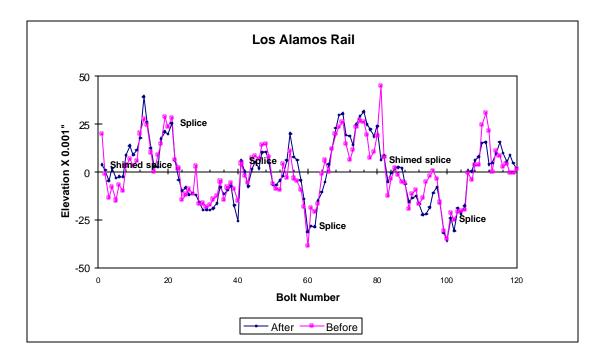
Eleven of the bolts that hold the rail clips to the rail plates were broken. When the loaded rail deflects into a section of degraded grout it causes the rail to lift at the adjacent rail plates thus breaking the rail plate bolts. The grout from below these rail plates was removed so that the broken bolts could be replaced with new ones.
