The original grout under the azimuth rail on the Mauna Kea, Hawaii VLBA antenna has slowly been degrading. On July 29 –August 8, 2004, a maintenance team consisting of Jay Apachito, Phillip Sanchez, Jon Thunborg and John Wall were dispatched to repair the grout with the help of site technicians Bill Hancock and Tony Sylvester.

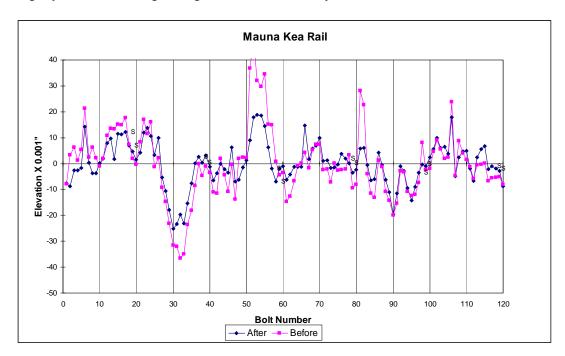
The initial rail measurement showed that the rail was high from bolt 27 to bolt 36. The wear pattern on the rail indicated that only the outside edge of the rail was high. A hand grinder was used in an attempt to level this part of the rail. The high spot was alleviated slightly, but additional grinding is still needed to fully level the rail.
