National Radio Astronomy Observatory  
Socorro, New Mexico

VLBA Antenna Memo #57

Owens Valley, CA. VLBA Maintenance Visit Sept. 23 thru Oct. 1 2004.

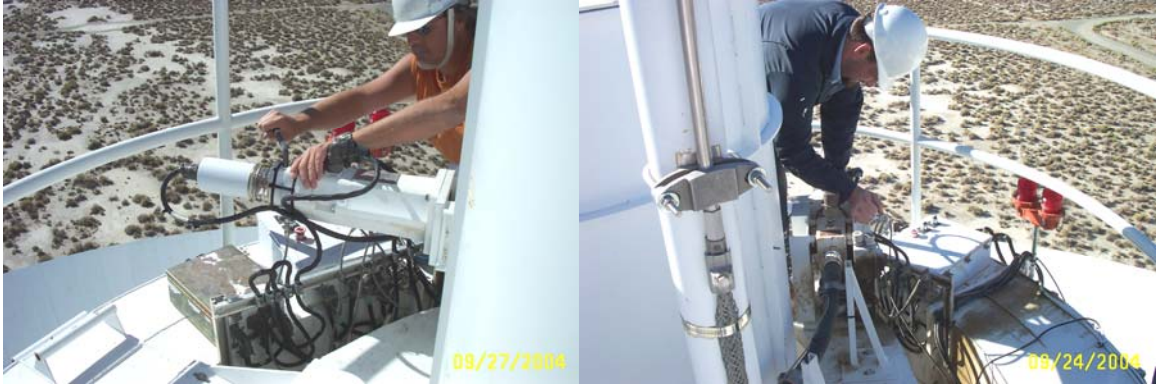
FRM was given a thorough inspection. A focus flex shaft was replaced and the new encoder coupling modification was installed.

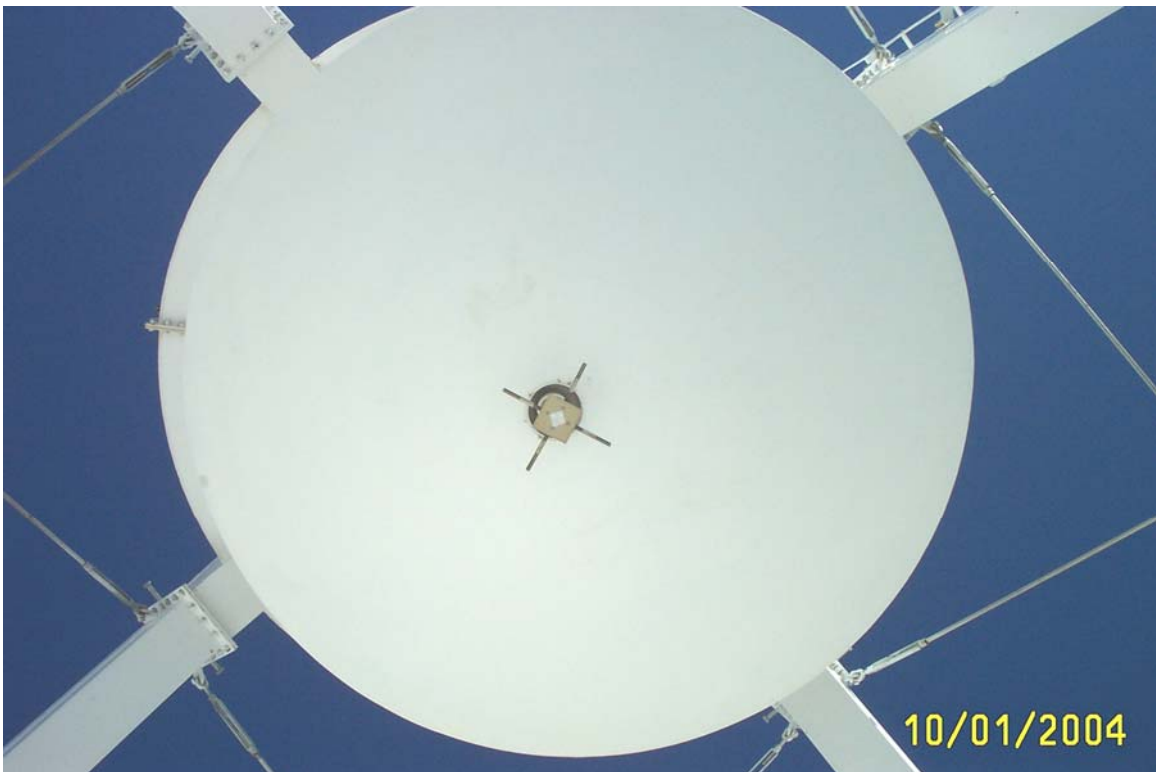
Subreflector is in good condition. Six 1inch holes were drilled in the center of the reflector for extra drainage. The snow tarp was removed.

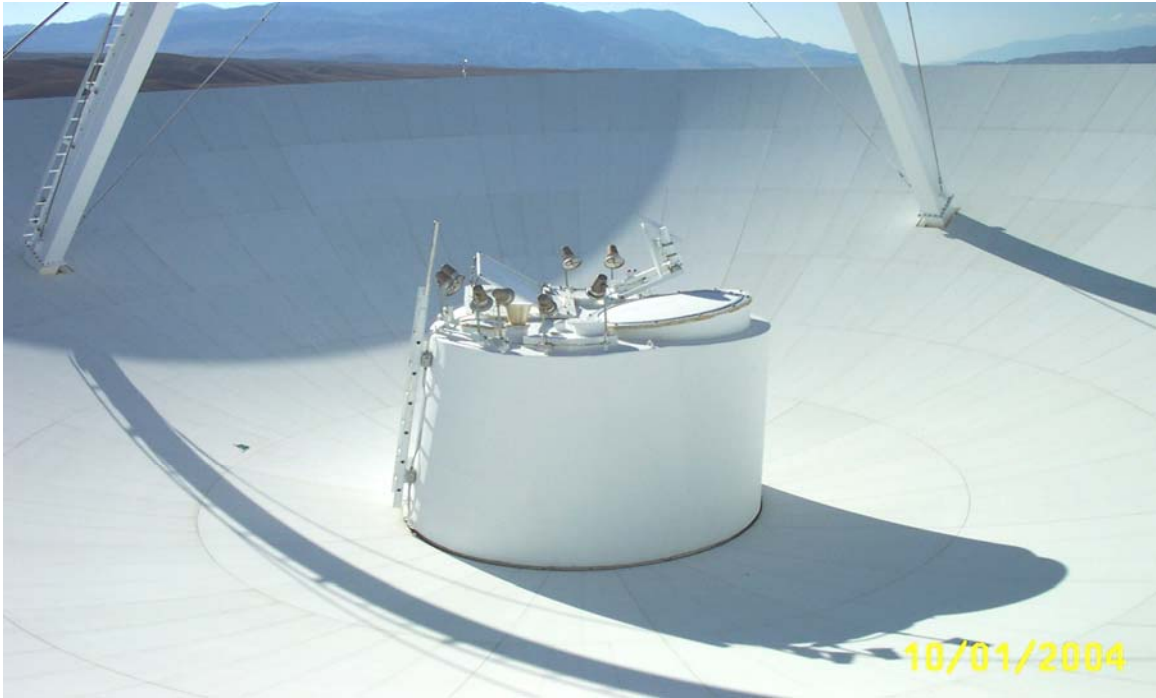
Feed cone was spot sealed and painted with elastomeric.

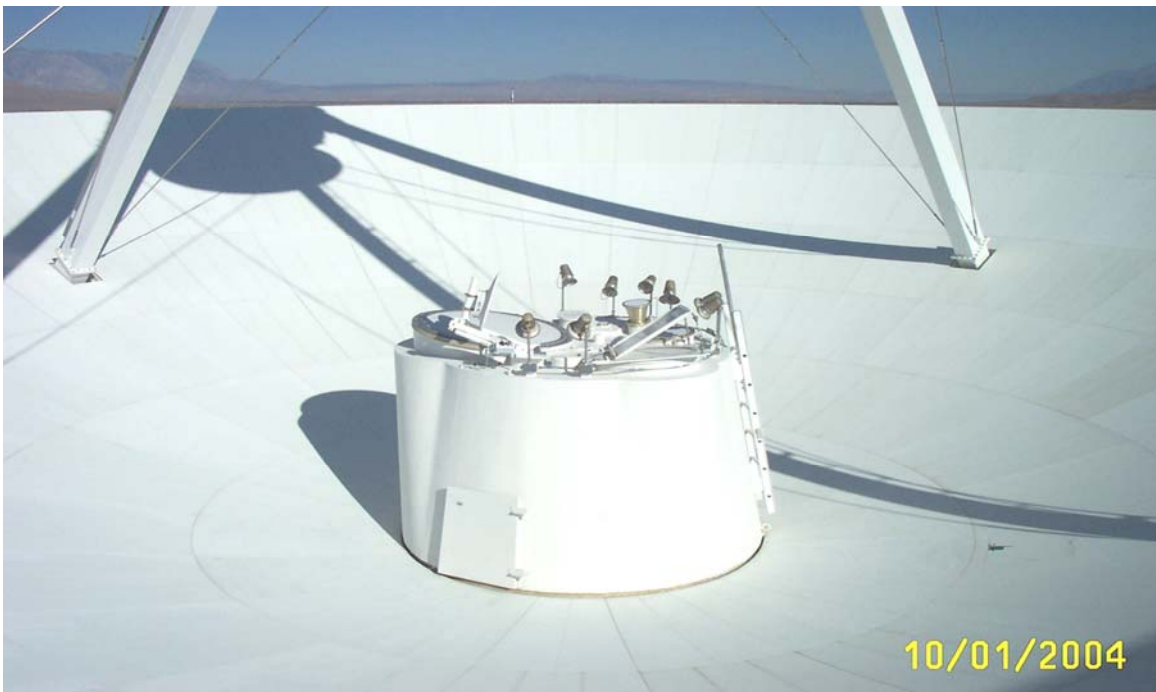
Dish panels, and the panels paint is in good condition. Quad leg paint is excellent. Guy wires are in good condition.

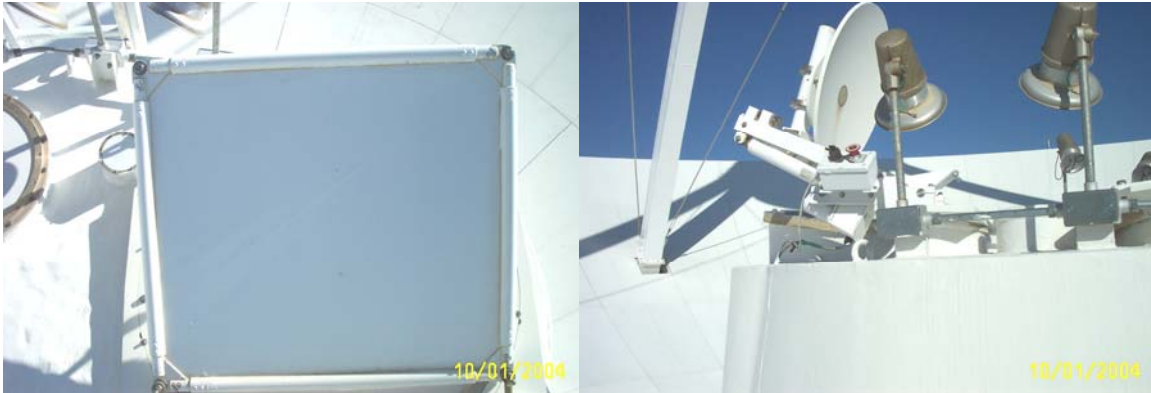
Dichroic reflector is good condition. Elipsoid reflector is in good condition.

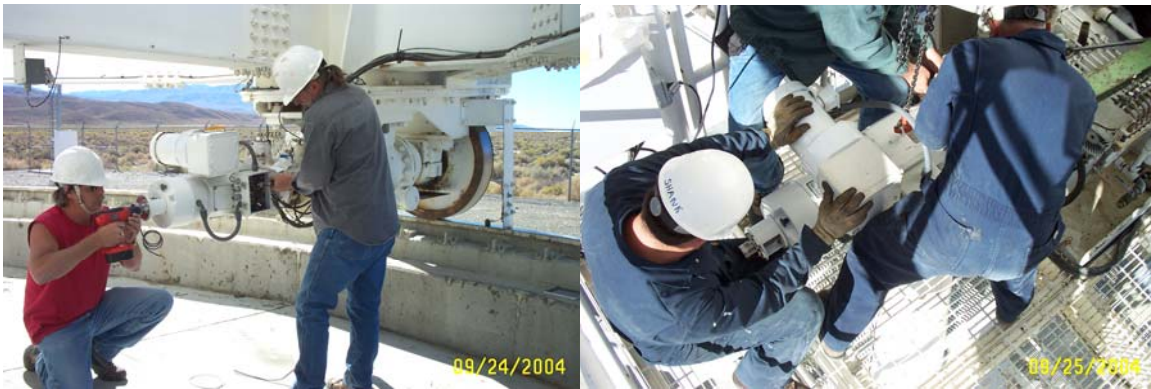
New digital tachs were installed on EL and AZ motors. Elevation #1 motor was replaced. The ACU power supply modification was previously installed by the site techs. The ACU backplane upgrade was installed and tested. An ACU +12 voltage regulator (U1) was replaced and tested.

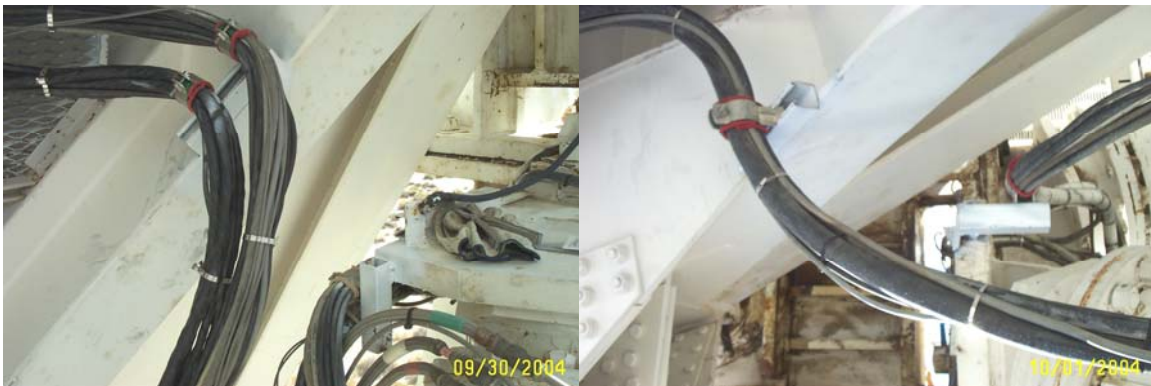
Both the encoder and synchro side elevation cable wraps were repaired by repositioning and replacing both sides strain relief brackets.

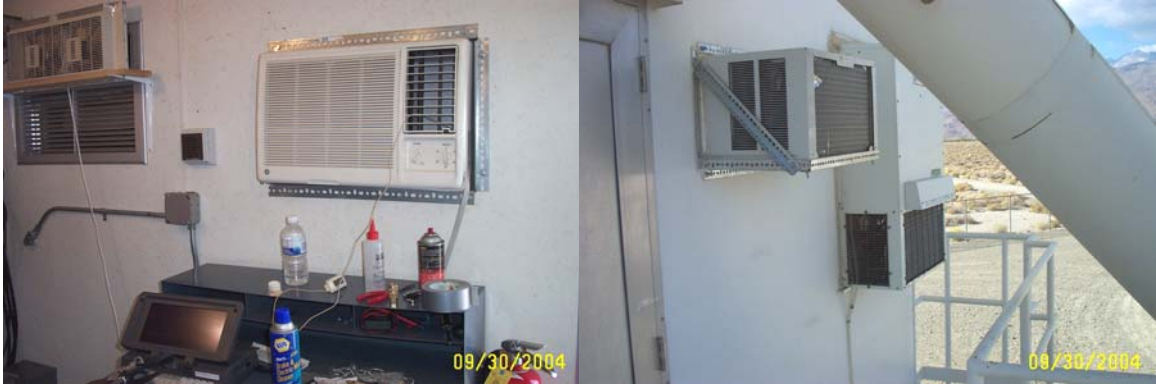
A backup AC was previously installed by the site techs in the ped room.

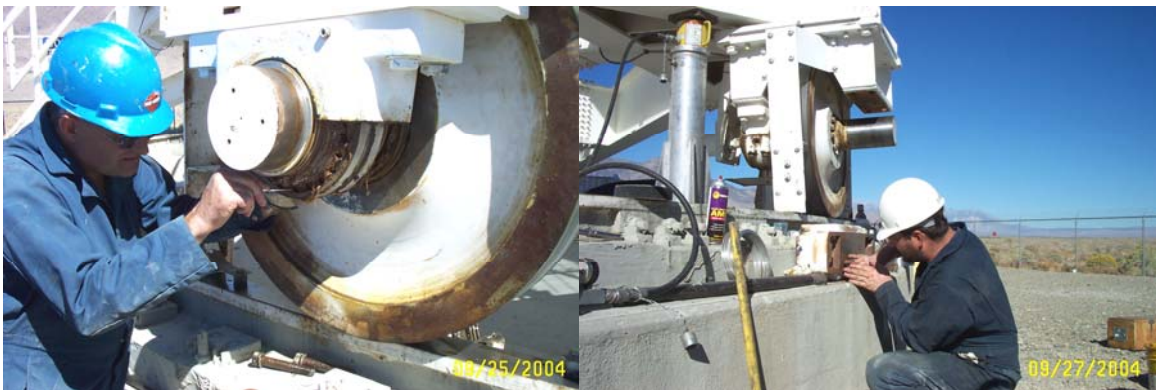
AZ bearings were inspected. AZ idler #1 outside bearing was replaced.

INNER BEARING	OUTER BEARING
D1	Metallic looking grease.	Same as inner bearing
D2	Needs to be replaced	Outer race severely grooved.
I1	OK	Replaced bearing.
I2	OK	OK
All bearings were very well lubricated. Azimuth D2 needs to be replaced.

1. Azimuth drive #2 Wheel/Bearing assembly needs to be replaced.
2. Elevation #2 motor needs replaced.

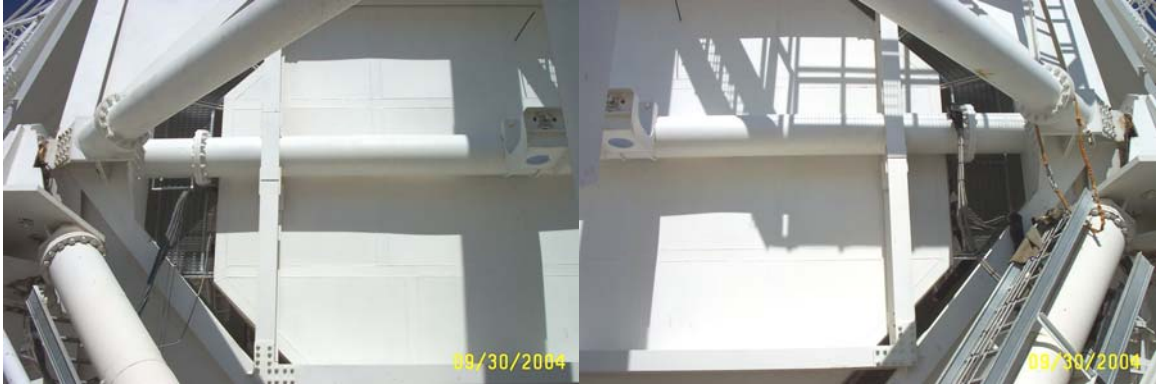
Elevation axle has no visible signs of cracks. Paint is in excellent condition.

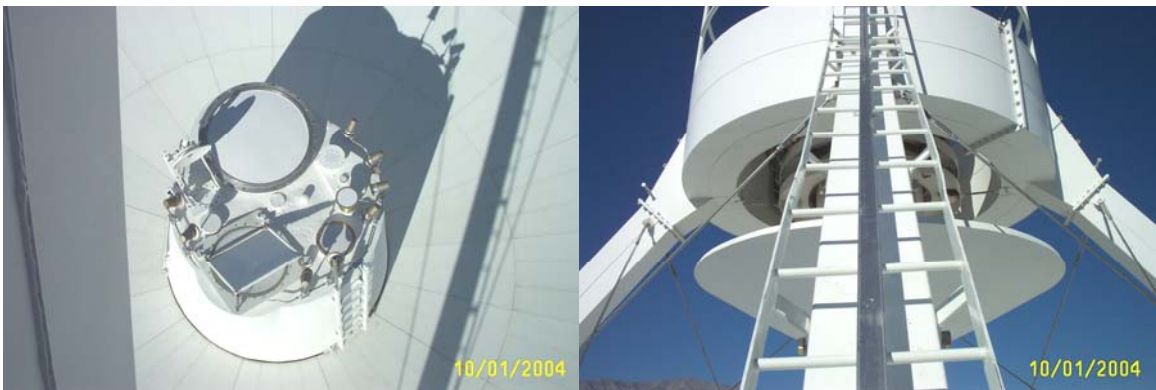
Feed cone and feed windows are in good condition. Apex paint is excellent.

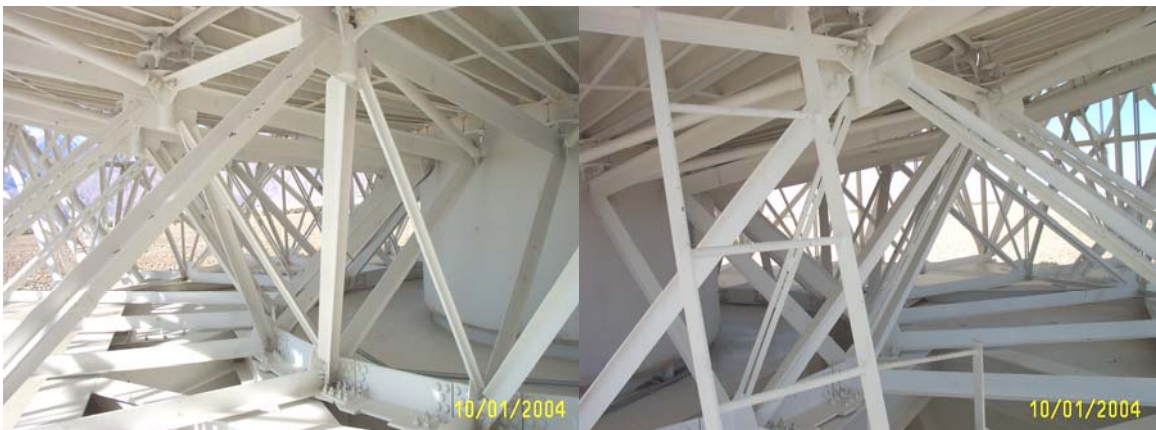
Backup structure paint is in excellent condition.

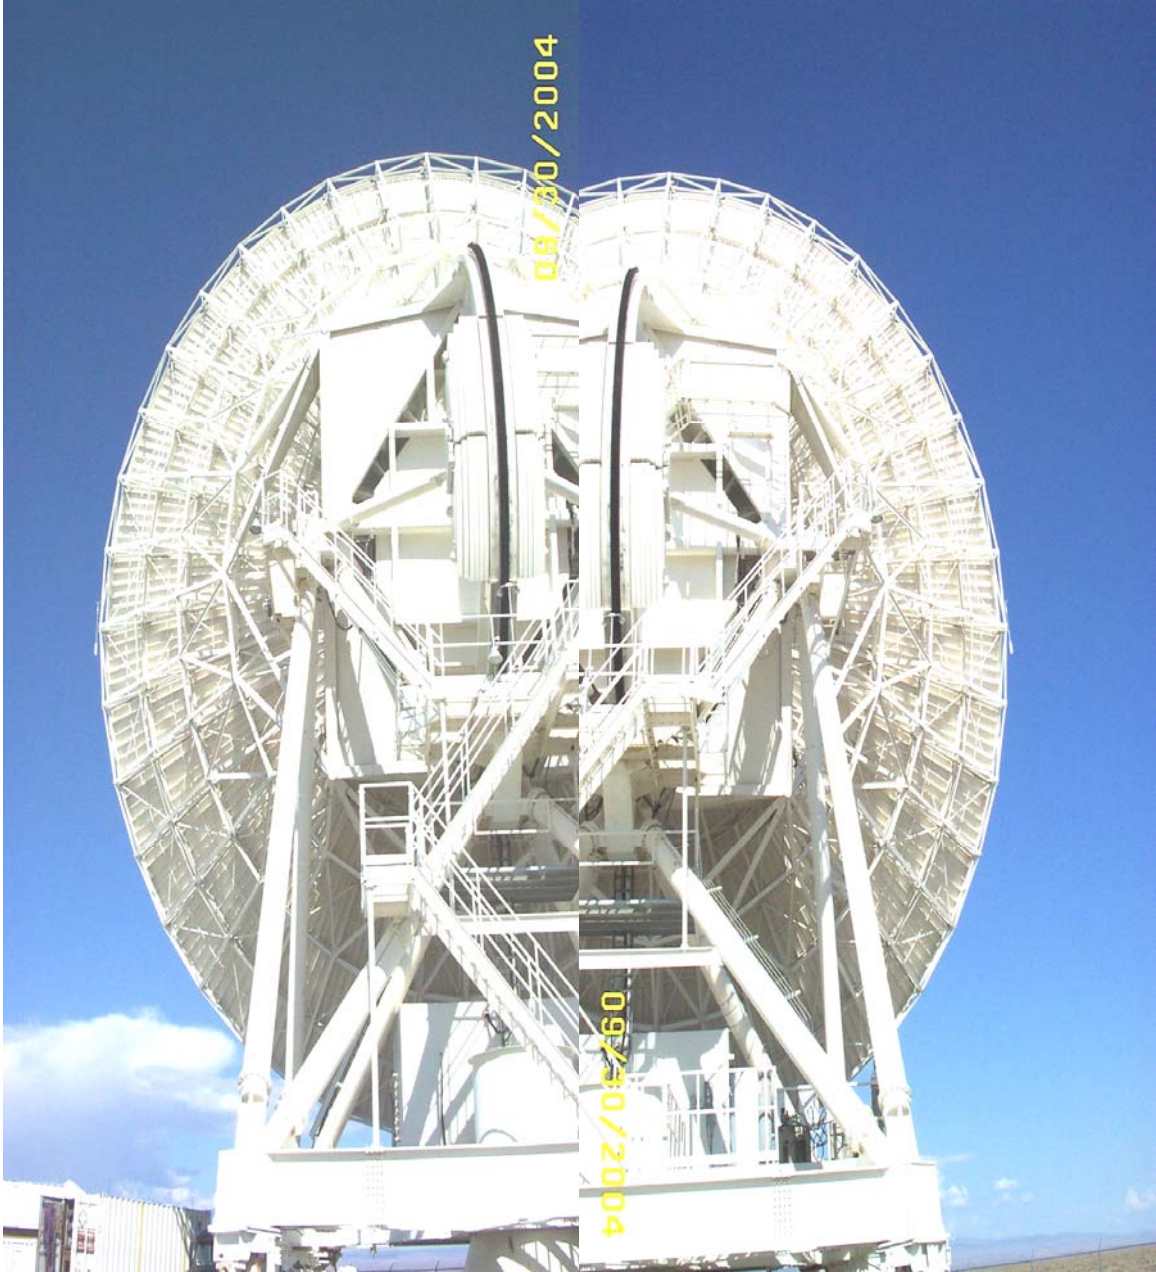
Overall paint on the OV antenna is in excellent condition.

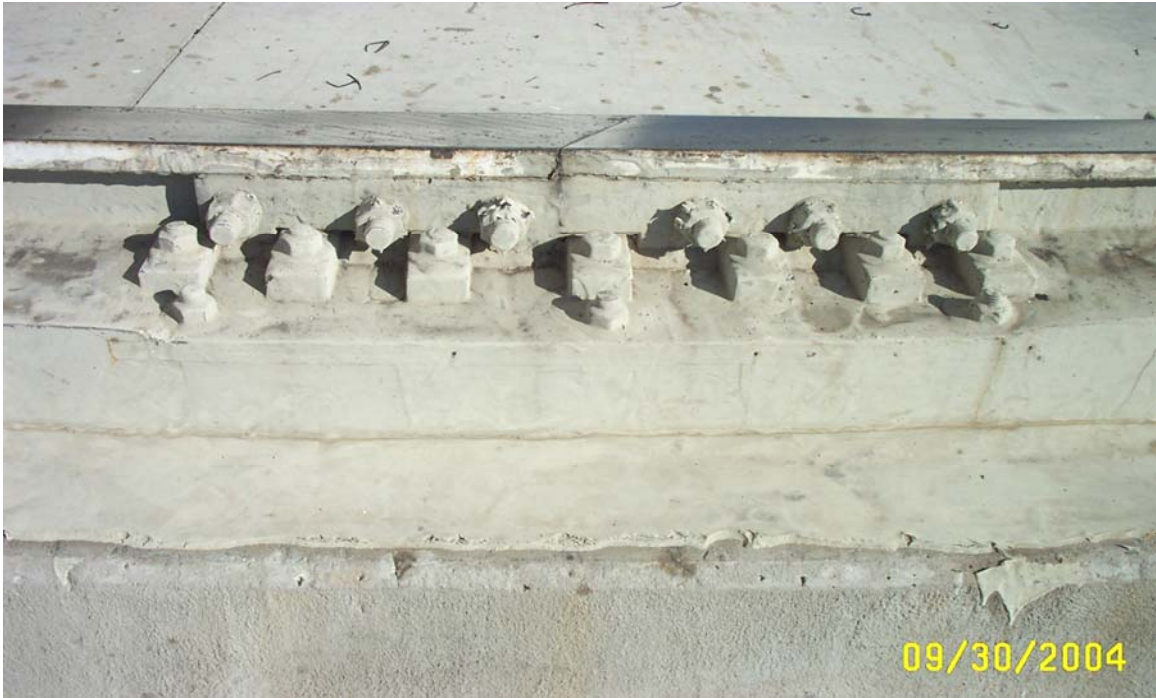
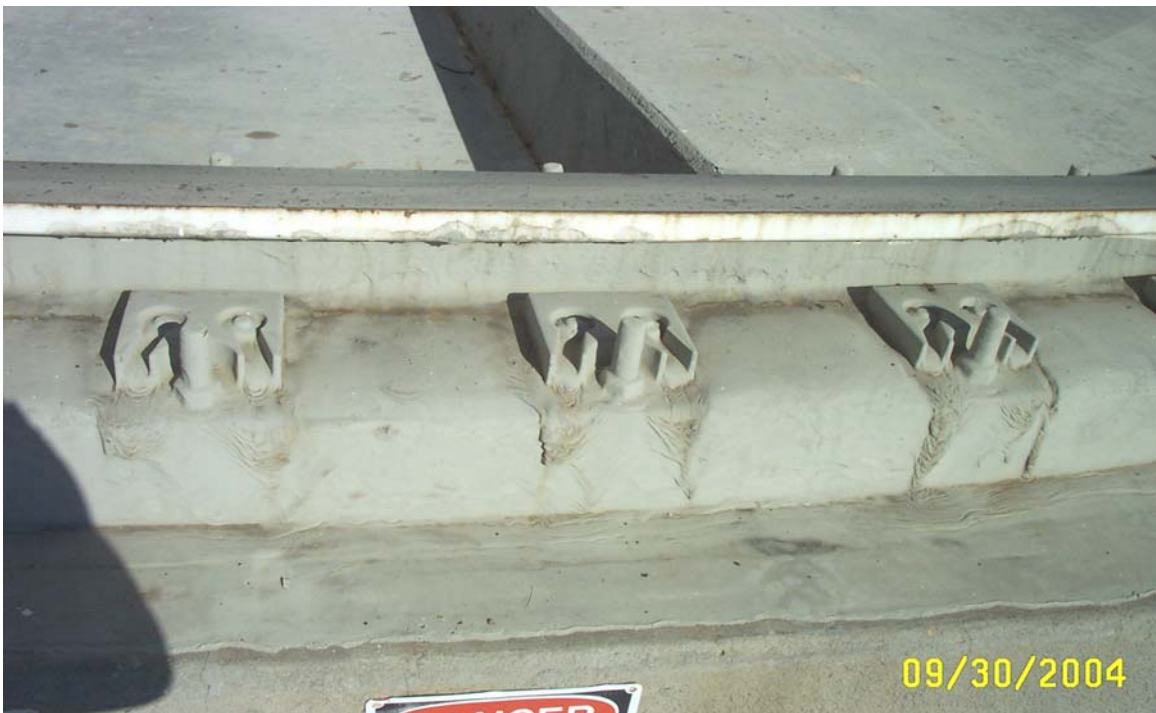
Vulchem is beginning to show signs of deterioration. Otherwise it is in fair to good condition all around the rail.
