National Radio Astronomy Observatory
Socorro, New Mexico

VLBA Antenna Memo #59

Saint Croix, VI. VLBA Maintenance Visit April 4th thru April 22nd 2005.

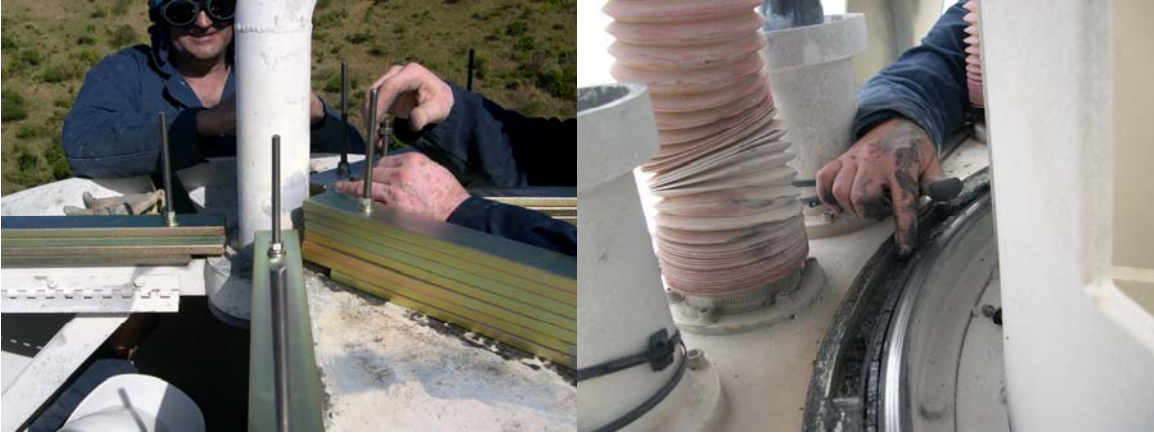
Sub reflector needed rebalancing. During the FRM inspection a broken INA bearing segment was found and repaired. The INA cap seal was replaced.

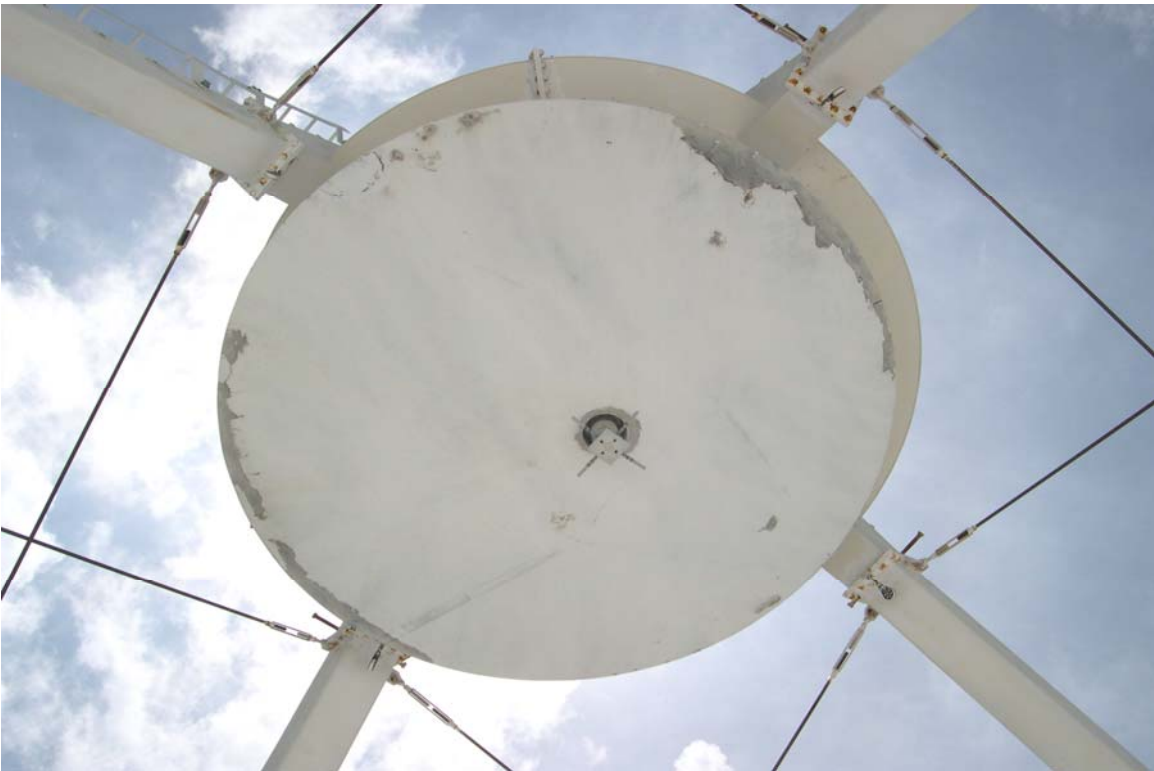
Sub reflector is in fair condition. The outside edges are soft, (spongy) and delaminating. Three 1 inch holes were drilled in the center of the reflector for extra drainage.

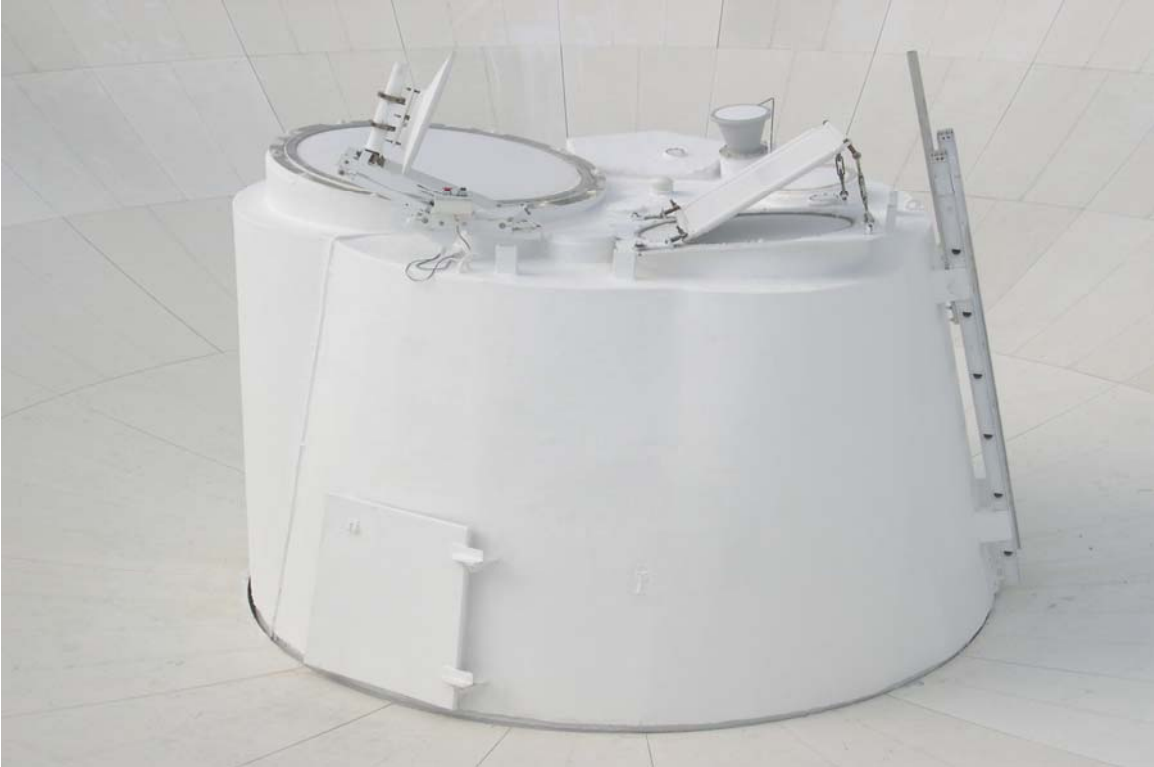
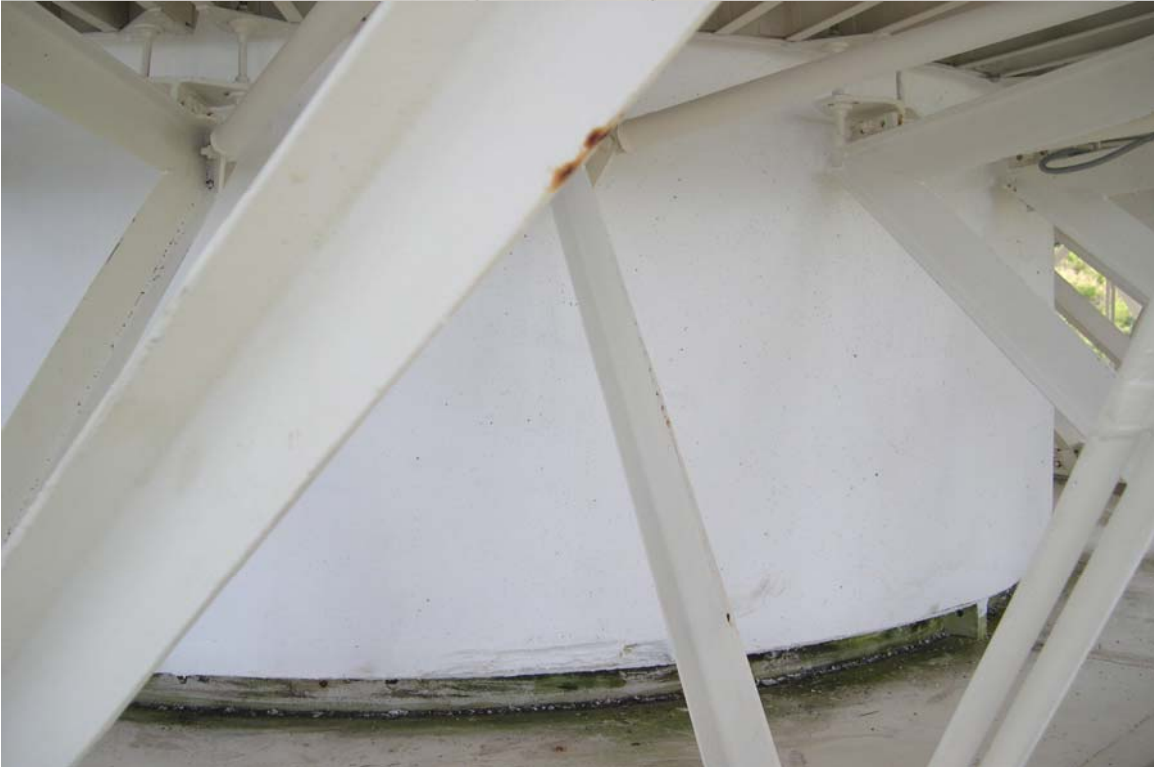
The feed cone was leaking into the vertex room. 5 gallons of elastomeric paint and 2 cases of caulk were used to seal it above and below the panels. The dish panel's paint is in good condition.

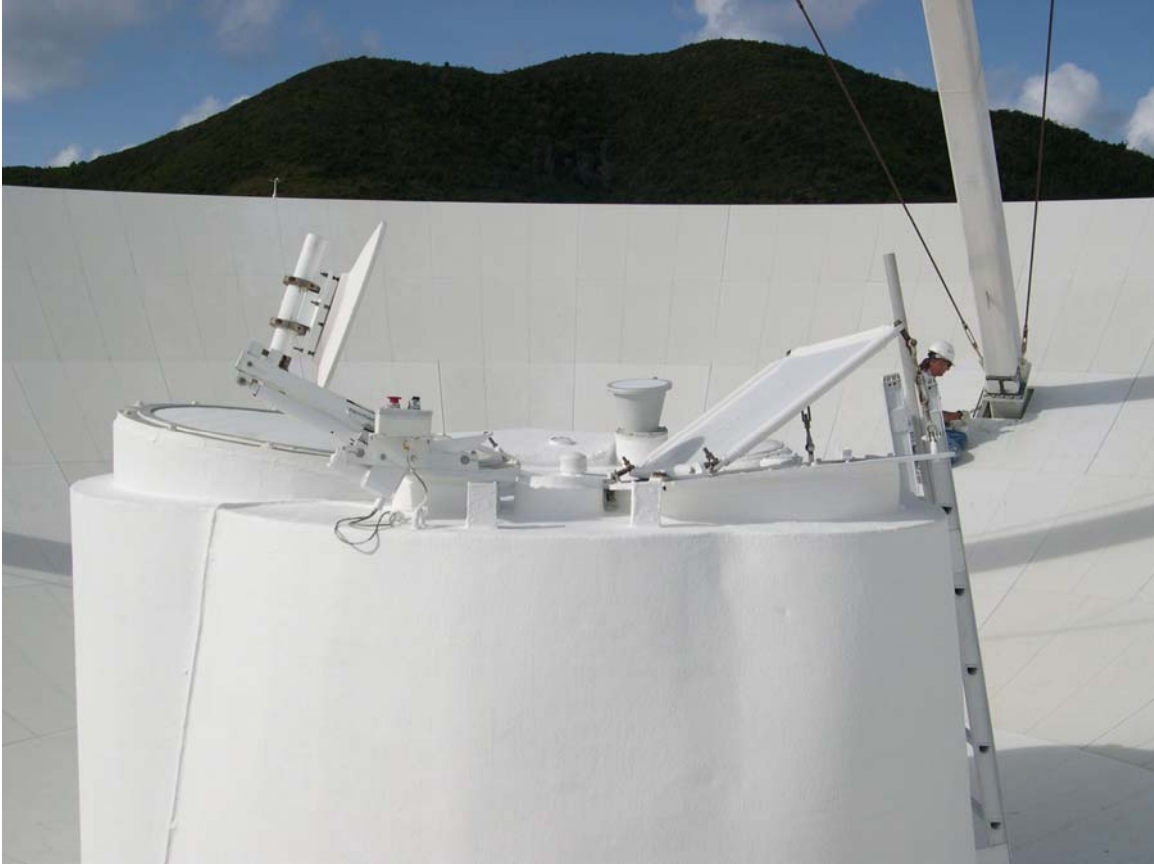
The ellipsoid actuator was replaced. Ellipsoid and the dichroic reflectors were aligned and are in good condition.

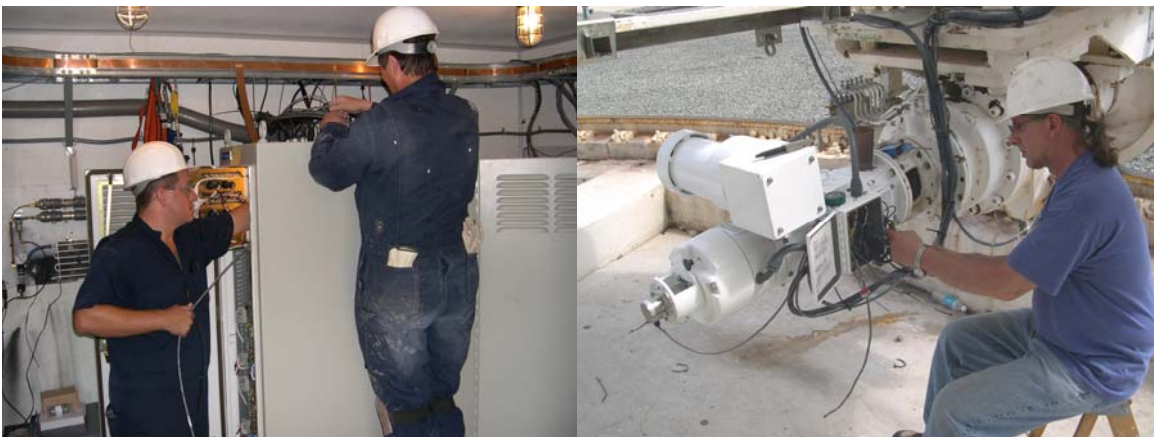
New digital tachs were installed on EL and AZ motors. Azimuth #1 and Elevation #2 motors were replaced. The ACU backplane upgrade was installed and tested.

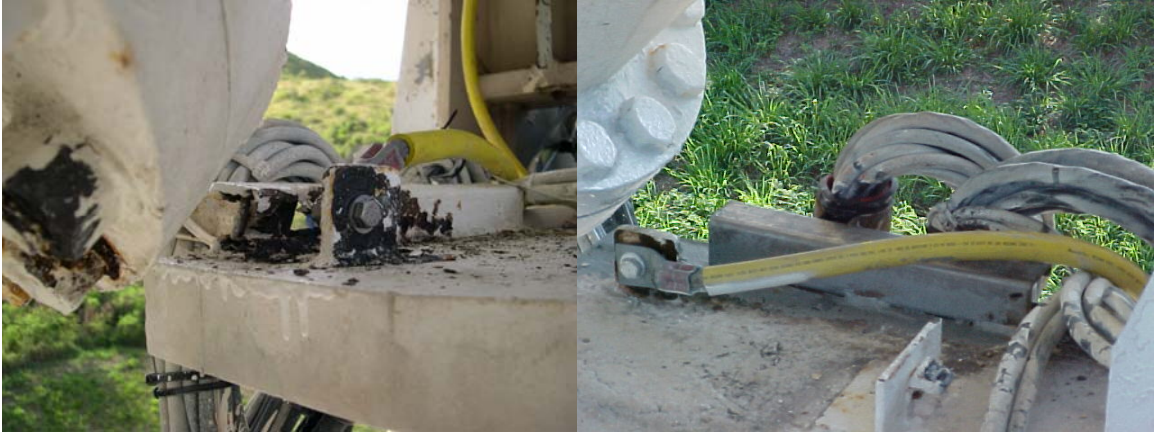
Both the encoder and synchro side elevation cable wraps were severely corroded. Stainless steel uni-strut was used to hold the new strain relief brackets in place.

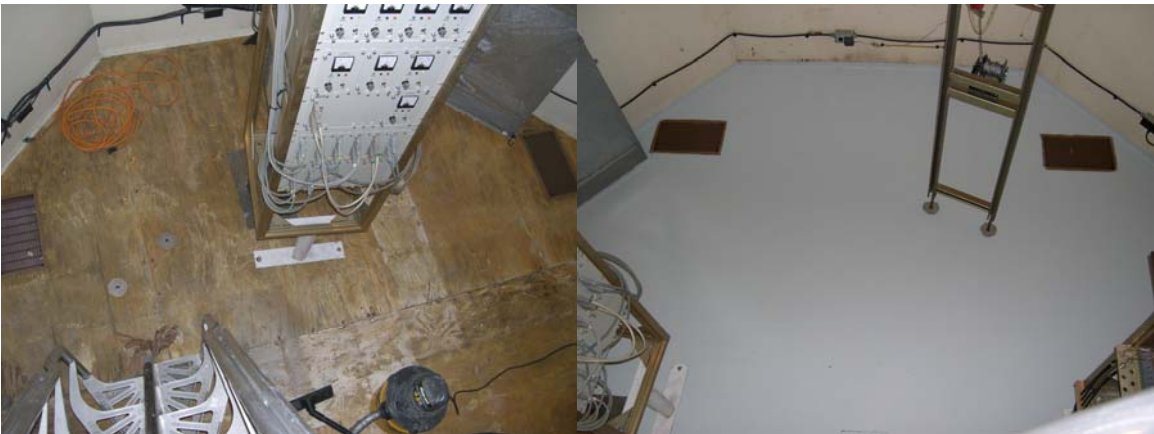
The feed cone leak had damaged part of the vertex room floor tiles. The floor was repaired and sealed, then covered with deck paint.

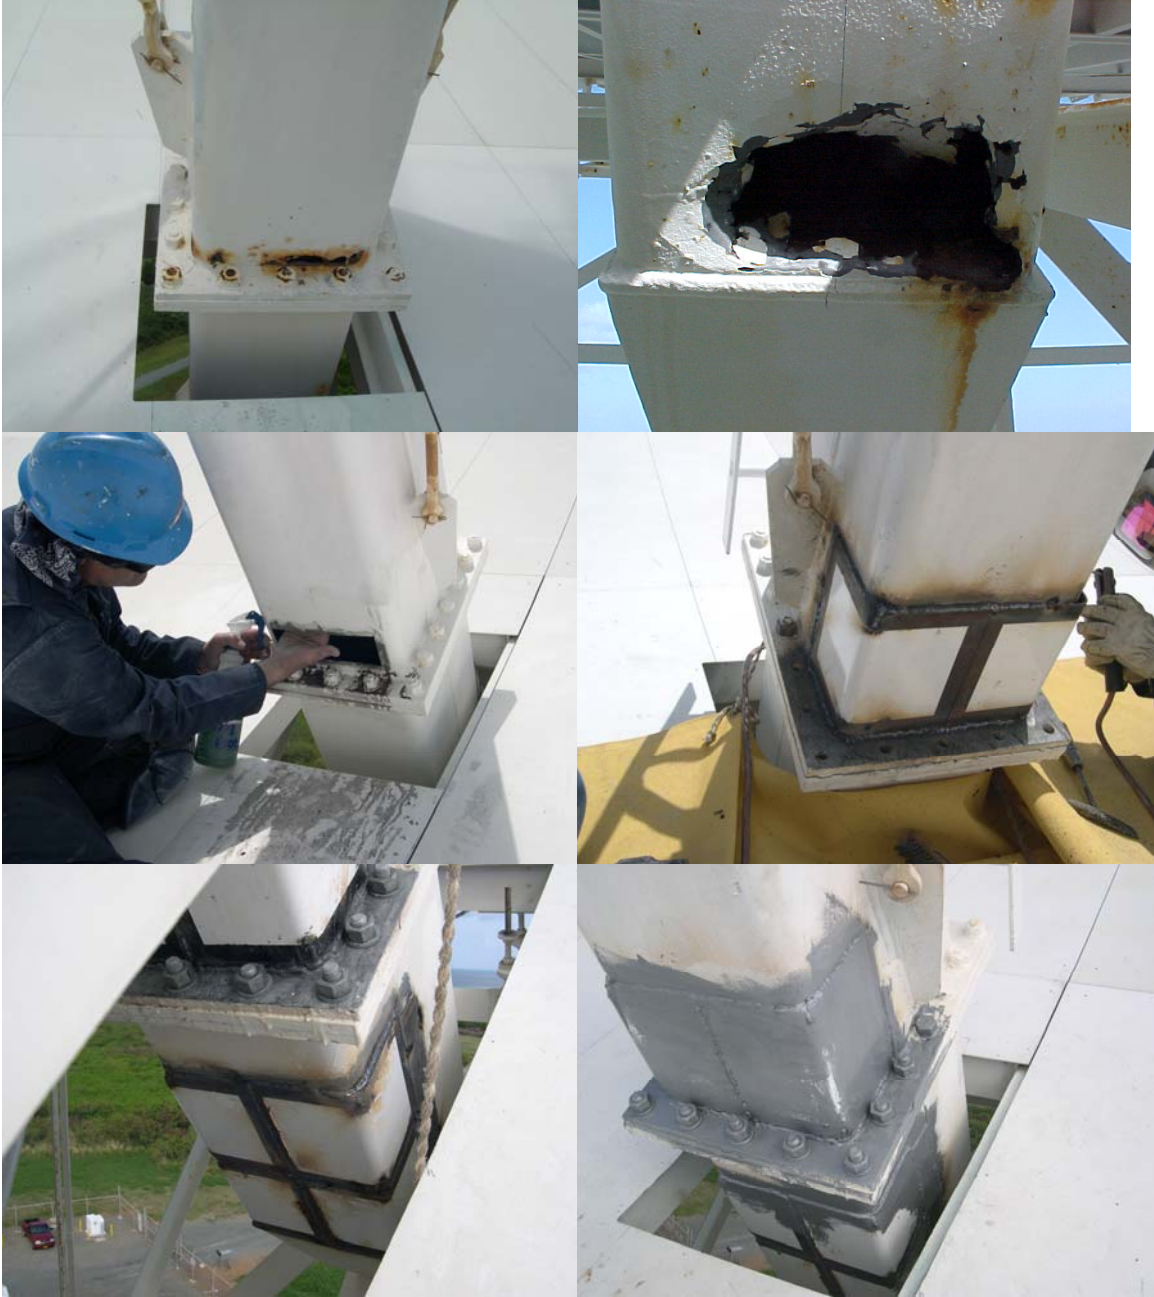
Rust holes were repaired in the ladder quad leg above and below the dish surface. All quad legs were inspected, patched and painted with rust bullet.

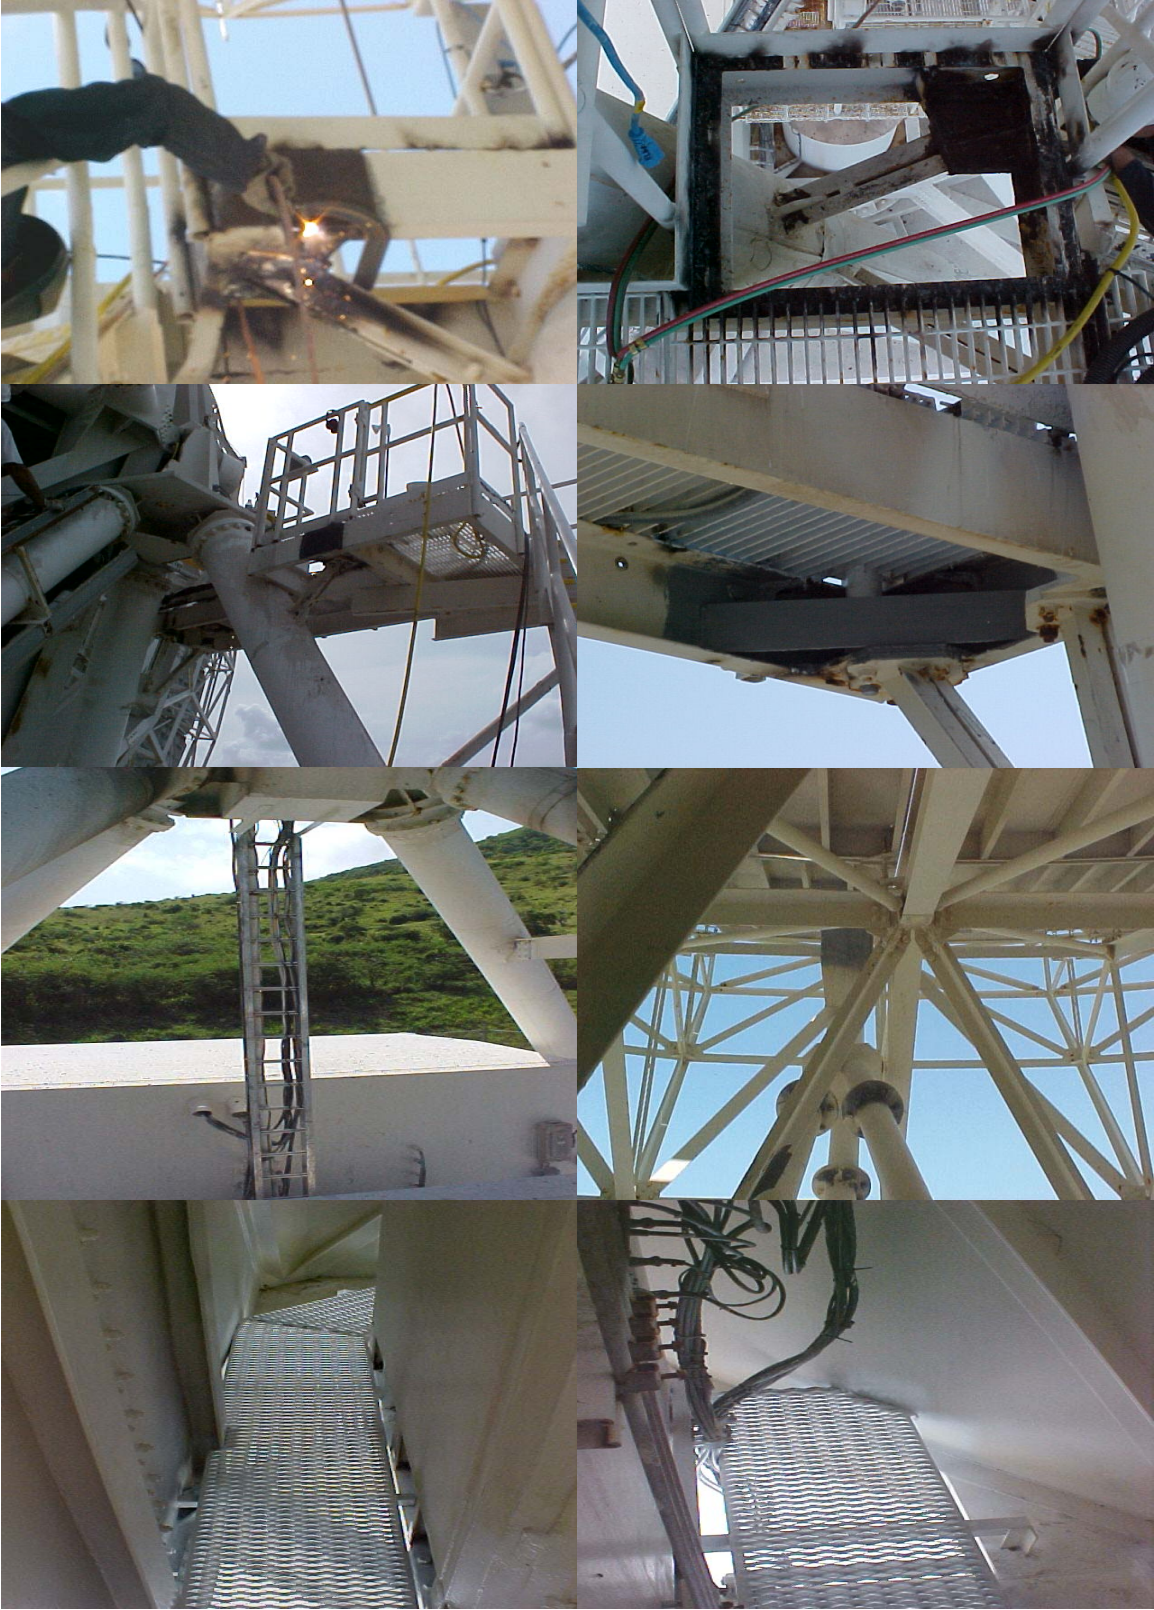
A tremendous amount of corrosion repair was accomplished. Much more work is still needed.

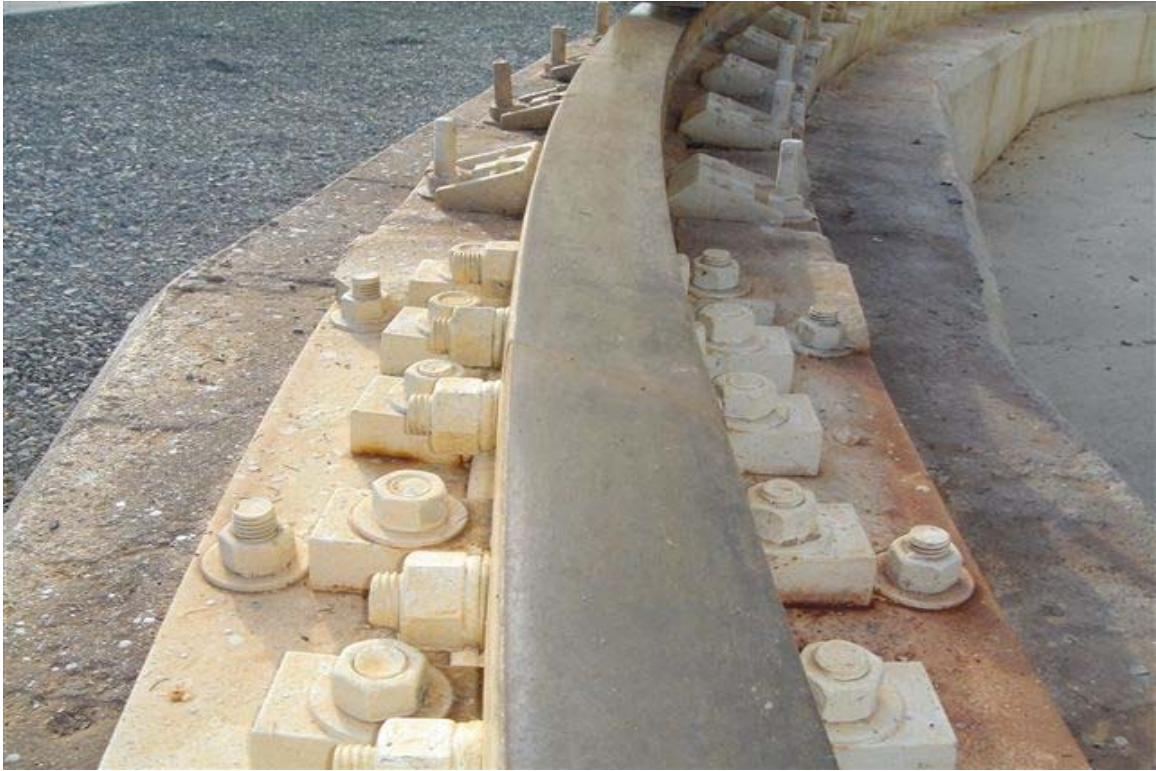
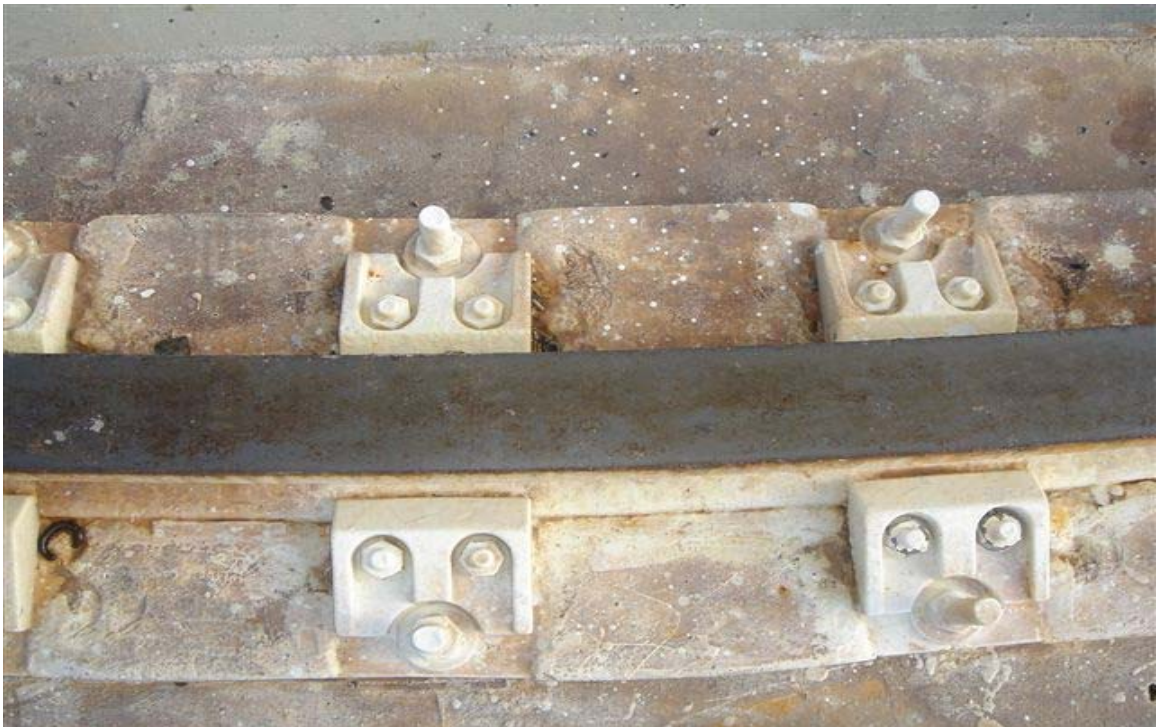
Site techs have done a great job removing vulchem and painting rail clips and splices. Overall the rail is in good condition.

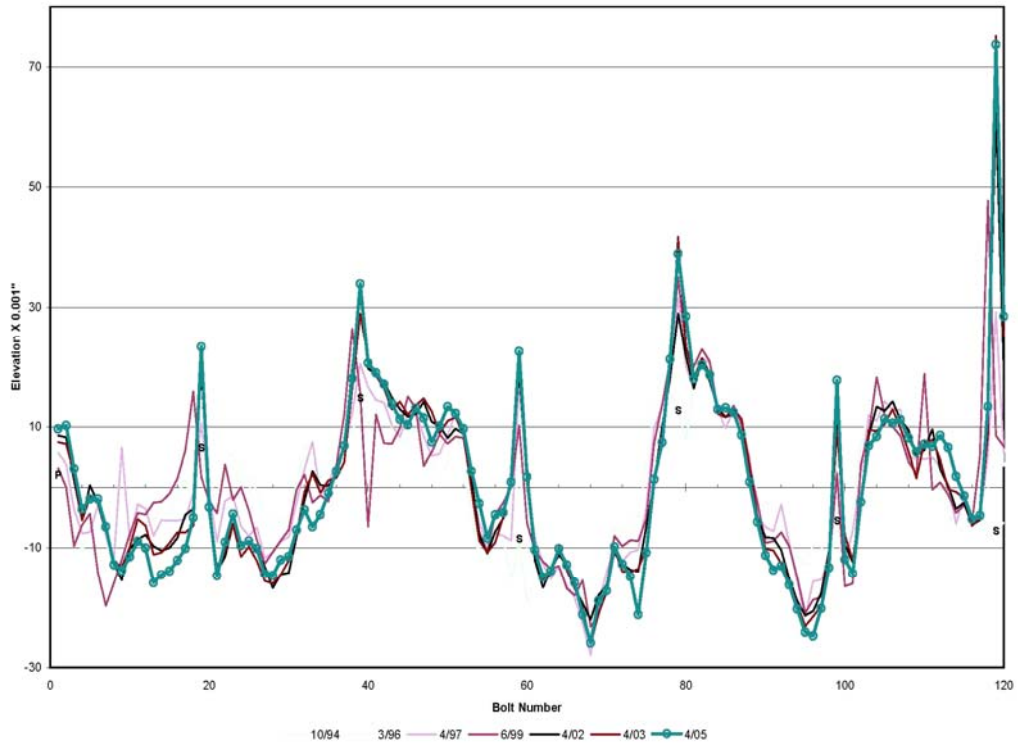
St Croix Az Rail Elevations
First Order Tilt Removed

It appears the rail splice at bolt # 119 the failing.
