VLBA Antenna Memo #60

Los Alamos, NM. VLBA Maintenance Visit July 28th – August 3rd 2005.

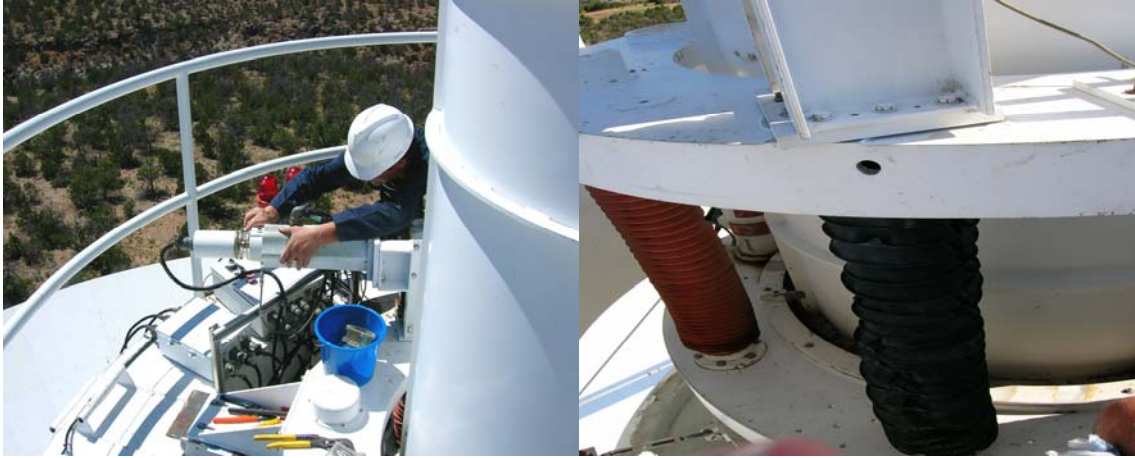
FRM was given a thorough inspection. A focus flex shaft was replaced and the new encoder coupling modification was installed. Both, 1st and 2nd screw bellows were replaced. Two bellows access holes were drilled in the mount.

FRM INA BEARING CHECK 50LBS PULL ON EAST MOTOR

East Travel:	+ .0005	West Travel:	- .0005
--------------	---------	--------------	---------

FRM INA BEARING CHECK 50LBS PULL ON WEST MOTOR

East Travel:	- .001	West Travel:	+ .001
--------------	--------	--------------	--------

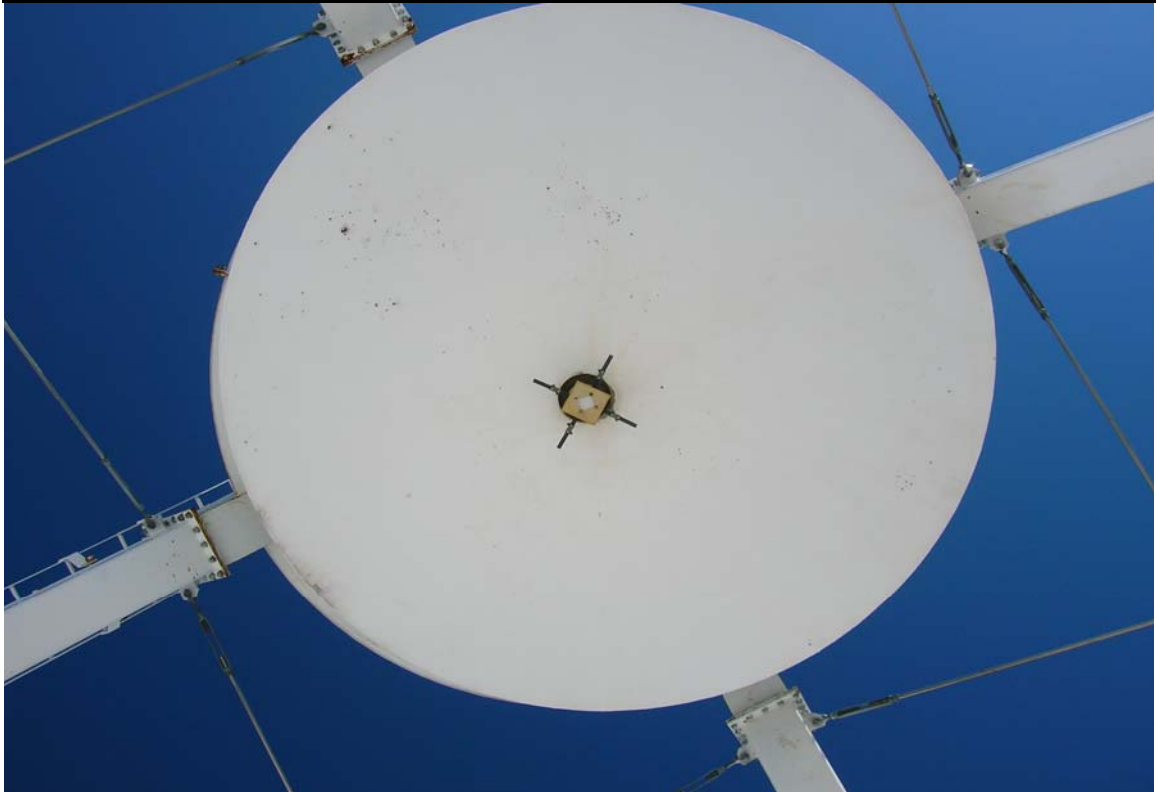
Sub reflector is in good condition. Three 1 inch holes were drilled in the center of the reflector for extra drainage. The snow tarp was removed.

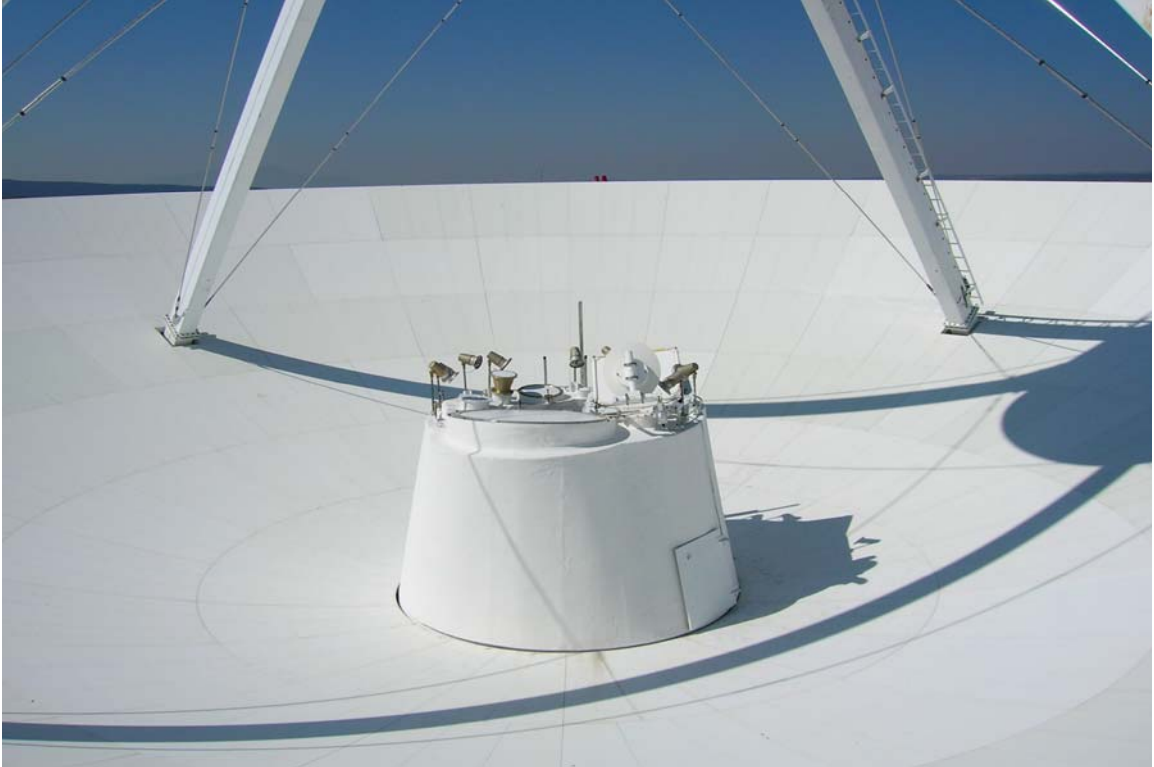
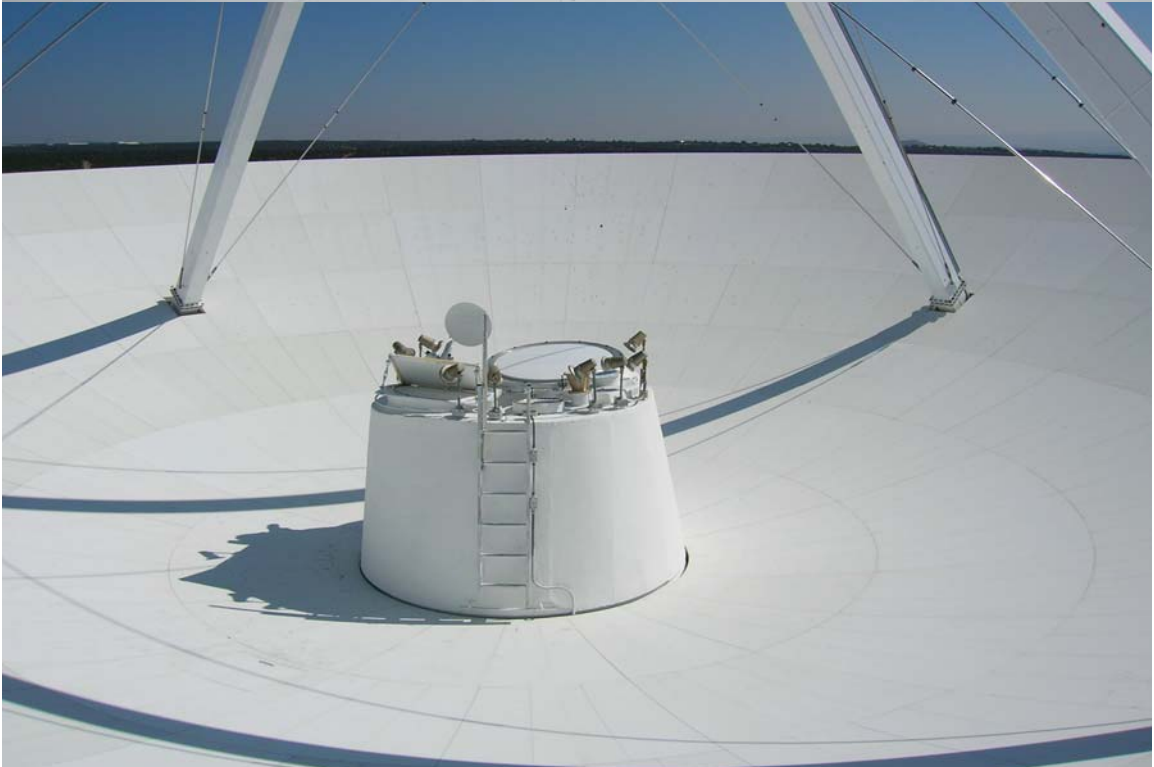
Dish panels, and the dish panels paint are in good condition. Guy wires are in good condition. Feed cone was spot sealed and painted with elastomeric.

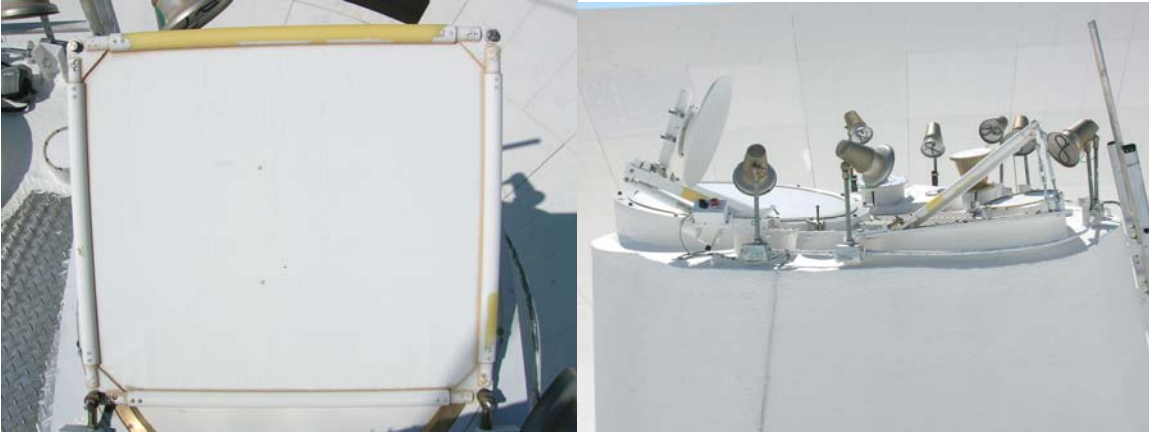
Dichroic reflector is good condition. Elipsoid reflector is in good condition.

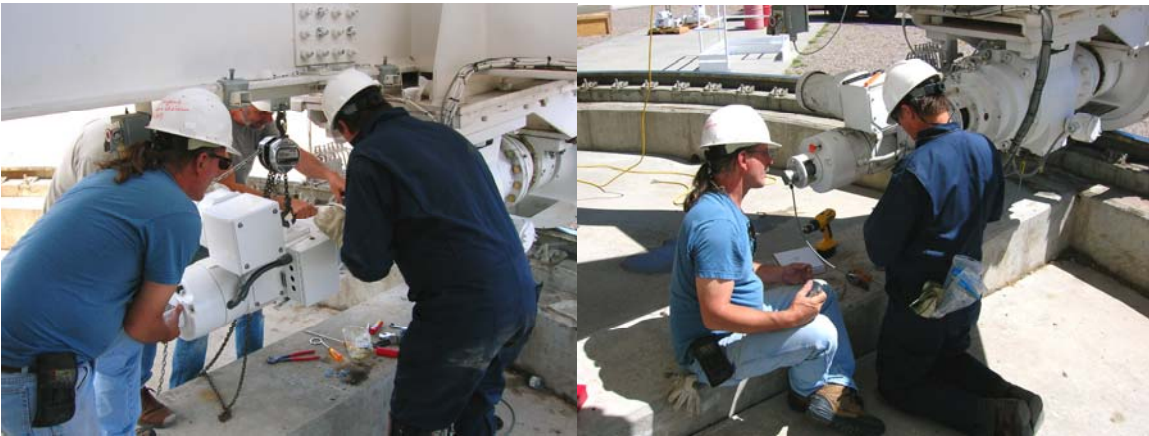
Elevation #2 and azimuth #1 motors were replaced. Digital tachometers were installed and calibrated on the azimuth and elevation motors.

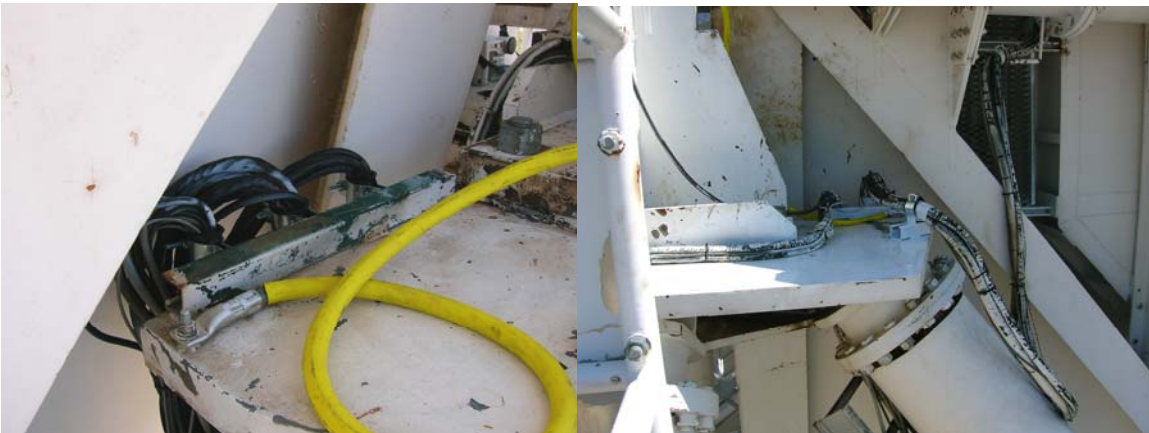
Both the encoder and synchro side elevation cable wraps were repaired by repositioning and replacing strain relief brackets. Both sides elevation ground cables were replaced.

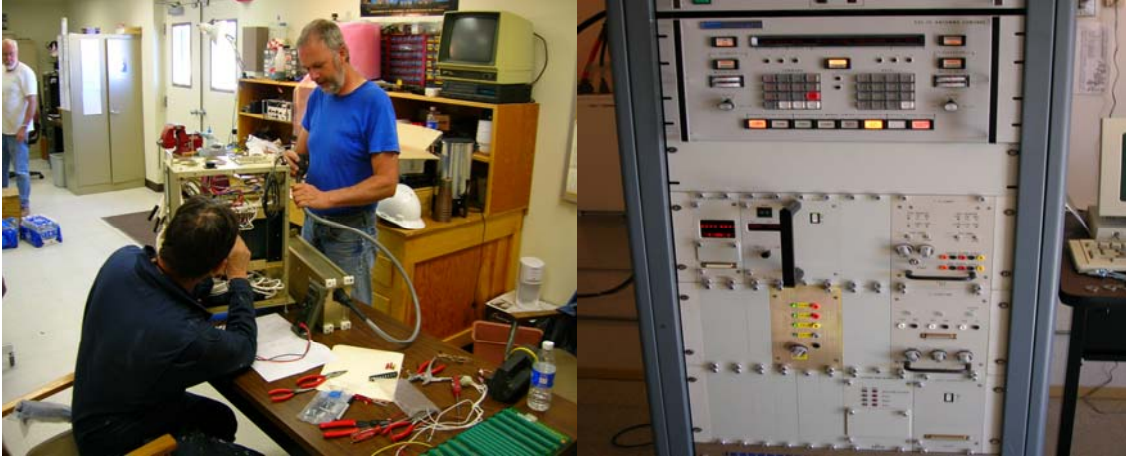
The ACU backplane upgrade was installed and tested. The ACU power supply modification had been previously installed by Paul Johnson.

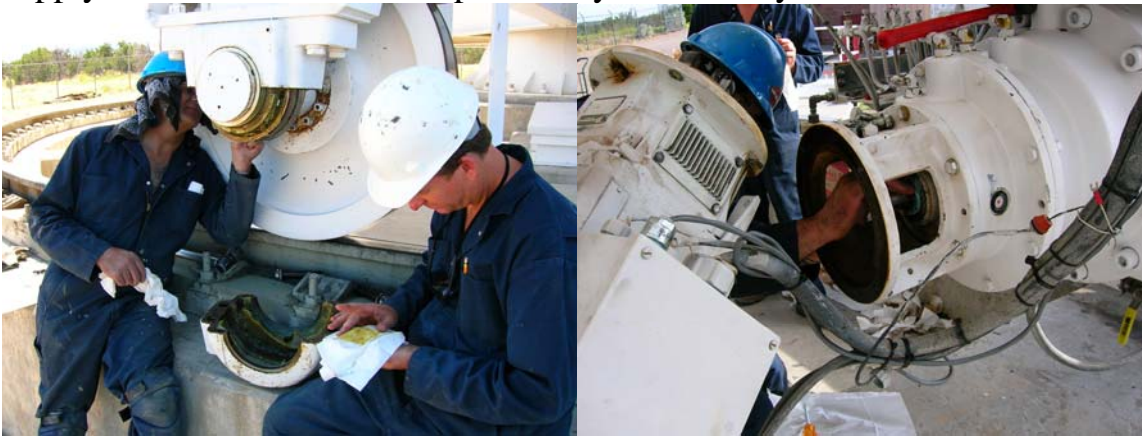
Azimuth wheel bearings were inspected. Azimuth #2 gear box seal was replaced with a double seal setup.

AZIMUTH BEARING GREASE INSPECTION

INNER BEARING	OUTER BEARING
D1	New drive wheel.	New drive wheel.
D2	New drive wheel.	New drive wheel.
I1	OK	OK
I2	A few flakes.	OK
All bearings were very well lubricated.

ELEVATION BEARING GREASE INSPECTION

Encoder	Good grease with no metal flakes.
Synchro	Good grease with no metal flakes.
Excess grease was removed from the encoder side bearing.

Pintle bearing is well lubricated with no metal flakes.

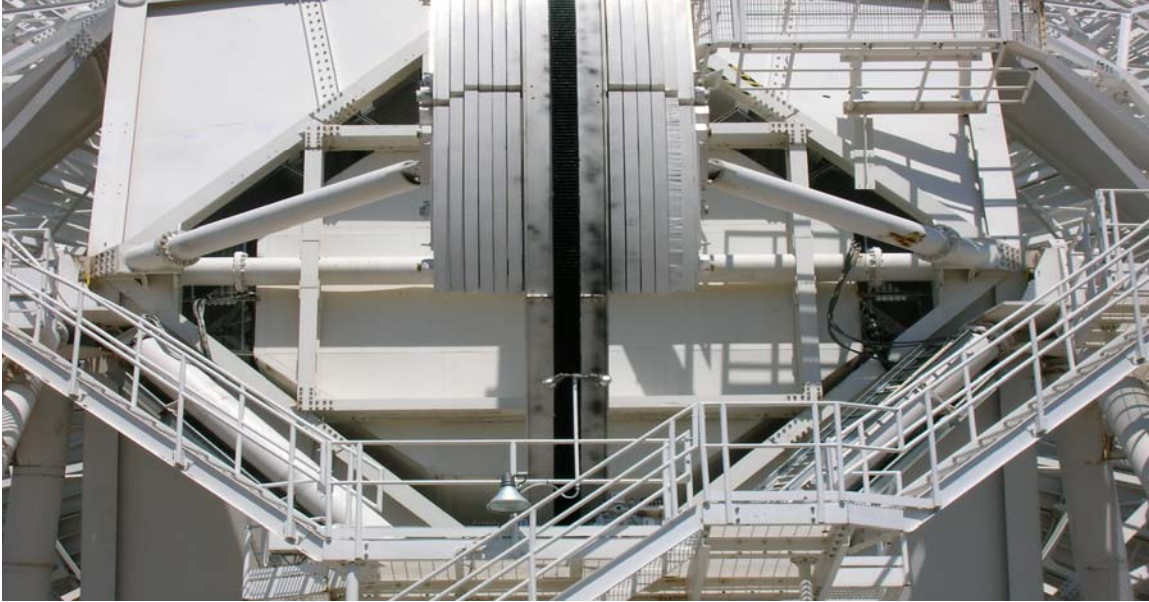
Elevation axle has no visible signs of cracks. Paint is in good condition.

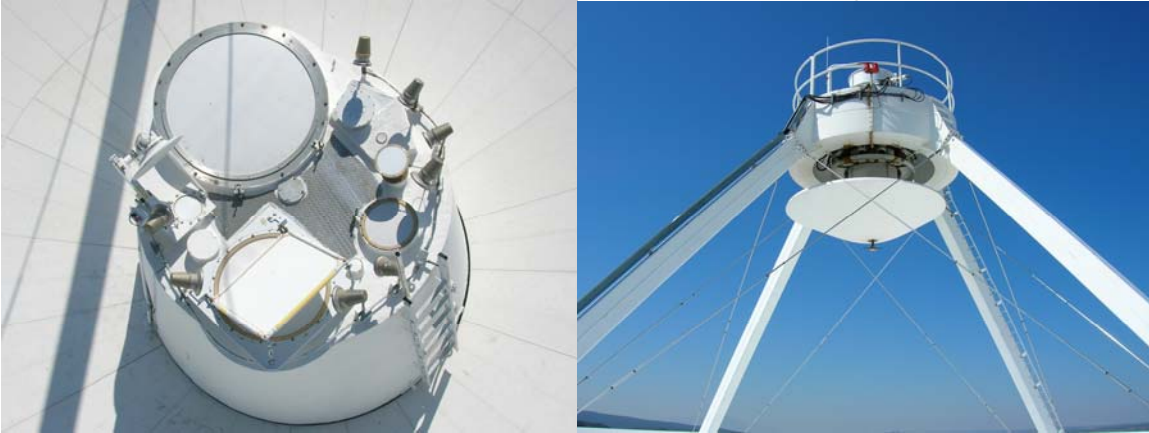
Feed windows & heaters are in good condition. Apex paint is in good shape.

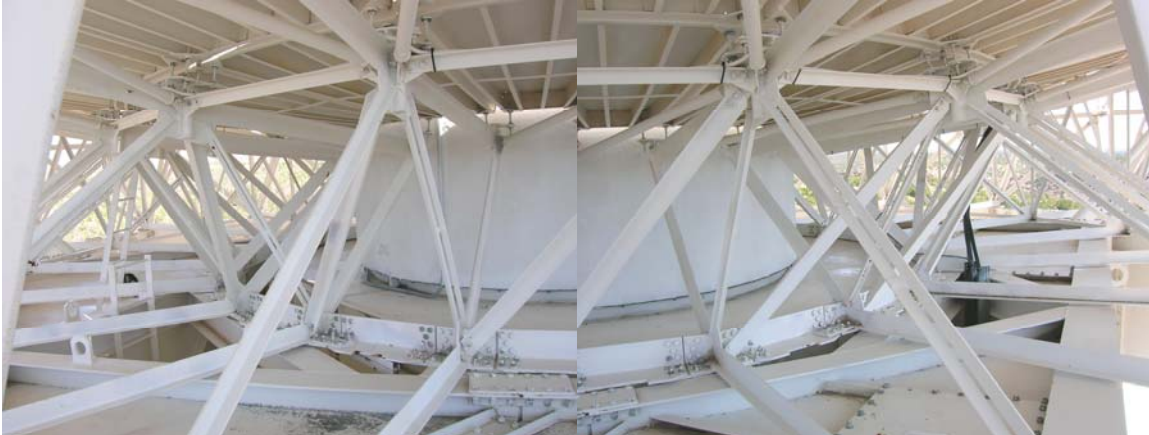
Backup structure paint is in good condition.

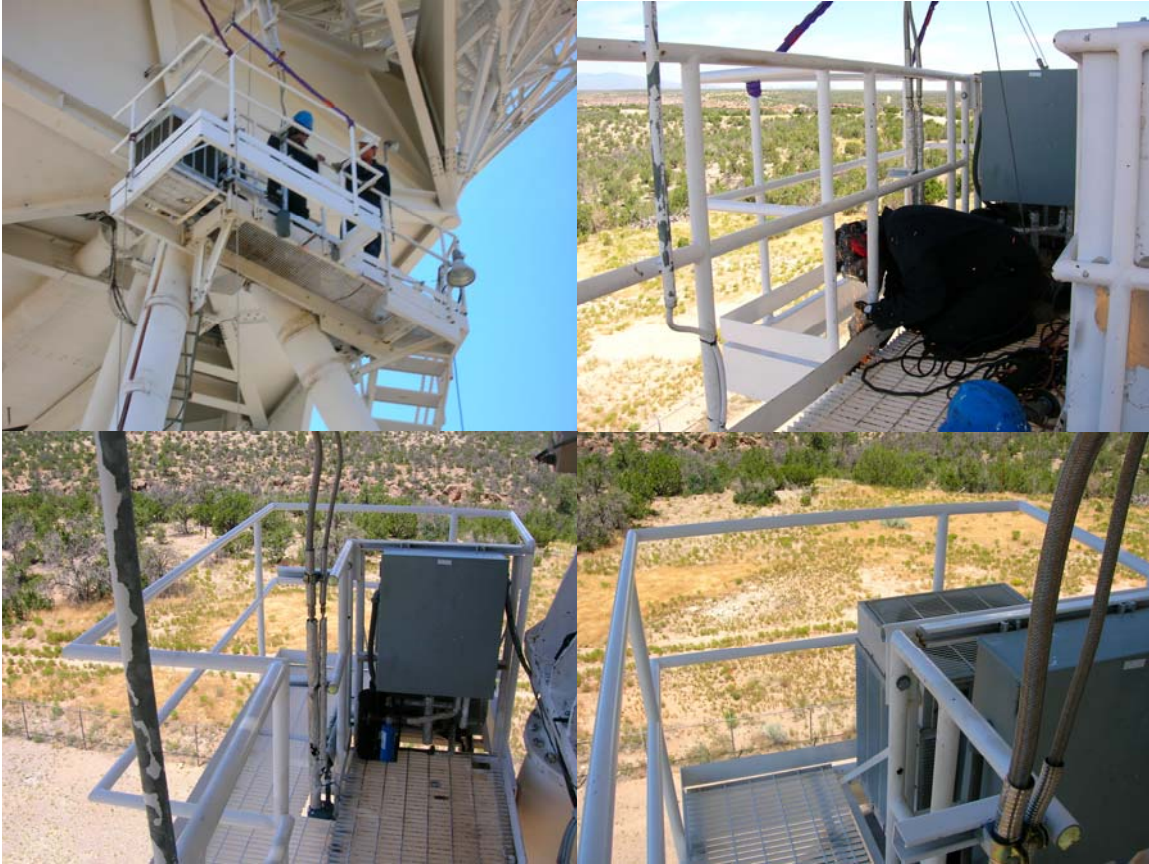
A new HVAC platform extension was installed. Maintenance performed on the vertex room compressor/condenser can now be completed safely.

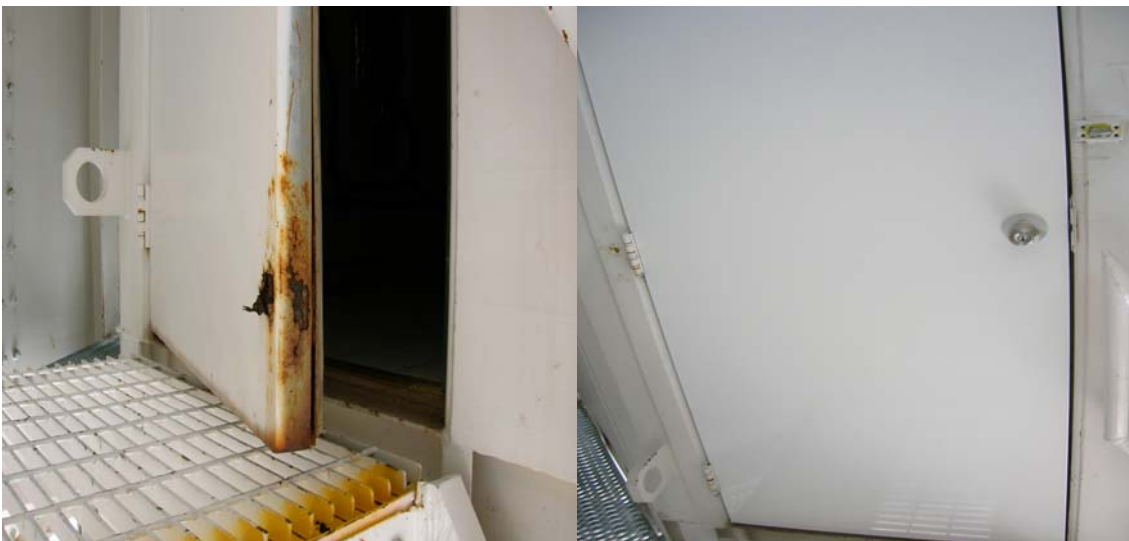
The vertex room door was replaced.

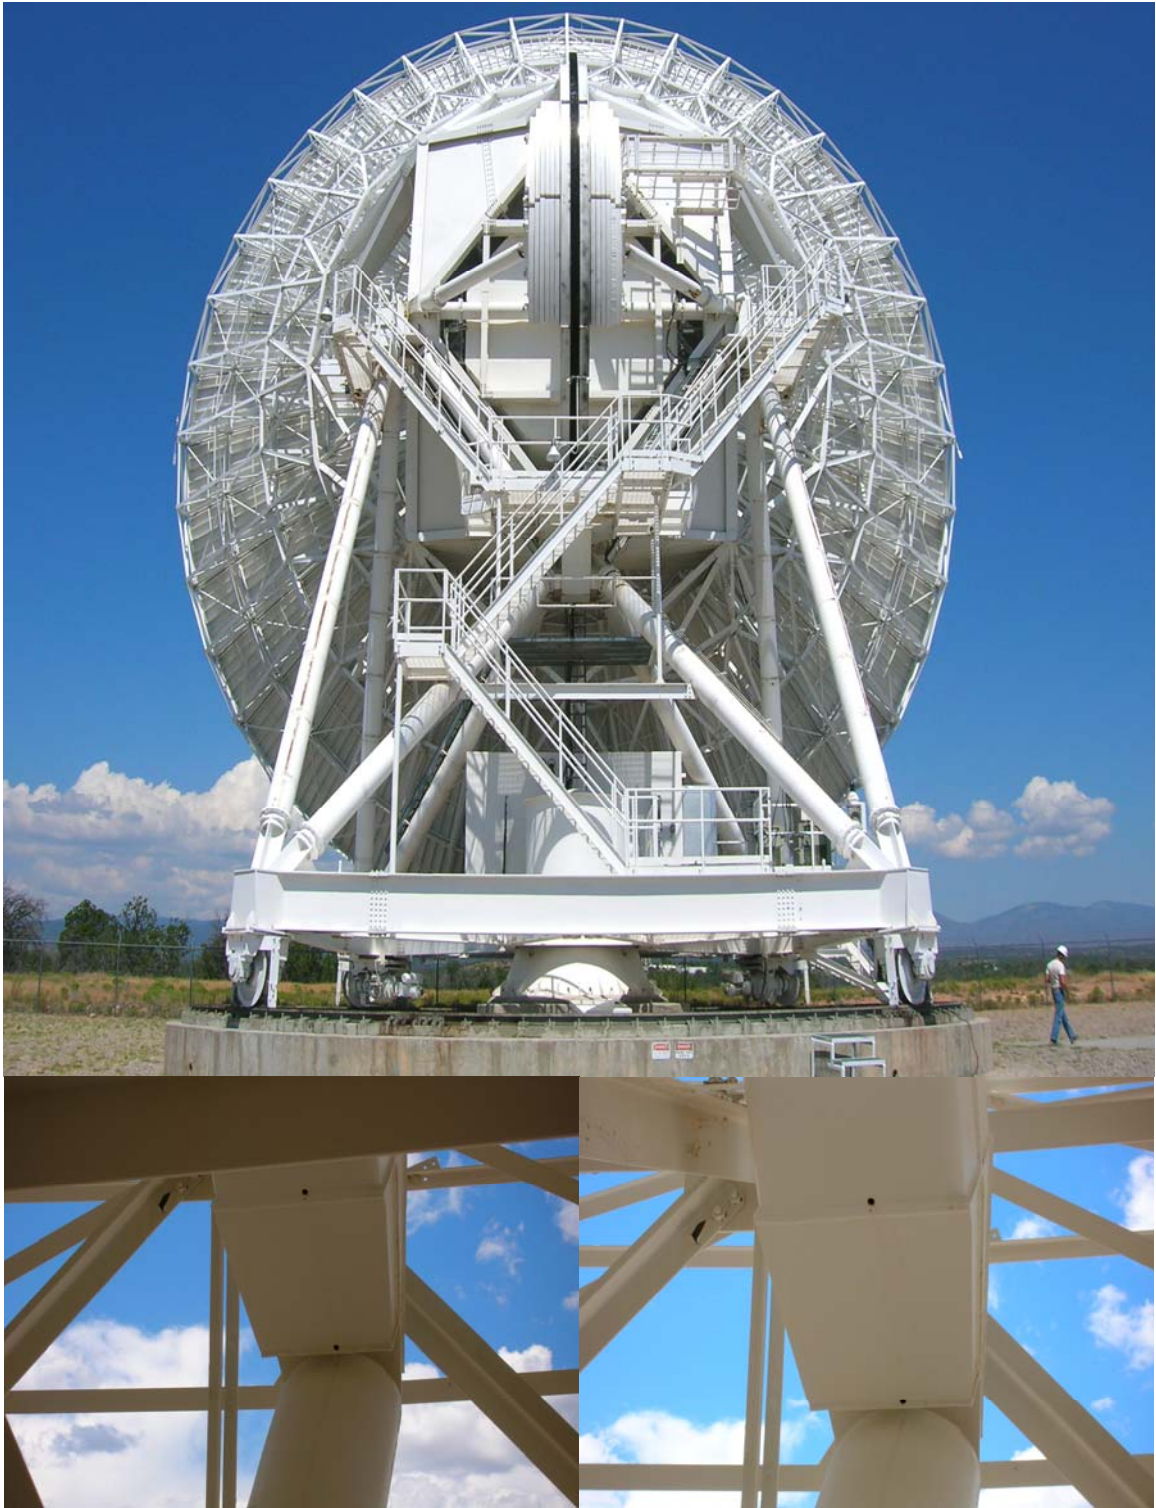
Overall the paint on the Los Alamos antenna is in good condition. Notice the drain holes drilled in the Quad Legs.

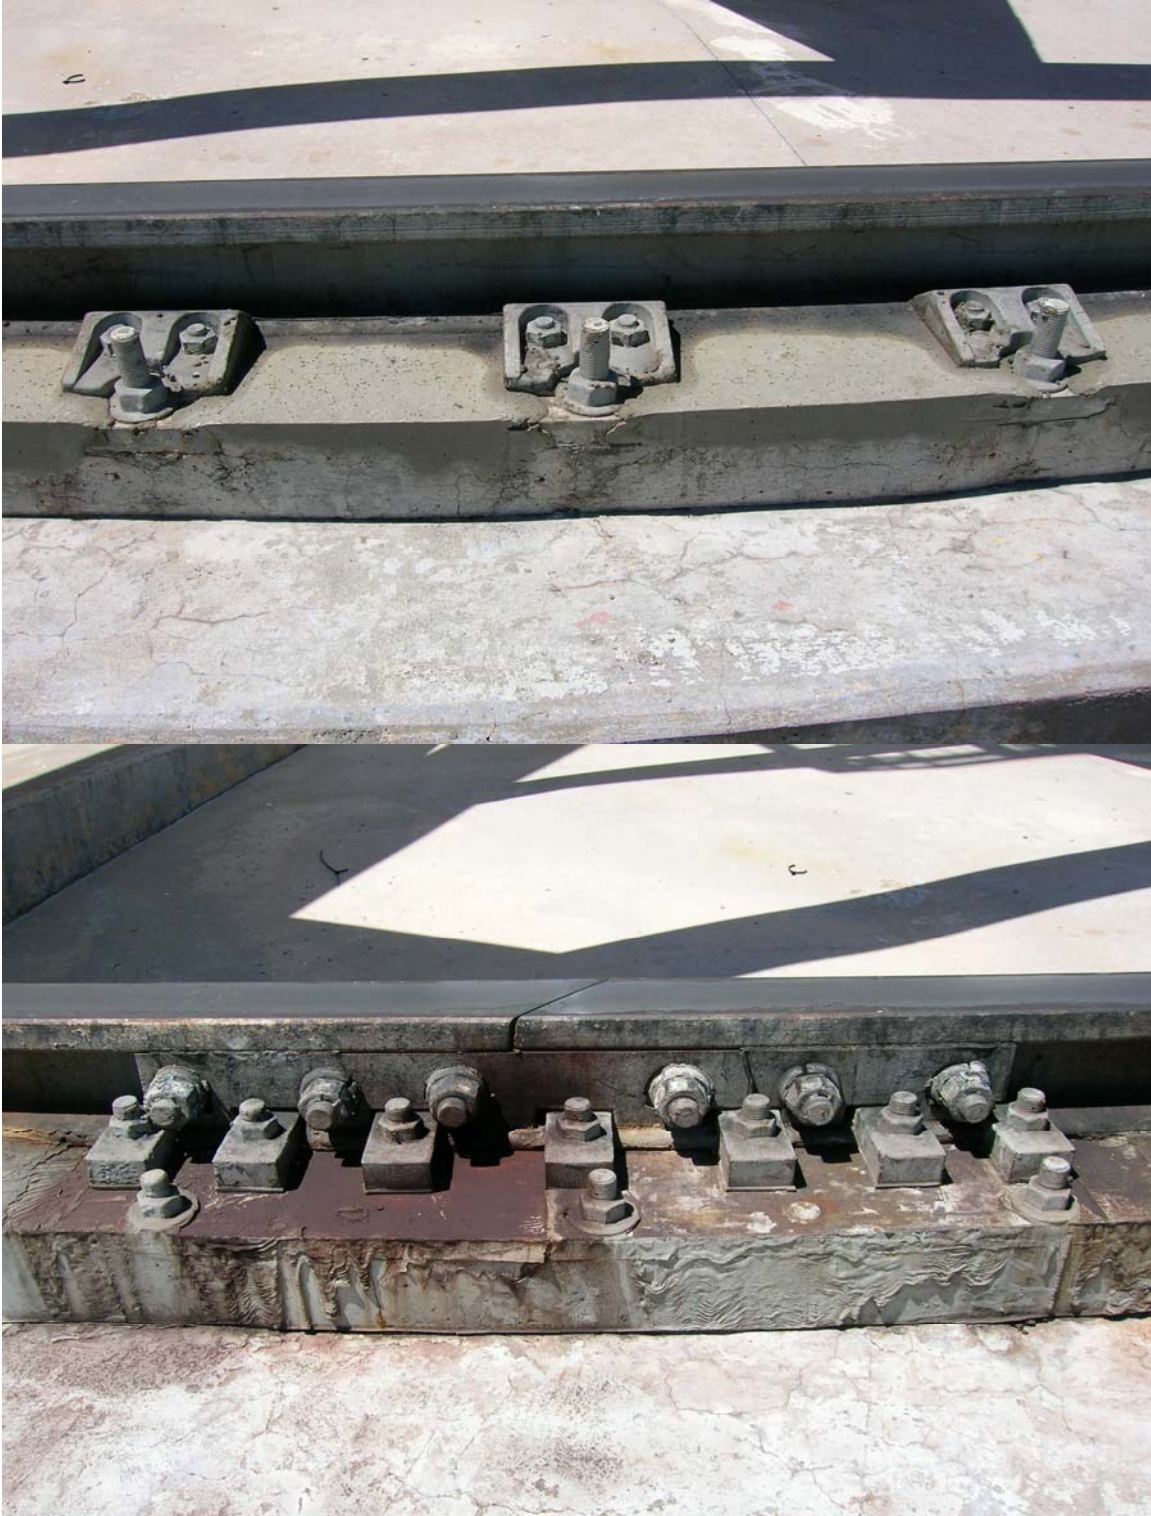
Rail is in good condition. Site techs will remove remaining vulchem.

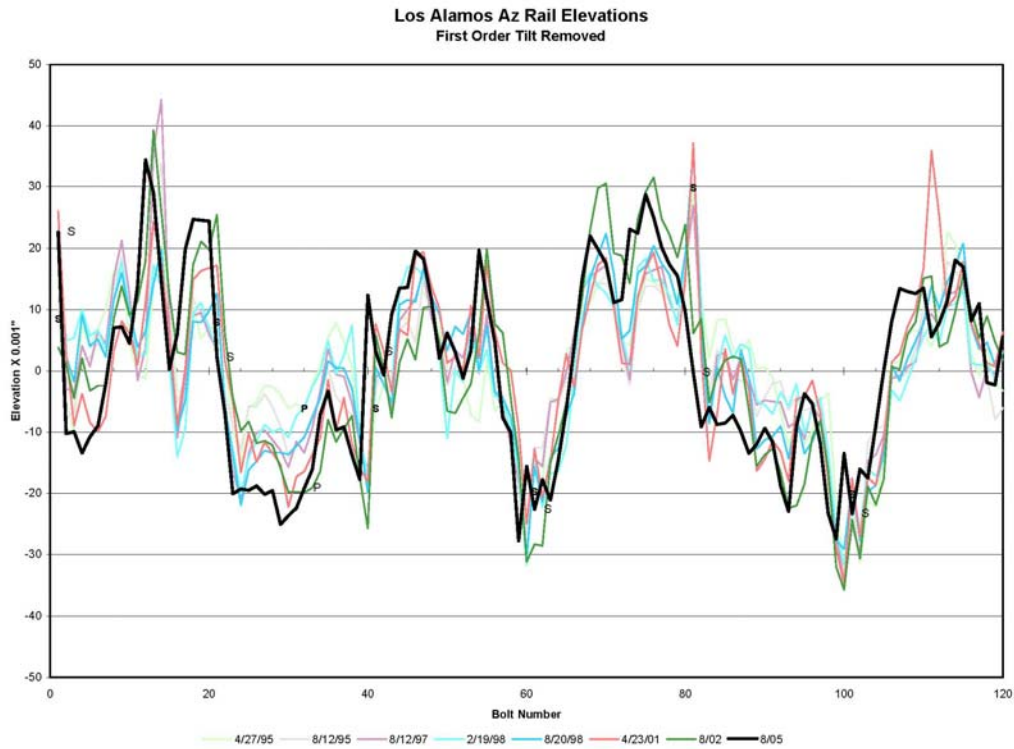
Los Alamos antenna rail elevations.
