National Radio Astronomy Observatory
Socorro, New Mexico
VLBA Antenna Memo #63

Kitt Peak, Arizona. VLBA Maintenance Visit May 16-22, 2006.
Team members consisted of Steve Aragon, Eric Carlowe, Kelly Greene,
Lonnie Guin, Ken Lakies and John Wall. VLBA Site Technicians Ray
McFarlin and Duane Clark assisted in all areas of antenna maintenance.

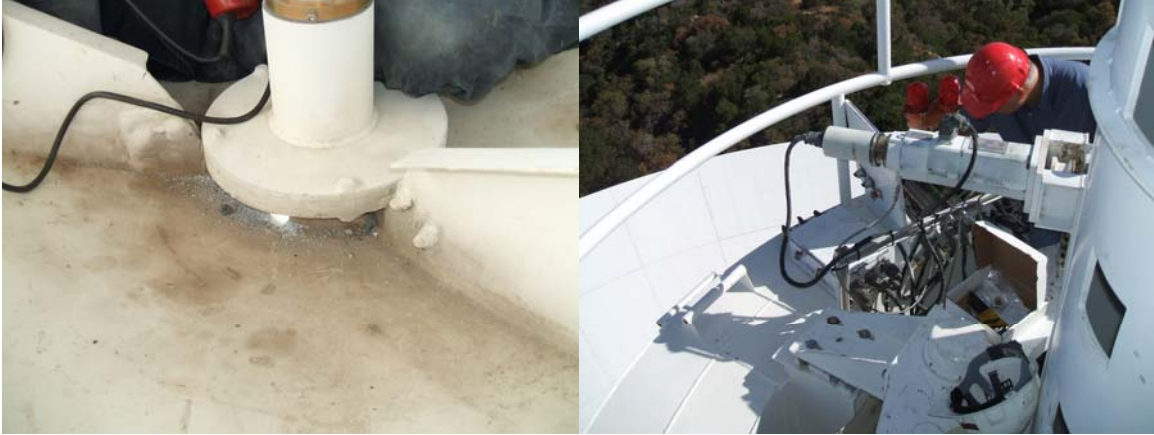
FRM was given a thorough inspection and the focus flex shaft was replaced. Rotation was modified to operate on the West position feedback motor only. The sub reflector did not need rebalancing. The snow tarp was removed and three 1 inch drain holes were drilled in the center of the sub reflector.

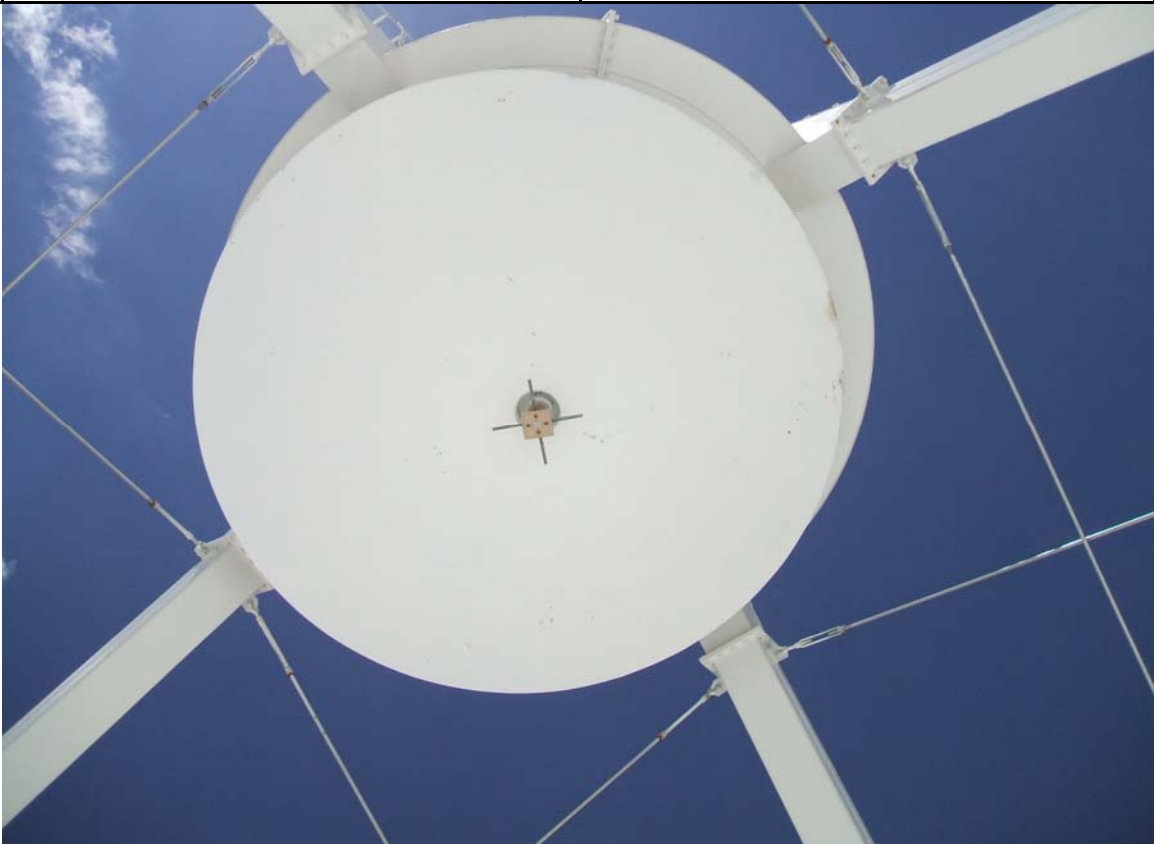
Sub reflector is in excellent condition

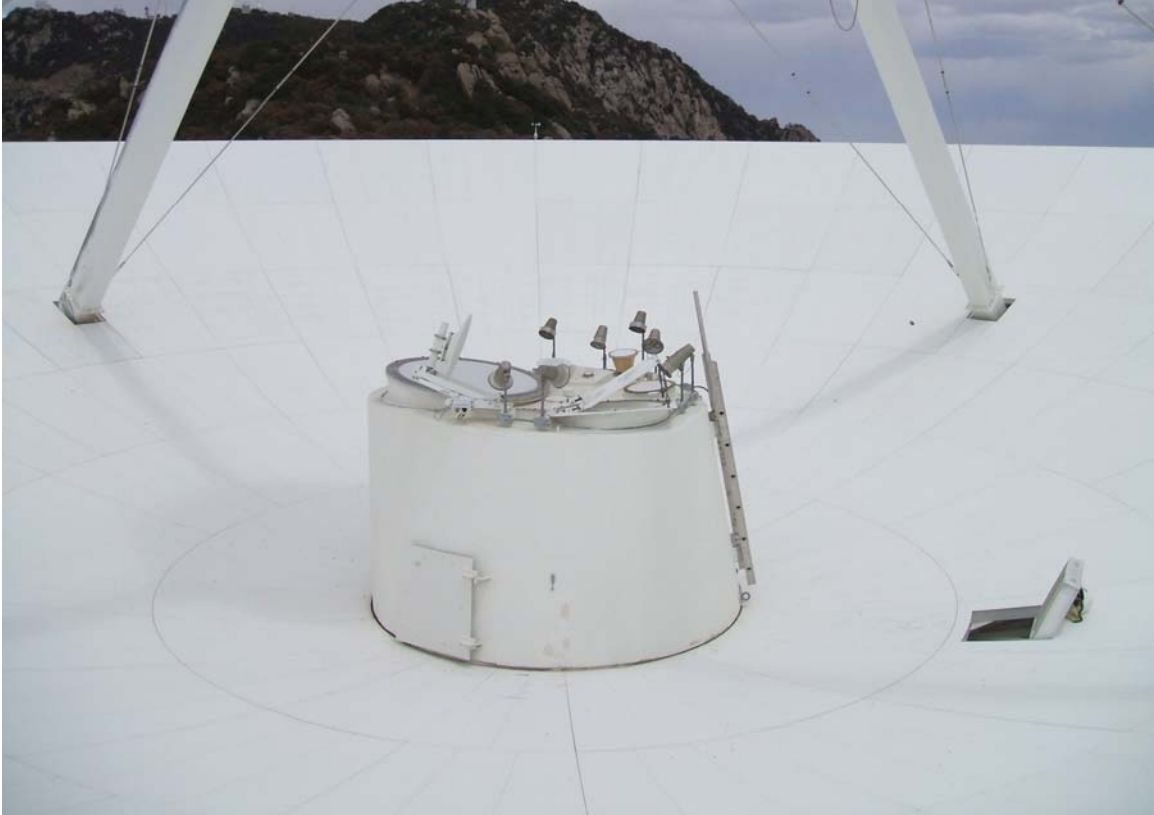
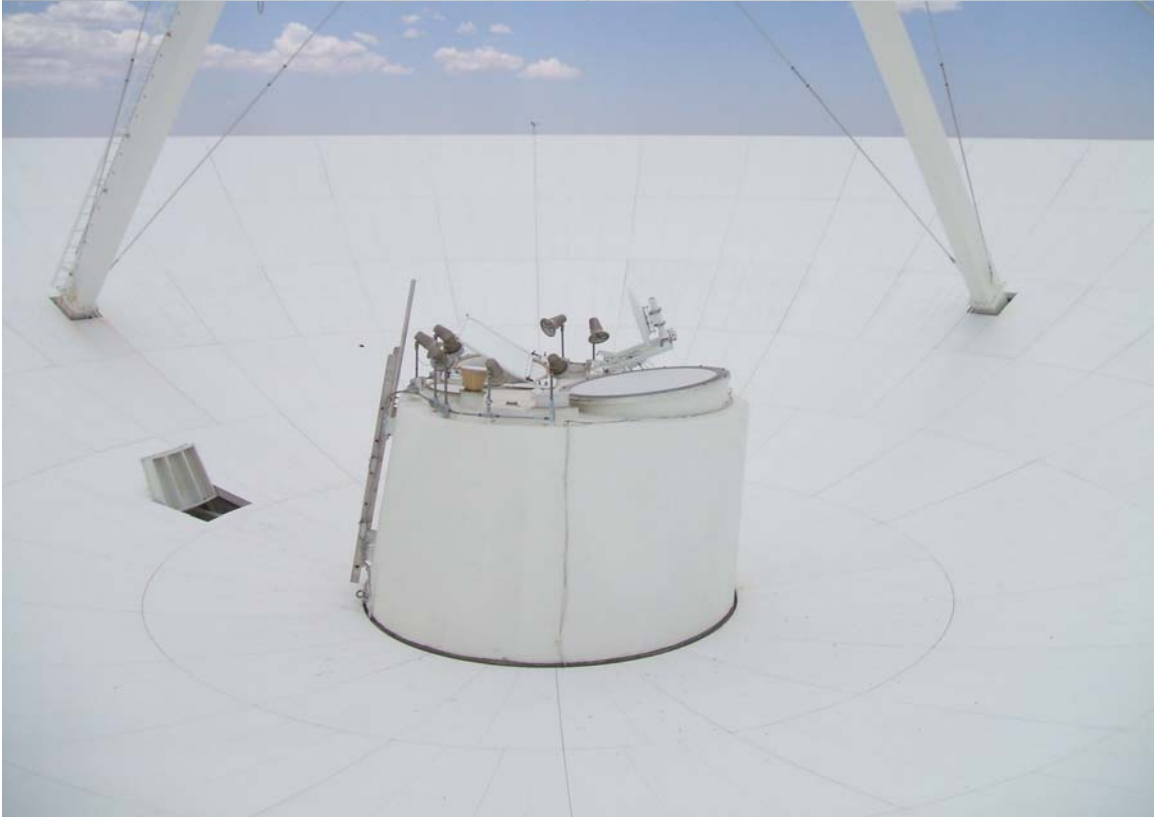
Dish panels are in good condition. Feed cone is in good condition.

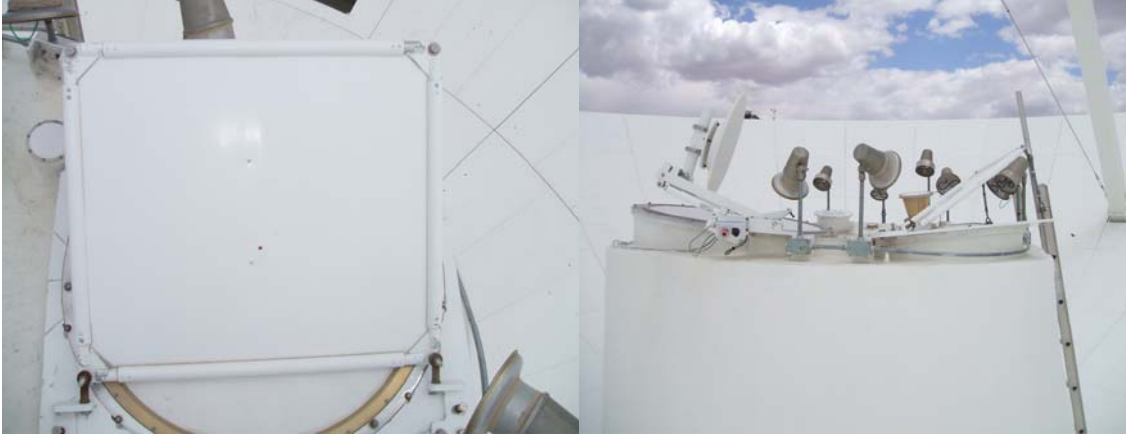
Dichroic reflector has a small vertical delamination in its center. Dichroic panel did not need replacing. Ellipsoid reflector is in good condition.

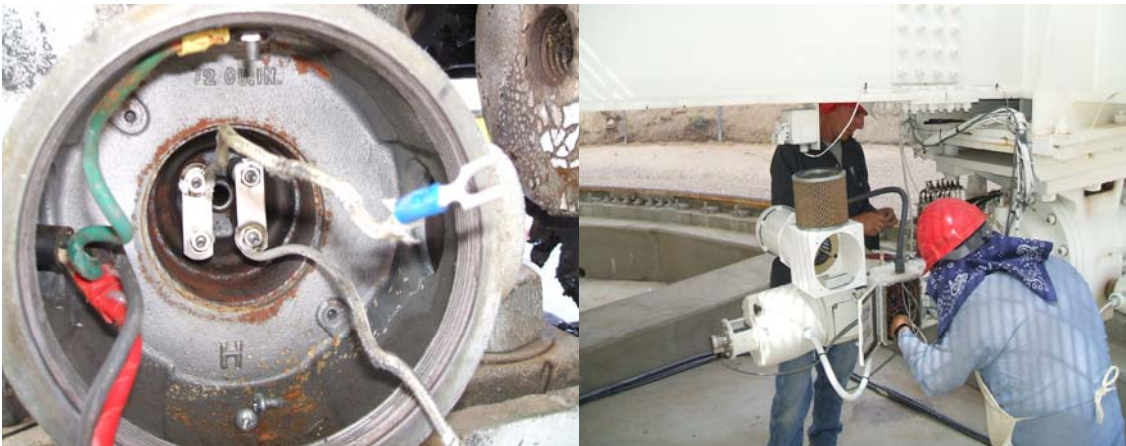
Elevation #2 gear box heater thermostat was replaced. New air boxes were installed on all four motors. Azimuth #2 blower motor was replaced.

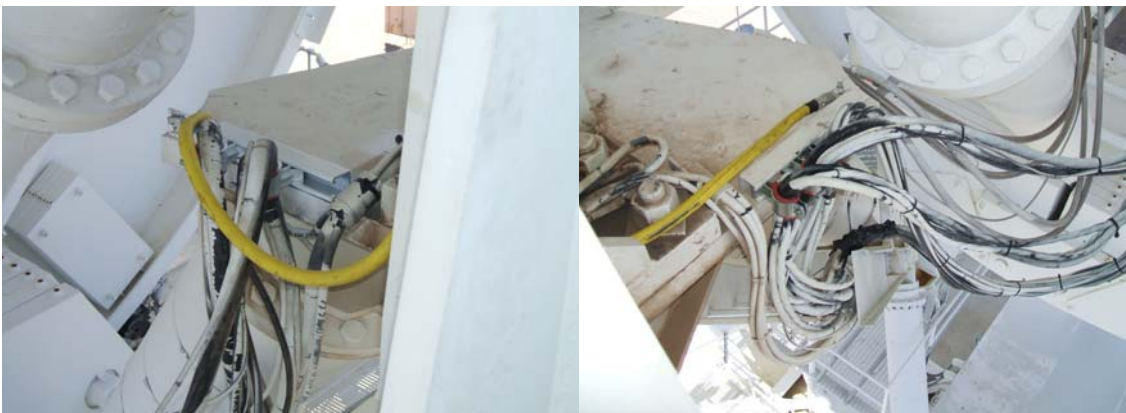
Synchro and Encoder side elevation cable wraps were repaired. Both sides' elevation ground cables were replaced.

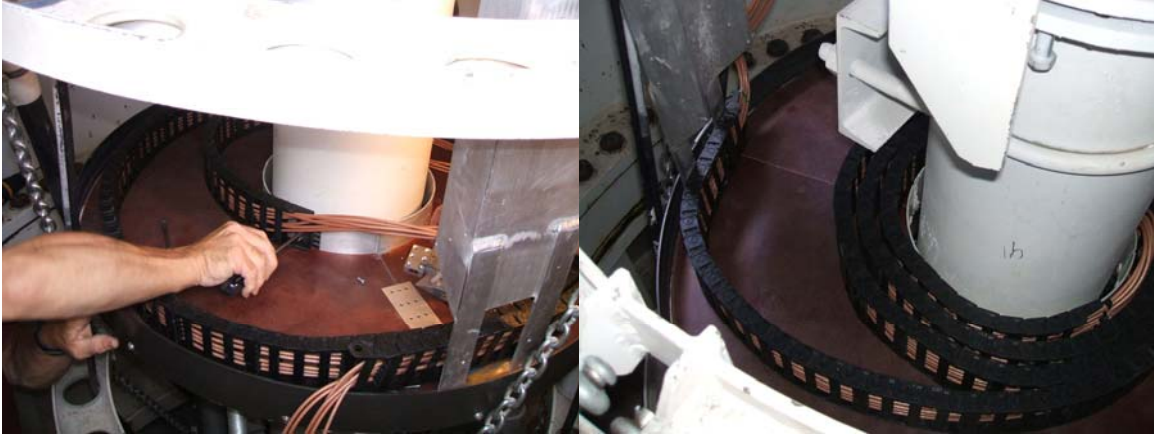
The new Azimuth cable wrap was installed and tested.

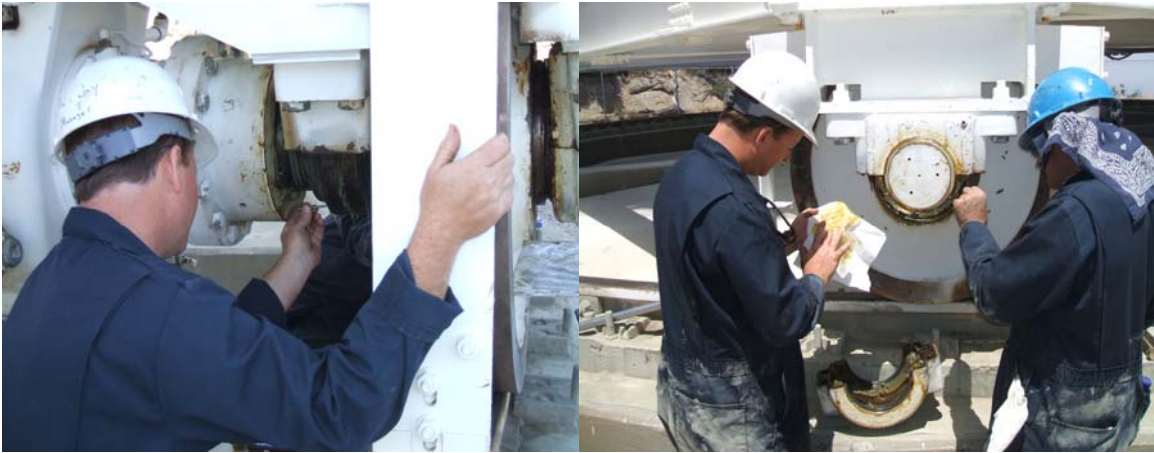
Azimuth wheel bearings were inspected, none were replaced.

INNER BEARING	OUTER BEARING
D1	Good, a few small flakes.	Good, no metal.
D2	Good, no metal.	Good, no metal.
I1	Good, no metal.	Good, no metal.
I2	Good, no metal.	Good, a few small flakes.
All bearings are very well lubricated.

Encoder	Good grease with no metal flakes.
Synchro	Good grease with no metal flakes.
All bearings are very well lubricated.

Pintle bearing is well lubricated with no metal flakes.

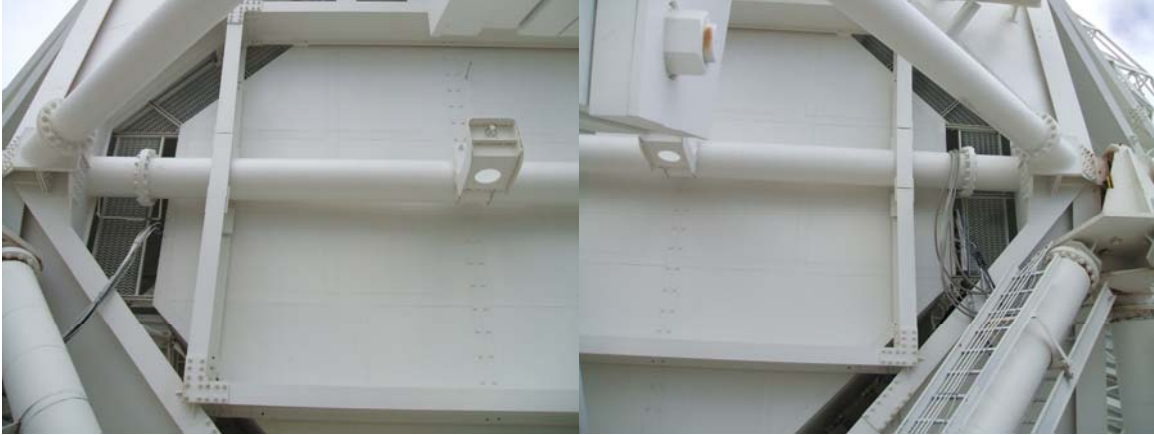
Elevation axle has no visible signs of cracks. Paint is in Good condition.

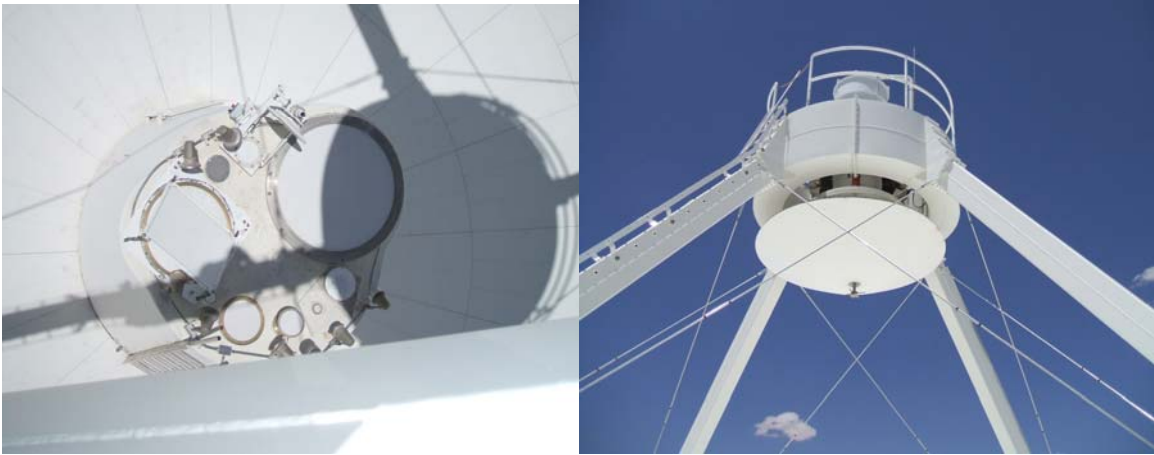
Feed heaters and FE windows are in good condition. Apex paint is in good condition.

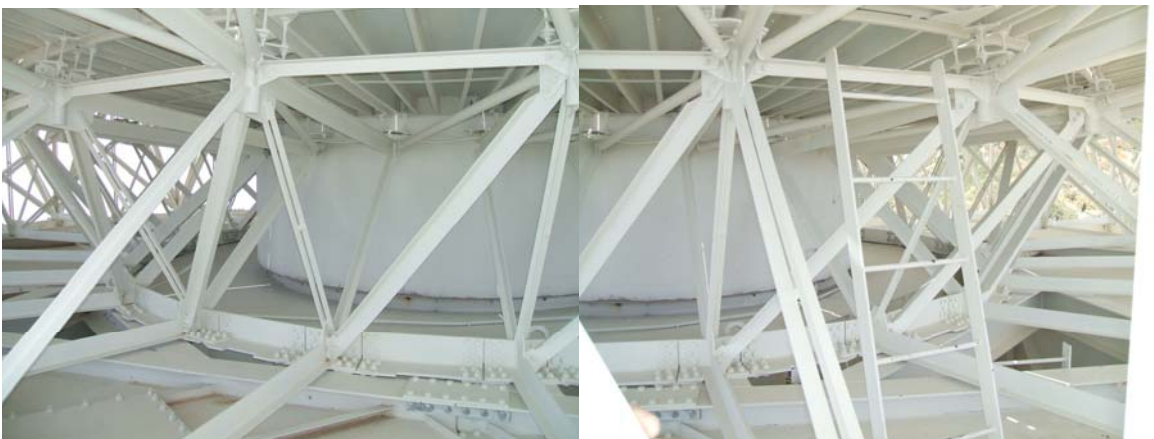
Antenna backup structure is in good condition. Paint is in good condition

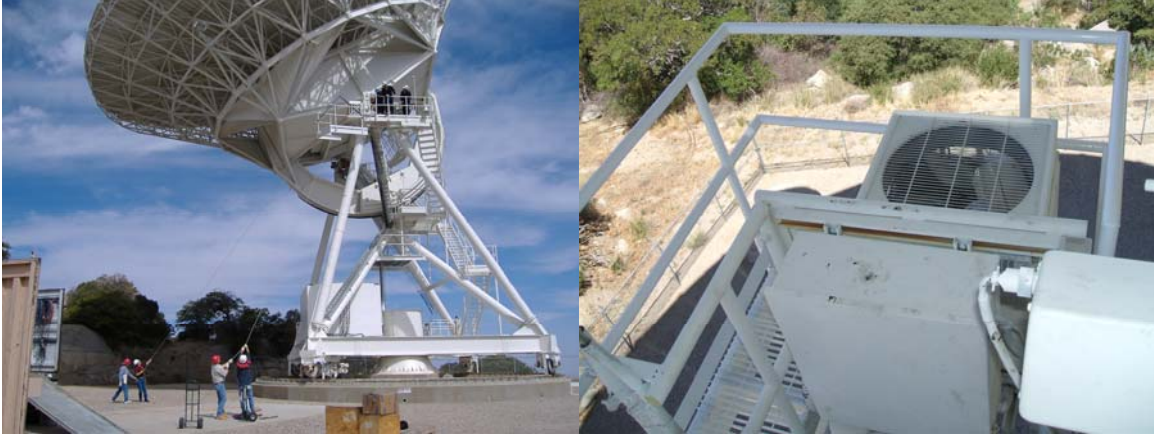
A new HVAC platform extension was installed.

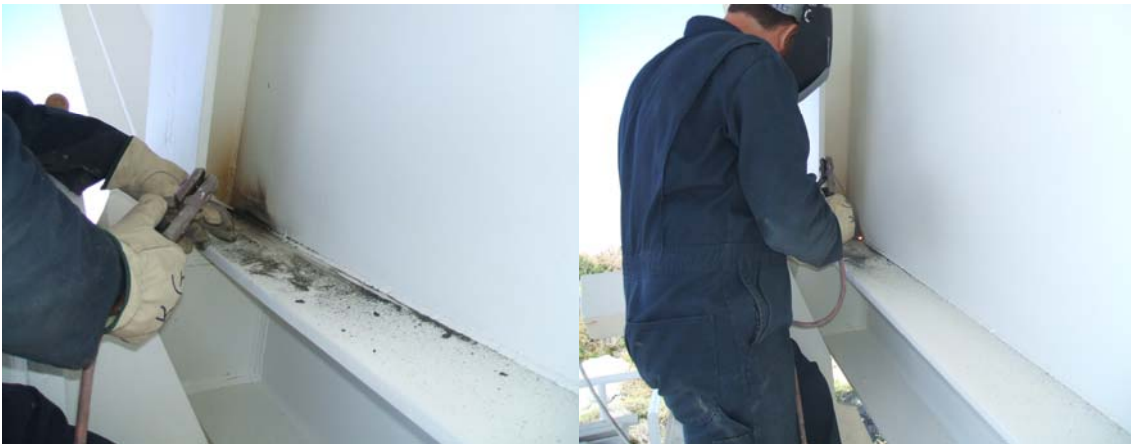
A four inch crack was repaired above the synchro side elevation axle.

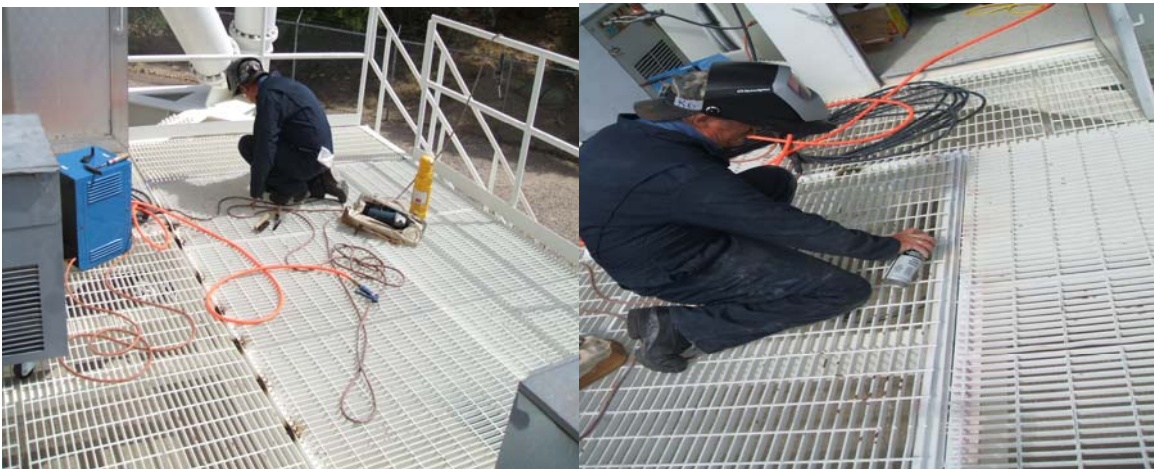
A two inch gap in the pedestal platform grating was repaired.

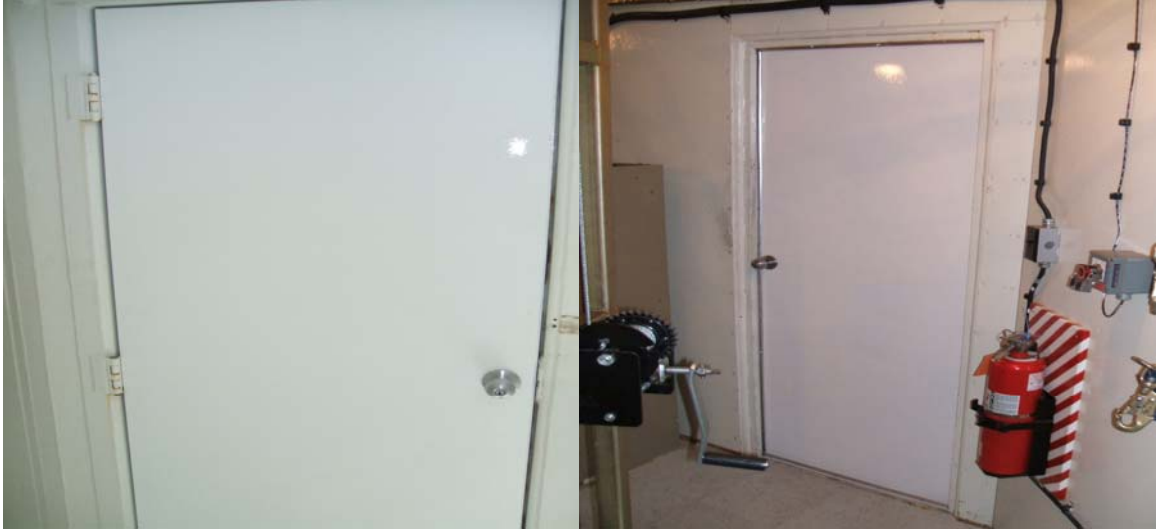
The Vertex room door was replaced.

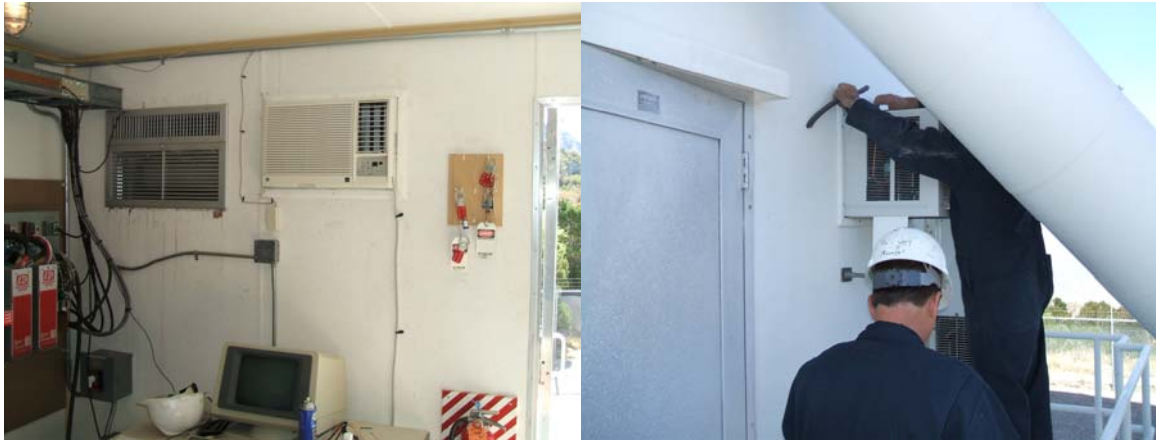
A new back up AC was installed for the Pedestal room electronics.

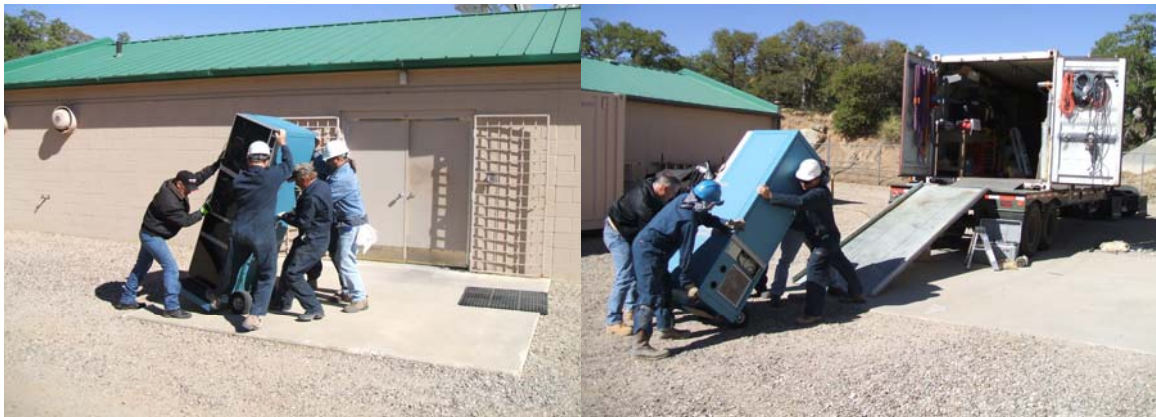
MKIII recorders were replaced by the new MKV recording system. Both MKIII recorders were loaded into the Tiger Team container.

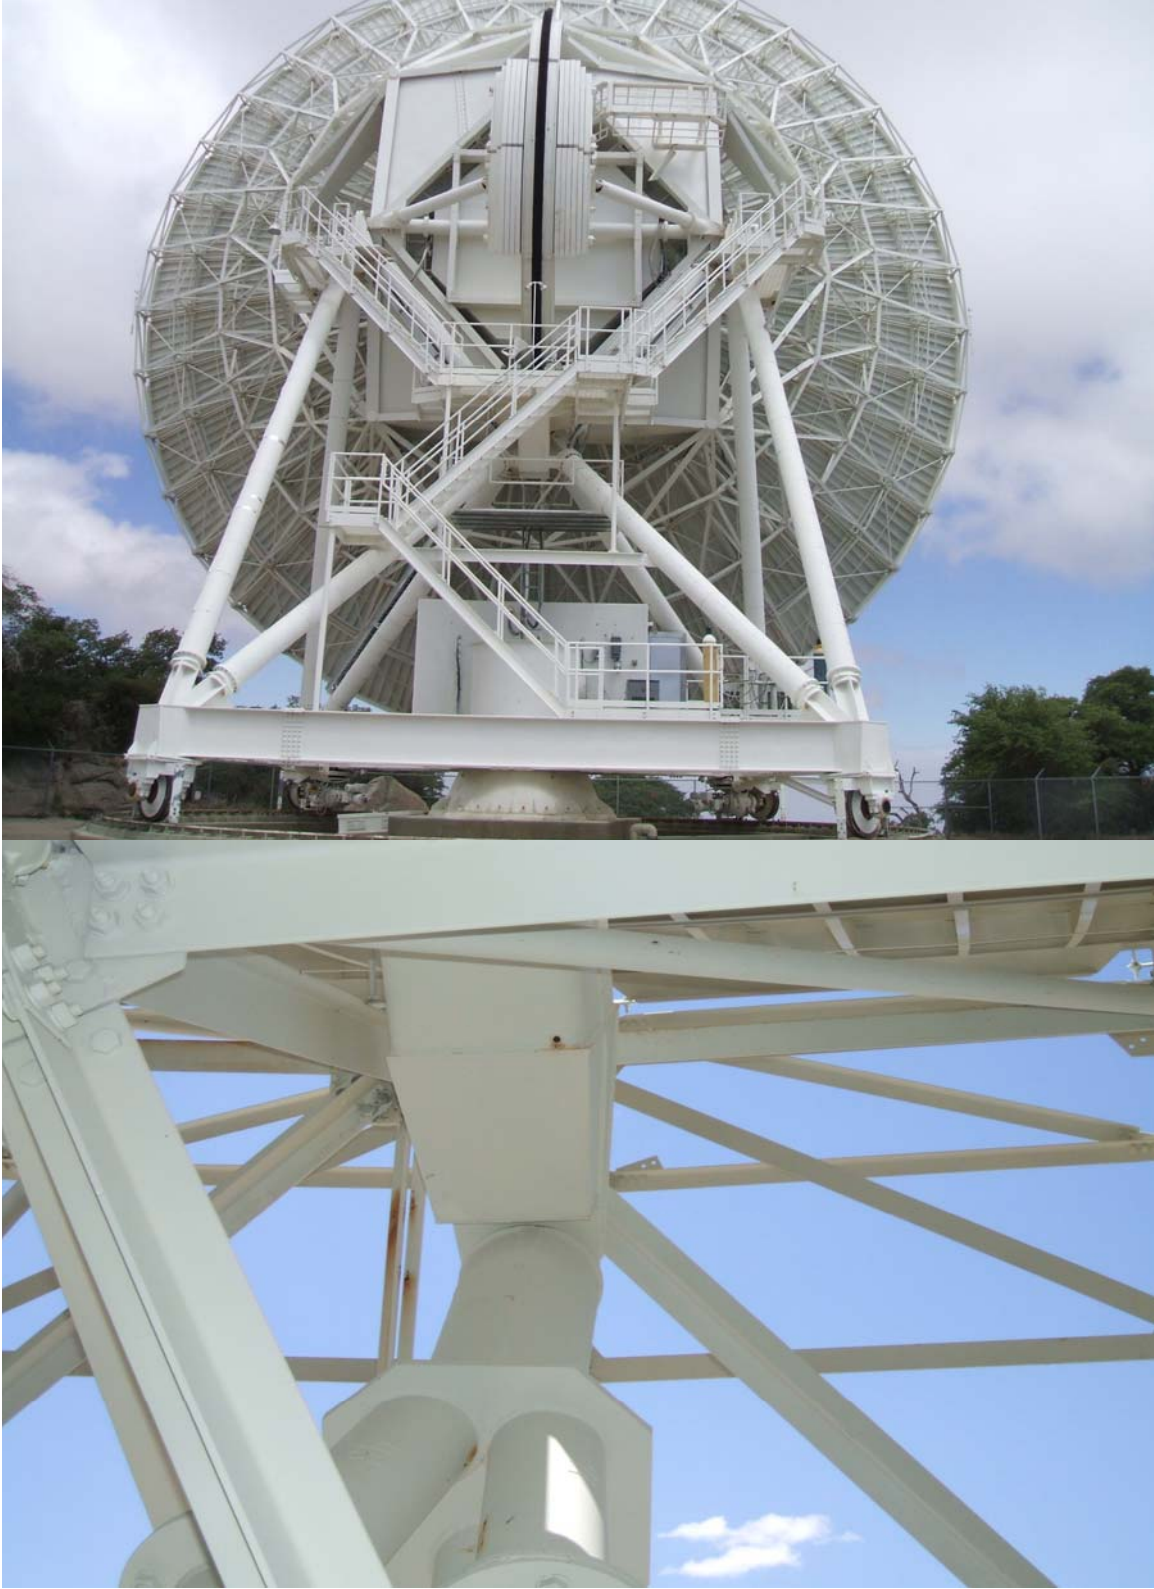
Overall paint on the antenna is in excellent condition with only a few surface rust spots. Notice the Quad leg drain hole.

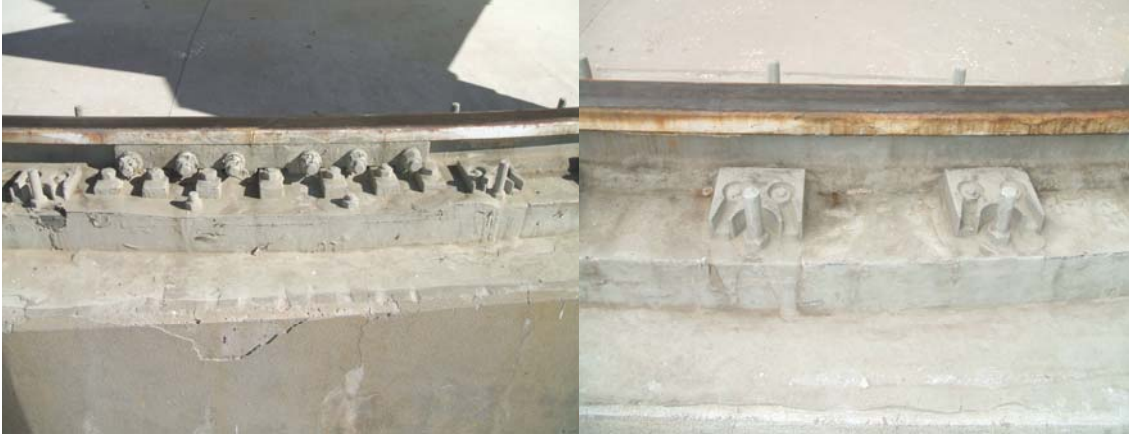
Kitt Peaks rail and grout is in good condition. Vulchem is beginning to deteriorate and the Site Techs will have to remove it.
