National Radio Astronomy Observatory  
Socorro, New Mexico  
VLBA Antenna Memo #64

Mauna Kea, Hawaii VLBA Maintenance Visit July 19-August 6, 2006.  
Team members consisted of Steve Aragon, Nelson Atencio, Eric Carlowe,  
Kelly Greene, Jim Gregg, Ramon Gutierrez and Ken Lakies. VLBA Site  
Technicians Bill Hancock and Tony Sylvester assisted in all areas of antenna  
maintenance.

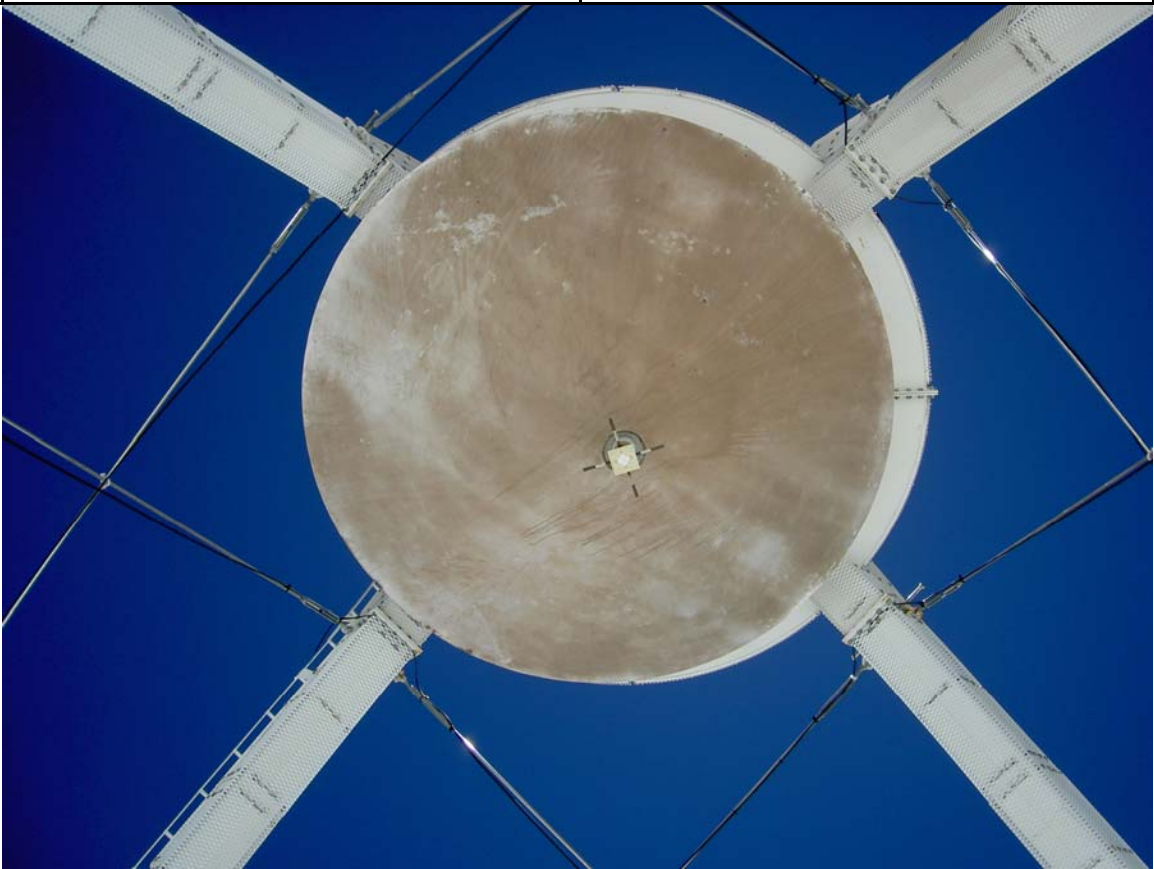
Sub reflector paint is discolored.

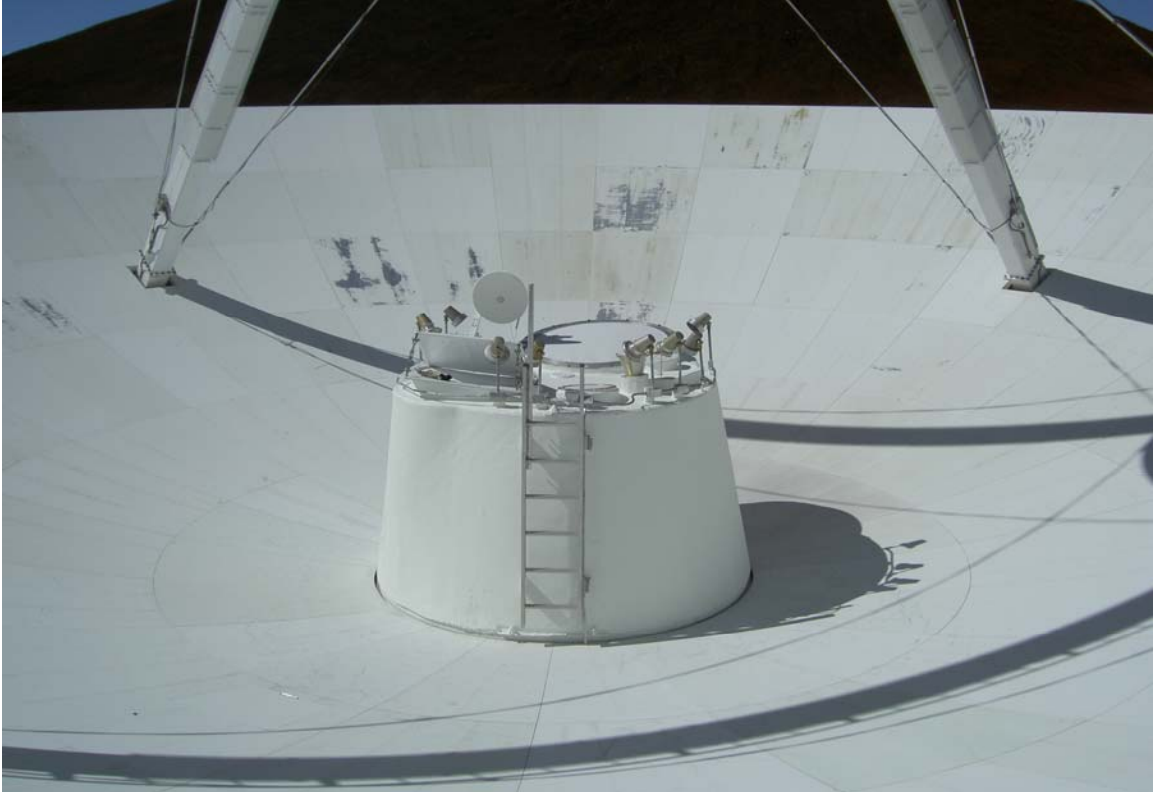
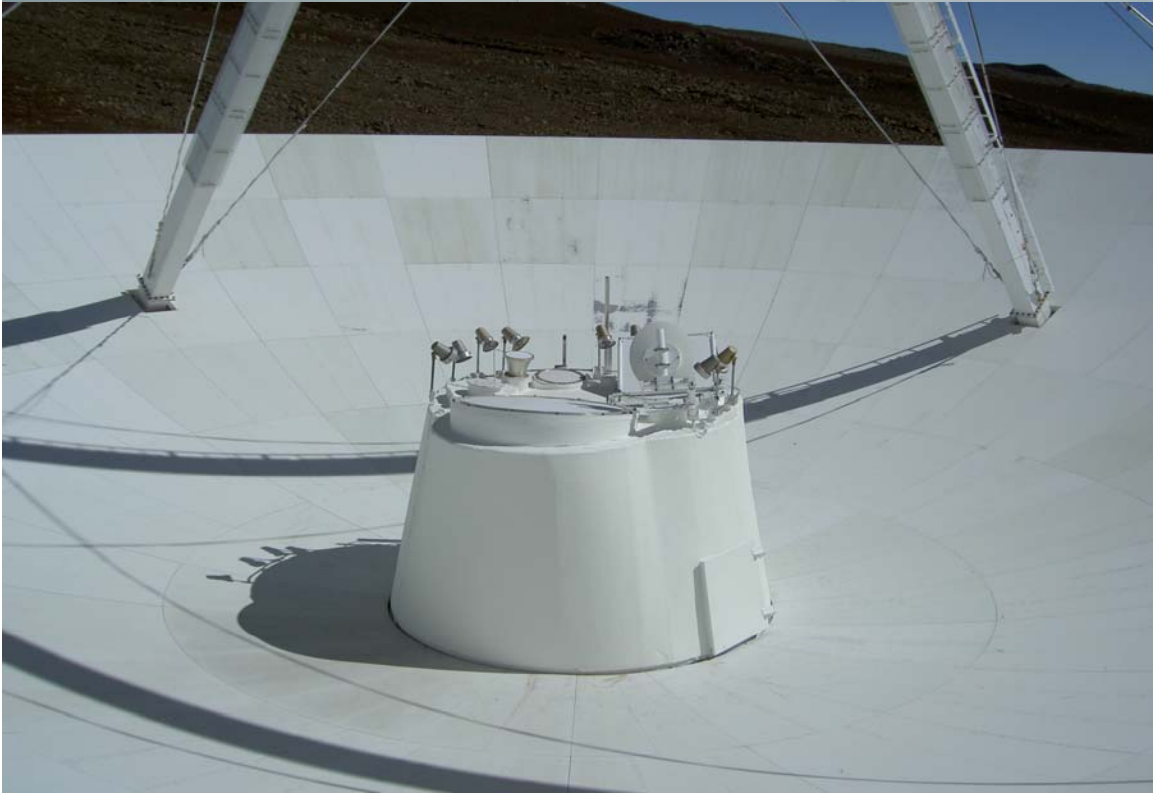
Dish panels are in good condition with only a few minor dents and 1 small hole next to the dish access door. The Feed Cone was spot sealed and painted with elastomeric.

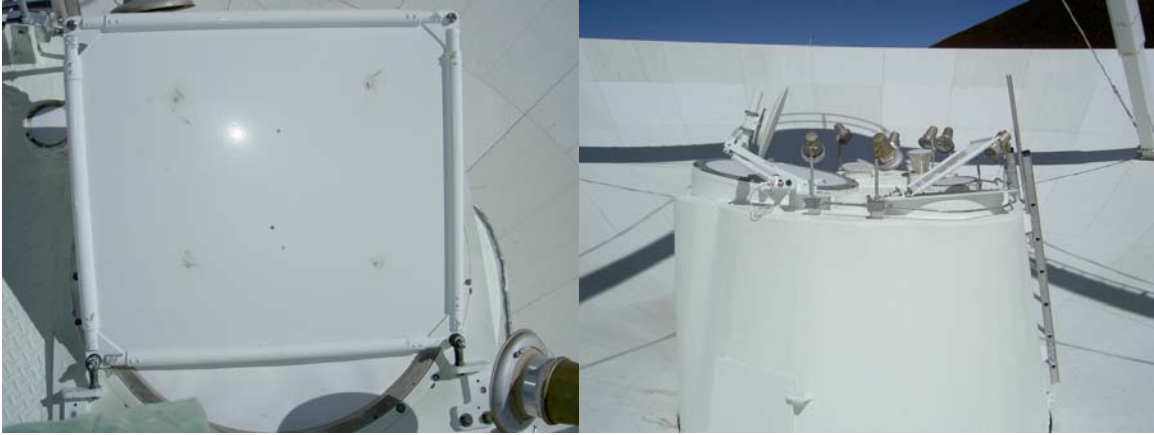
Dichroic reflector is in good condition. Ellipsoid reflector is in good condition and operates correctly.

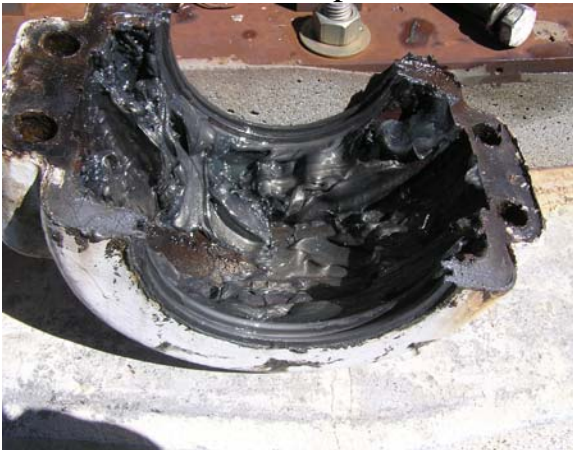
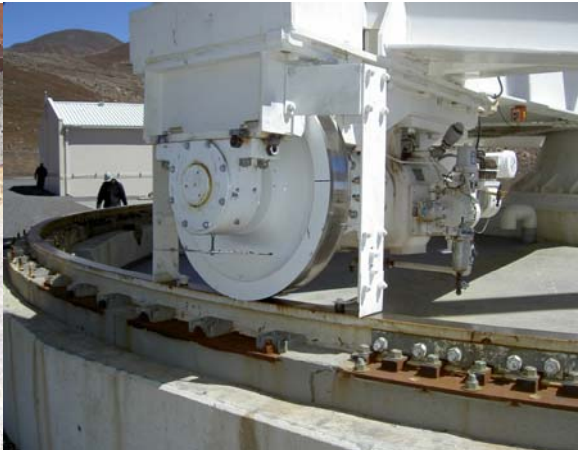
Azimuth wheel bearings were inspected. Azimuth Drive #1 wheel assembly was replaced.

INNER BEARING	OUTER BEARING
D1	Full of metal.	Full of metal.
D2	1 tiny flake, little scratches.	Good, no metal.
I1	Good, no metal.	Good, no metal.
I2	Good, no metal.	Tiny flakes, very few scratches.

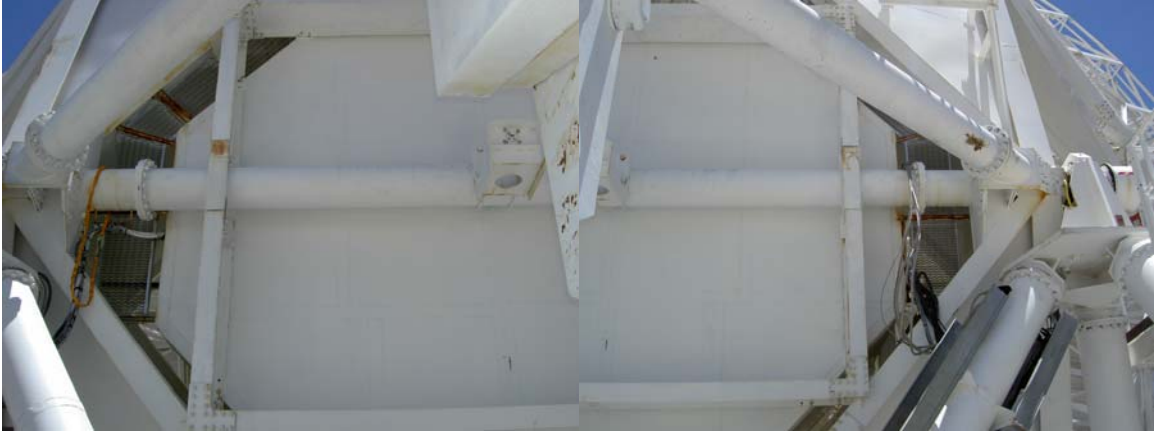
Elevation axle has no visible signs of cracks. The elevation synchro side cable wrap was repaired. Both elevation axle ground cables were replaced.

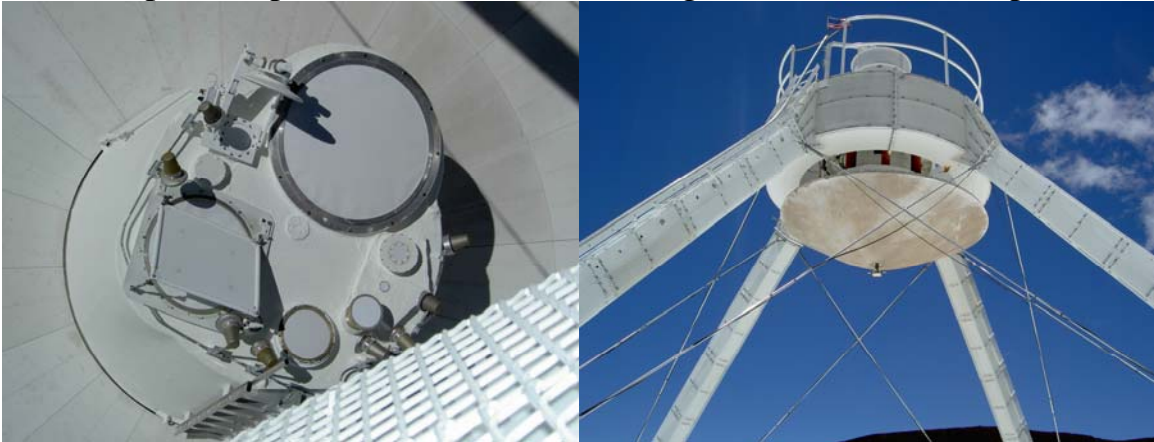
Feed heaters and FE windows are in good condition. Feed heaters operated correctly. Apex paint is in fair to good condition.

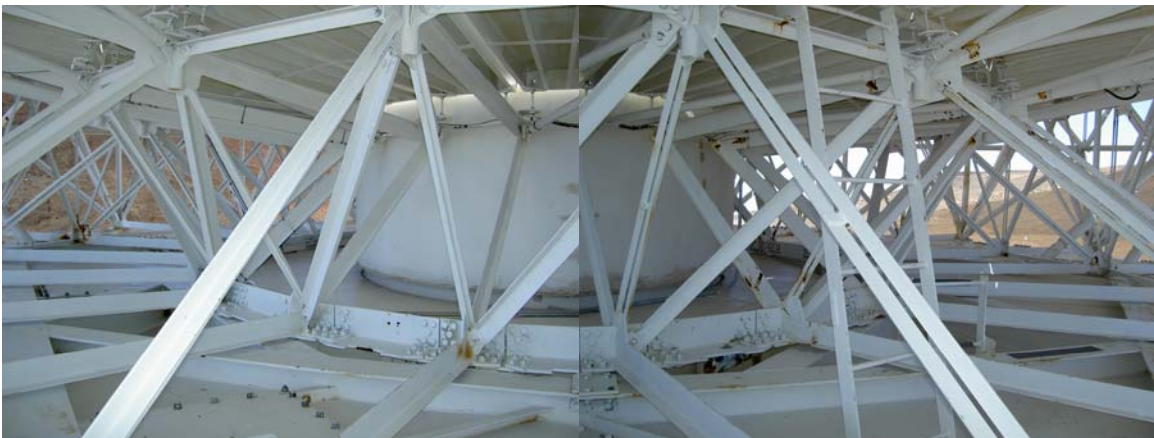
Antenna backup structure is in good condition. Paint is in fair condition.

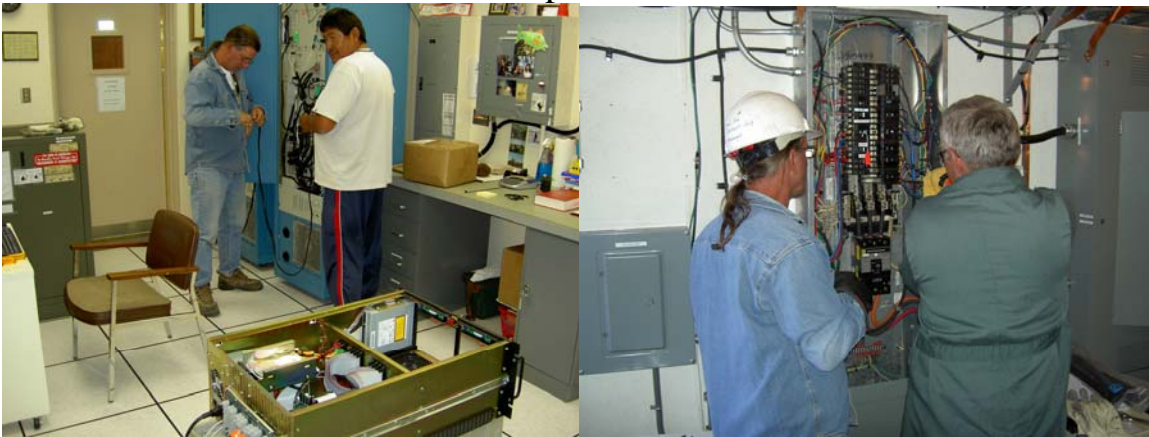
The MKV recorder and its communications were put on UPS power with the addition of a new terminal block mounted underneath the floor in room 103. Both MKIII recorders were removed. Inside the Servo drive cabinet and the Ped Room power panels many loose connections were found.

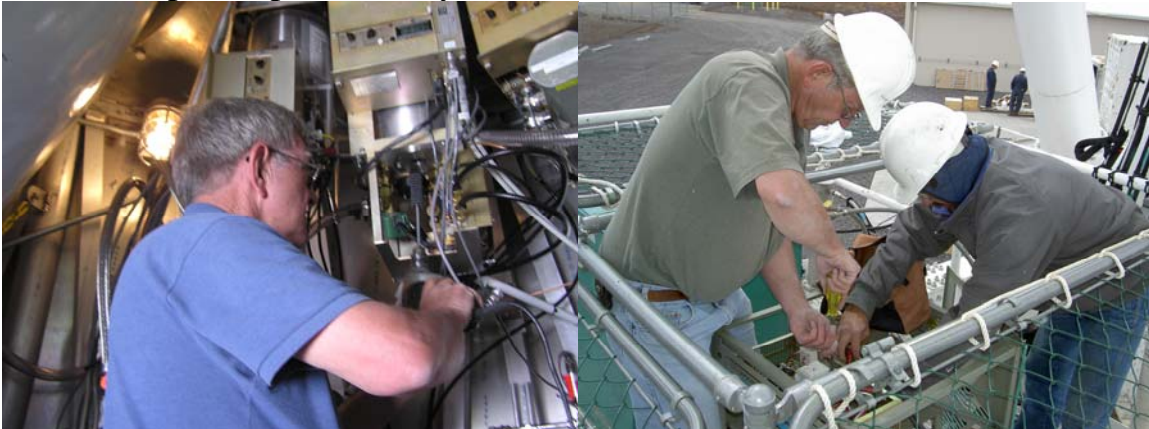
The MK antenna CRYO system was given a complete overhaul. Many persistent CRYO problems were isolated and repaired. Dry air system leaks were repaired and the system pressures adjusted for the VTX and Apex.

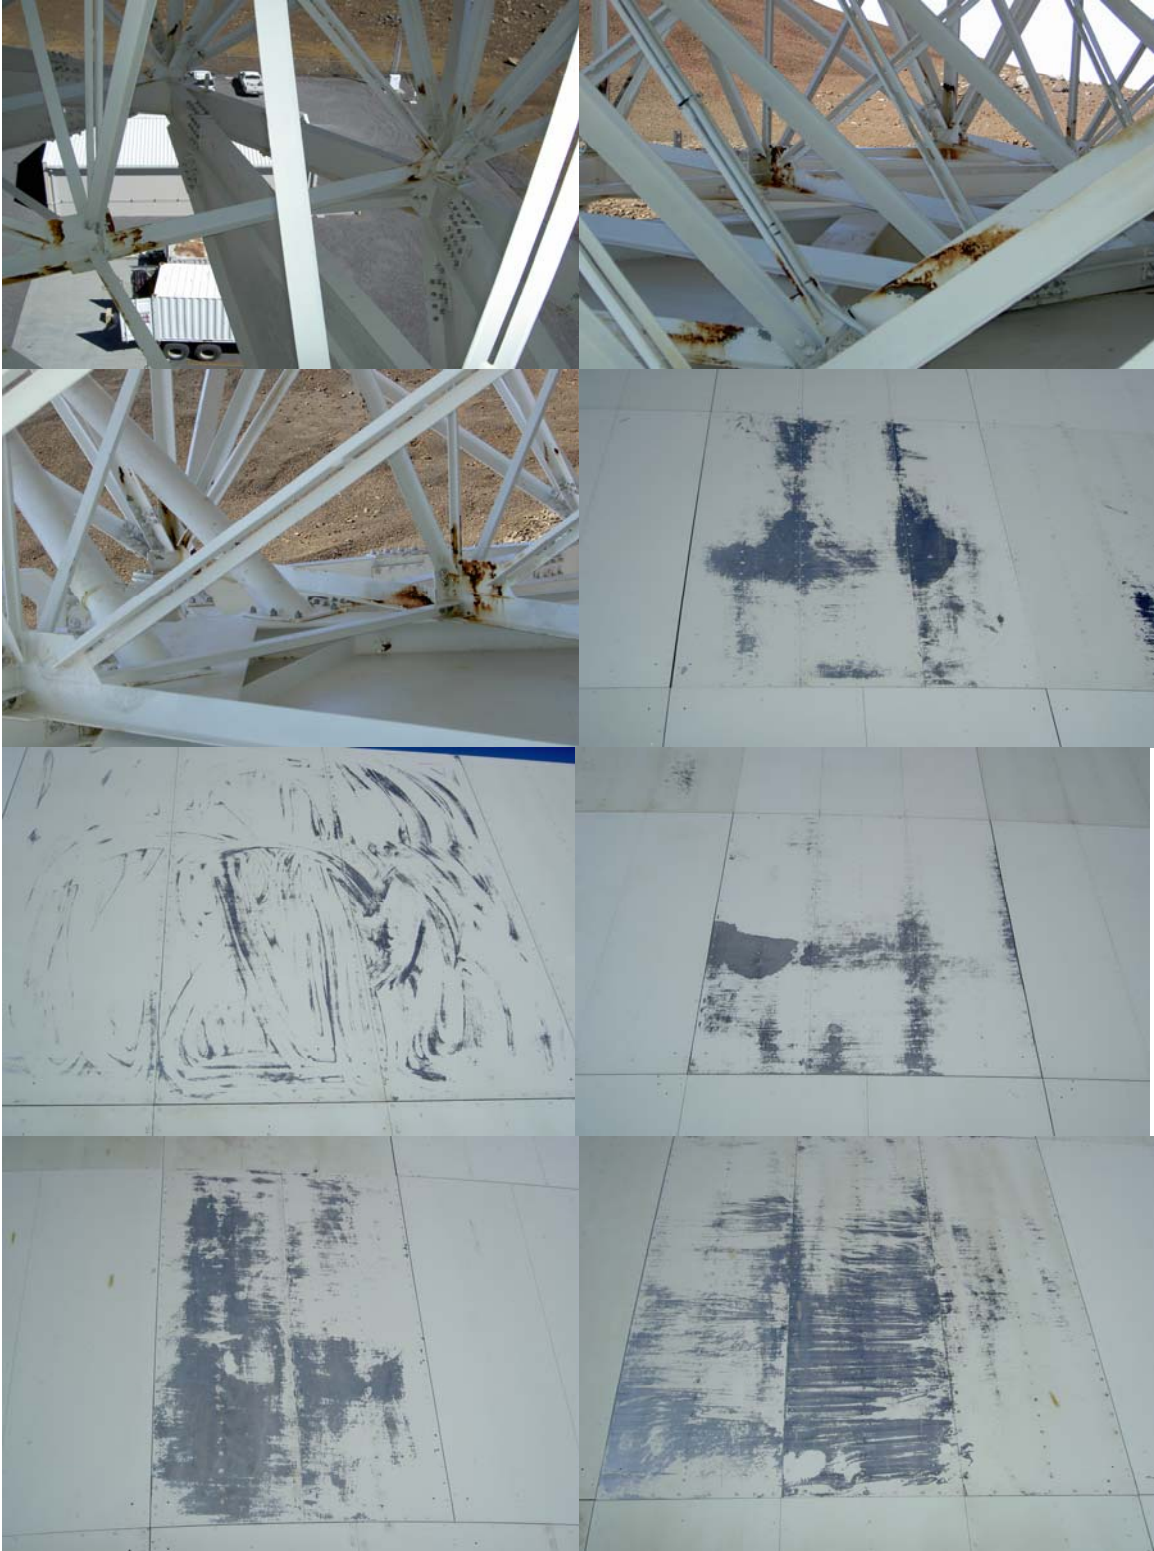
Overall the Antenna paint is in fair to good condition with surface rust found mainly on the backup structure. Paint is deteriorating on several dish panels.

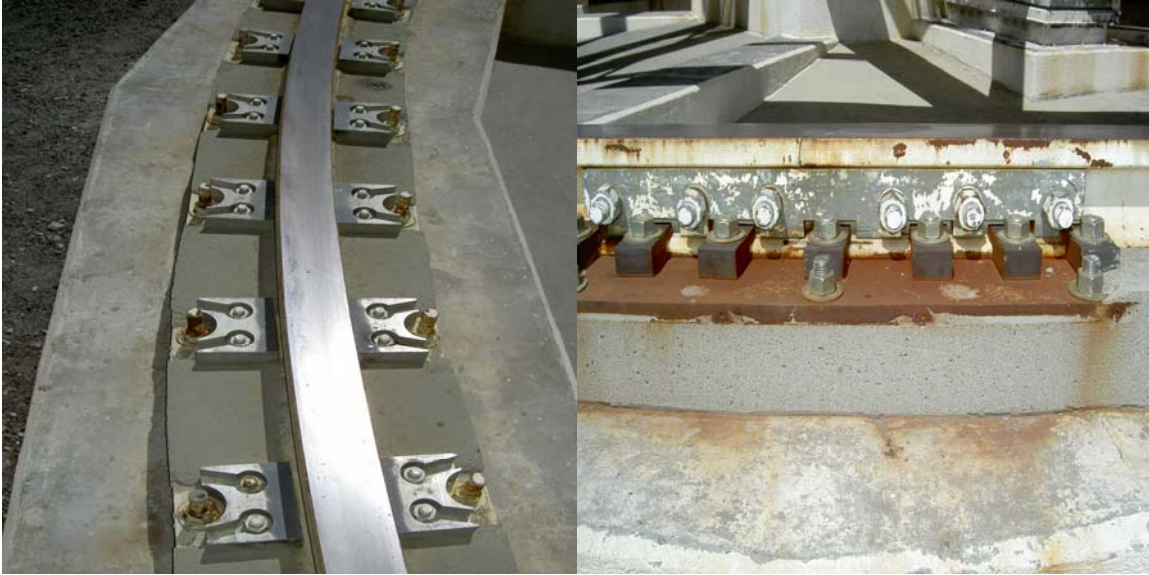
Mauna Kea's rail and grout is in good condition.
