NATIONAL RADIO ASTRONOMY OBSERVATORY
Socorro, New Mexico

VLBA Antenna Memo Series No. 70

Fort Davis Elevation Bearing Replacement - Trip Report

J. E. Thunborg
February 27, 2008

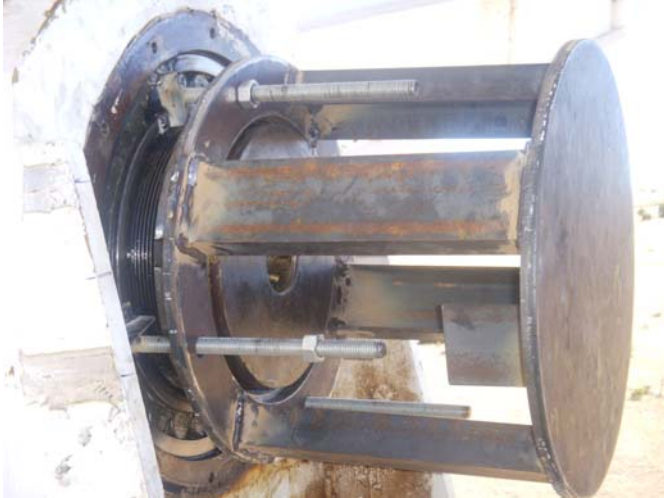
During previous bearing changes, one side of the dish was lifted and the entire pillow block was removed from the antenna. The old bearing was then pressed out and a new bearing pressed into the pillow block before it was reinstalled on the antenna. This was a time consuming procedure that required torch cutting of the large bolts and welded stiffeners that attached the pillow block to the antenna. This procedure also required that the dish be lifted high enough for the pillow block to clear the structure. In order to increase efficiency and keep from lifting the dish as high, the maintenance team decided to remove and replace the Fort Davis bearing without removing the pillow block. Using this method, the dish was lifted approximately 0.005 inches until a feeler gage could be inserted under the bearing rollers. A prefabricated press was then welded to the pillow block and used to force the tapered sleeve inward until it released its grip on the axle.

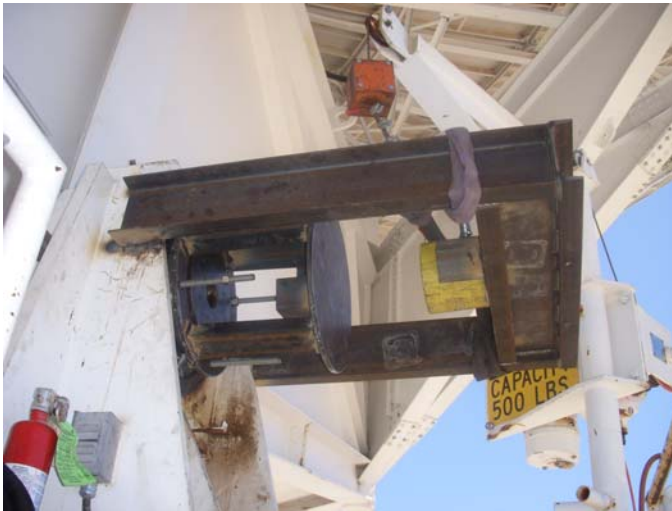
The next step, removing the old bearing from the pillow block proved to be problematic. Threaded rod studs were welded to the bearing and a prefabricated pulling fixture with a 100 ton jack were used to try and pull the bearing from the pillow block. This method proved unsuccessful because the welds to the hardened steel bearing race did not have adequate strength to withstand the pulling force. A torch was then used to cut the rollers from opposing sides of the bearing. This allowed the threaded rod to be inserted

through the bearing. Nuts were then screwed onto the threaded rod on the back side of the bearing enabling a robust attachment to the pulling fixture. This method proved successful, but the force required to remove the bearing was substantial causing both the inner and outer bearing races to shatter.

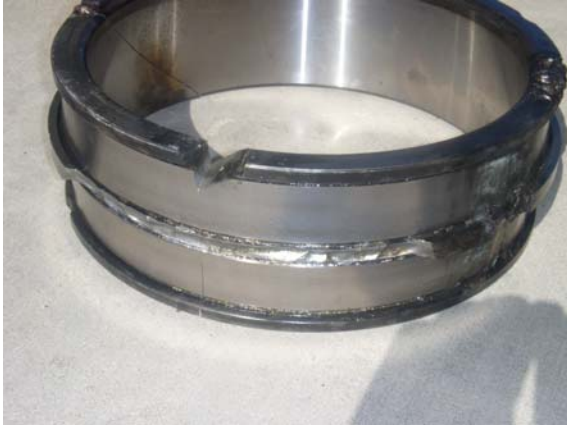
A new bearing was then inserted into the pillow block using the prefabricated press shown in the adjacent photograph. The taper coupling nut was then tightened until the bearing clearance was reduced to the manufacturer's recommendation. This reduction in clearance was insufficient because after the maintenance team left Fort Davis, the taper coupling slipped on the axle causing the pillow block to move relative to the axle. The maintenance team subsequently returned to Fort Davis and increased

the taper coupling tension.

The movement of the bearing relative to the axle indicated that the bearing was installed in such a way that it was axially loaded. This axial loading would have caused premature bearing failure had it not been relieved by the bearing slipping on the axle. In order to have the bearing axially loaded we must have locked the bearing onto the axle while the antenna was in a deflected position due to the off center loading of the jacks on the bearing platform. We should account for this deflection on subsequent bearing changes by installing the bearing loosely initially allowing it to slip into the correct position before it is rigidly locked into place.

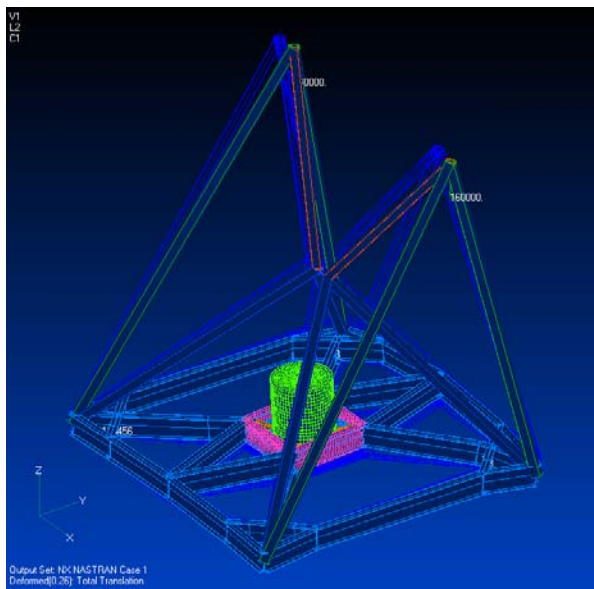
The original bearing's inner ring center guide flange was fractured. According to engineers at Torrington Bearing, this kind of fracture is due to excessive axial load on the bearing. This is the same type of failure that we have seen on both elevation bearings that have been previously replaced. Therefore, the author feels that it is safe to assume that all of the VLBA antennas were assembled in such a way that the elevation bearings are subjected to thrust loads.

The VLBA antennas were assembled by installing the elevation axle and then adding the backup structure, quad legs and dish panels. This additional weight was added after the elevation bearings were locked in place. A finite element model of the VLBA antenna base shows that the elevation platforms deflect away from each other as weight is applied to the structure. The axle constrains this movement resulting in a thrust load in the elevation bearings. From the FEA model, the thrust load is estimated to be approximately 10,000 lbs. Bearing life calculations show that a 10,000 lb thrust load would decrease the bearing life by approximately 60%.
