VLBA Sensitivity Upgrade Memo 38
Mark5C Voltage and Temperature Measurements

Walter Brisken, Bob McGoldrick, Doug Gerrard & Steve Durand

July 13, 2011

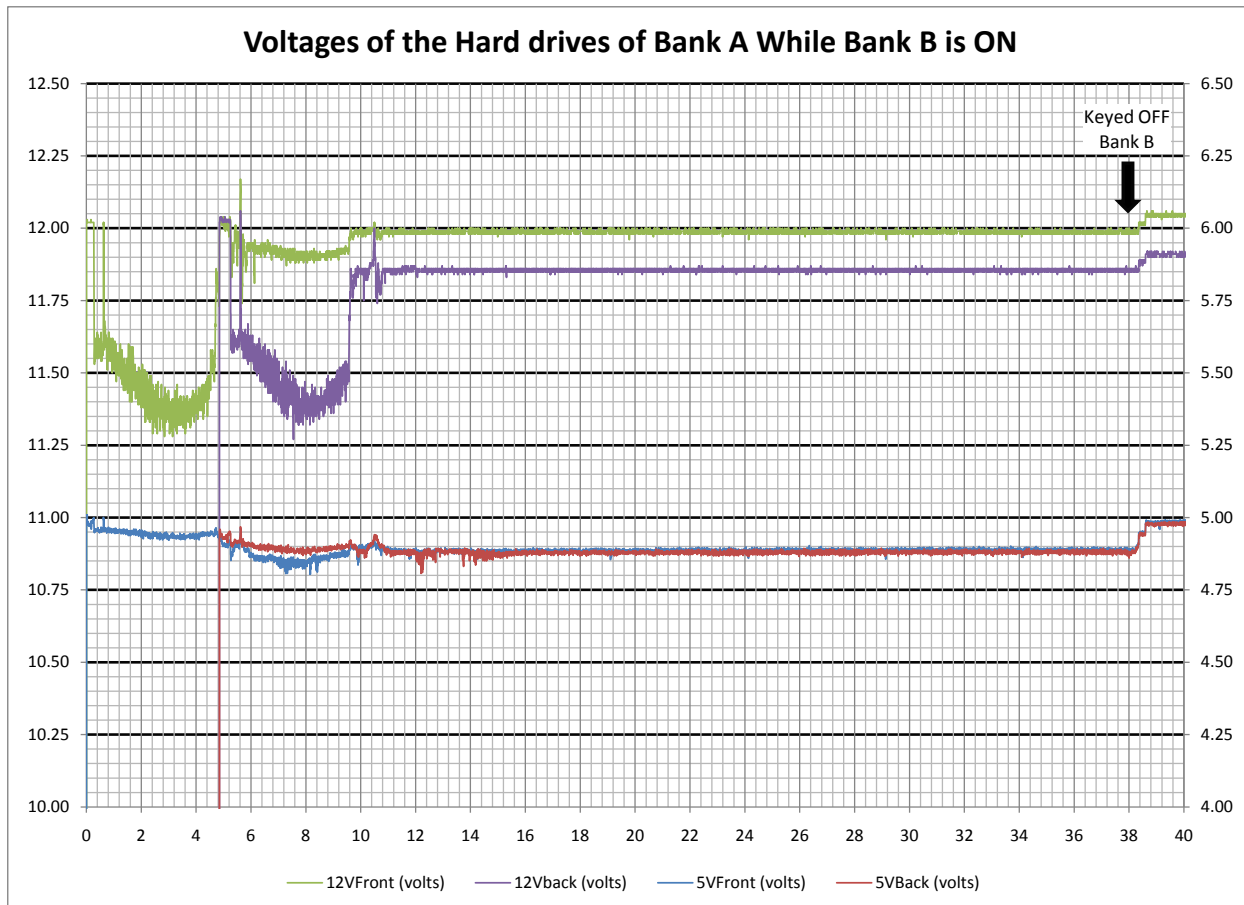
The 5 V power was seen to drop as low as 4.8 V and the 12 V to 11.2 V, both in a transient manner during initialization. The steady state 12 V supply to disks 0 to 3 returned to a full 12 V after initialization,

Figure 1: This figure shows the voltages measured on a module during its spin-up and initialization in the case that a disk module is already powered on and in steady state in the other bank. The green and purple traces show the 12 V power to disks 0 and 4 respectively (see left hand scale). The blue and red traces show the 5 V power to disks 0 and 4 (see right hand scale).

but the 12 V supply to disks 4 through 7 recovered only to 11.85 V and both 5 V supplies levelled off just under 4.9 V. No documentation could be found indicating minimum and maximum voltages for operation.

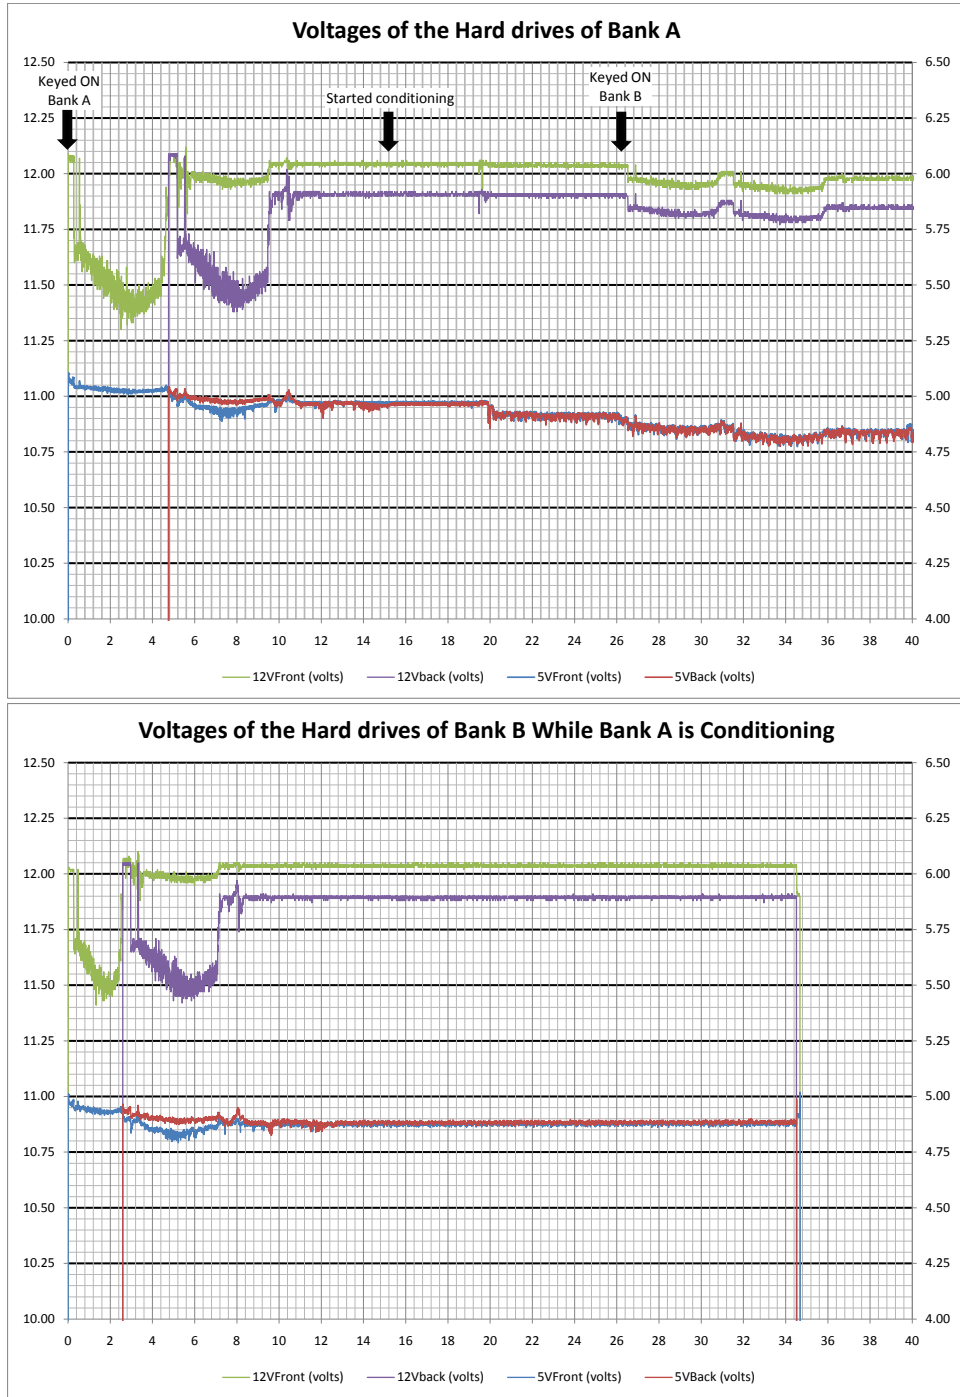
Figure 2: Similar to Figure 1 but in two different situations. Top: Module in bank A is measured while it is turned on, started conditioning, and the other bank is turned on. Bottom: Module in bank B is measured while module in bank A is turned on and conditioning is started.
