Development Upgrades of the Atacama Large
Millimeter/submillimeter Array

*Band 3 Cold Cartridge Assembly Magnet and Heater
Installation for Deflux Operation*

Cycle 2 Final Report

Institution: Herzberg Astronomy and Astrophysics Research Centre, National Research
Council of Canada

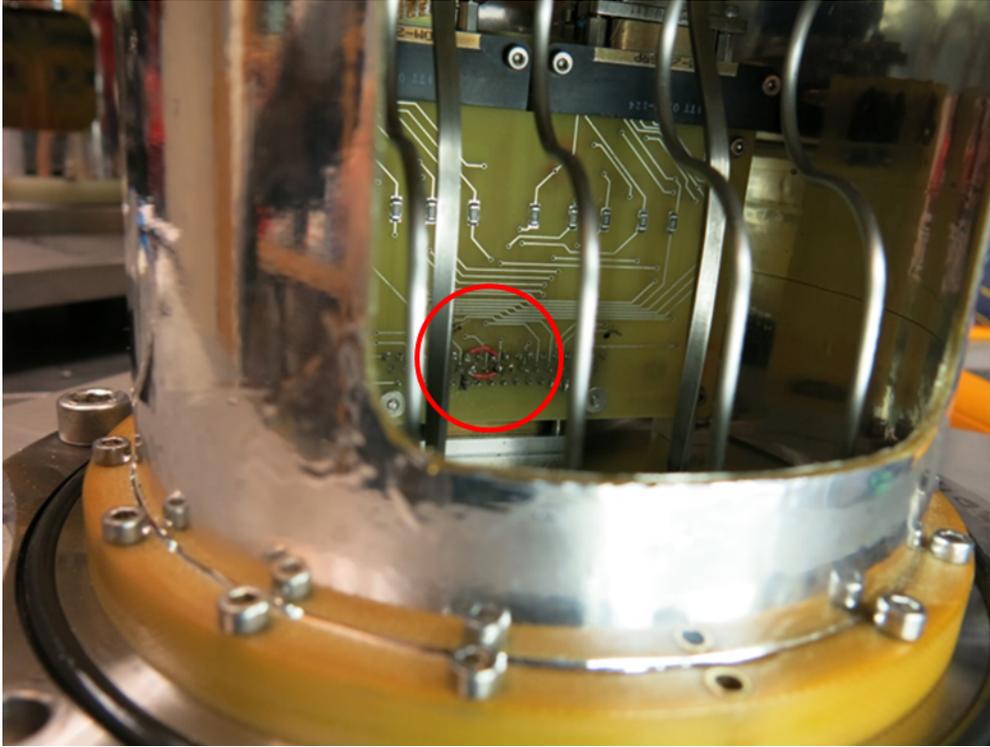
Figure 3: Jumper wires on Pol0 ESD card

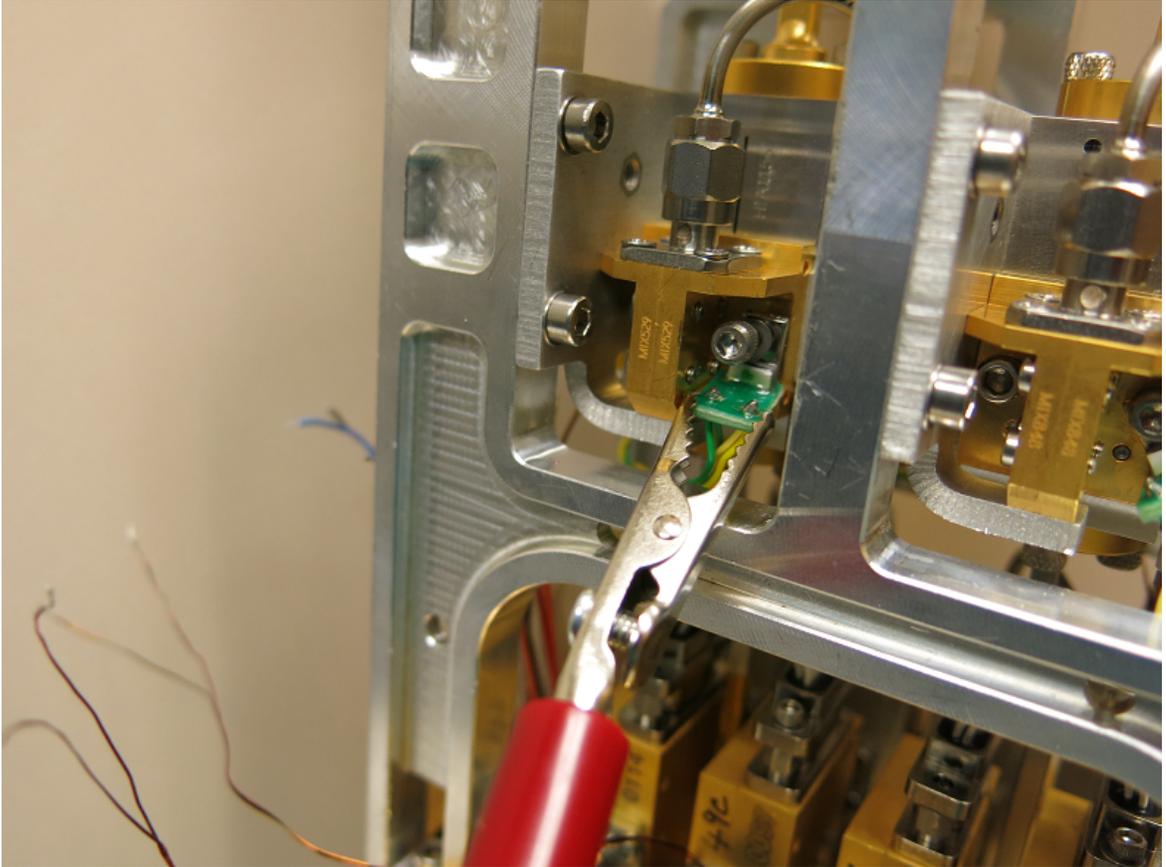
Figure 35: Jig to hold resistor

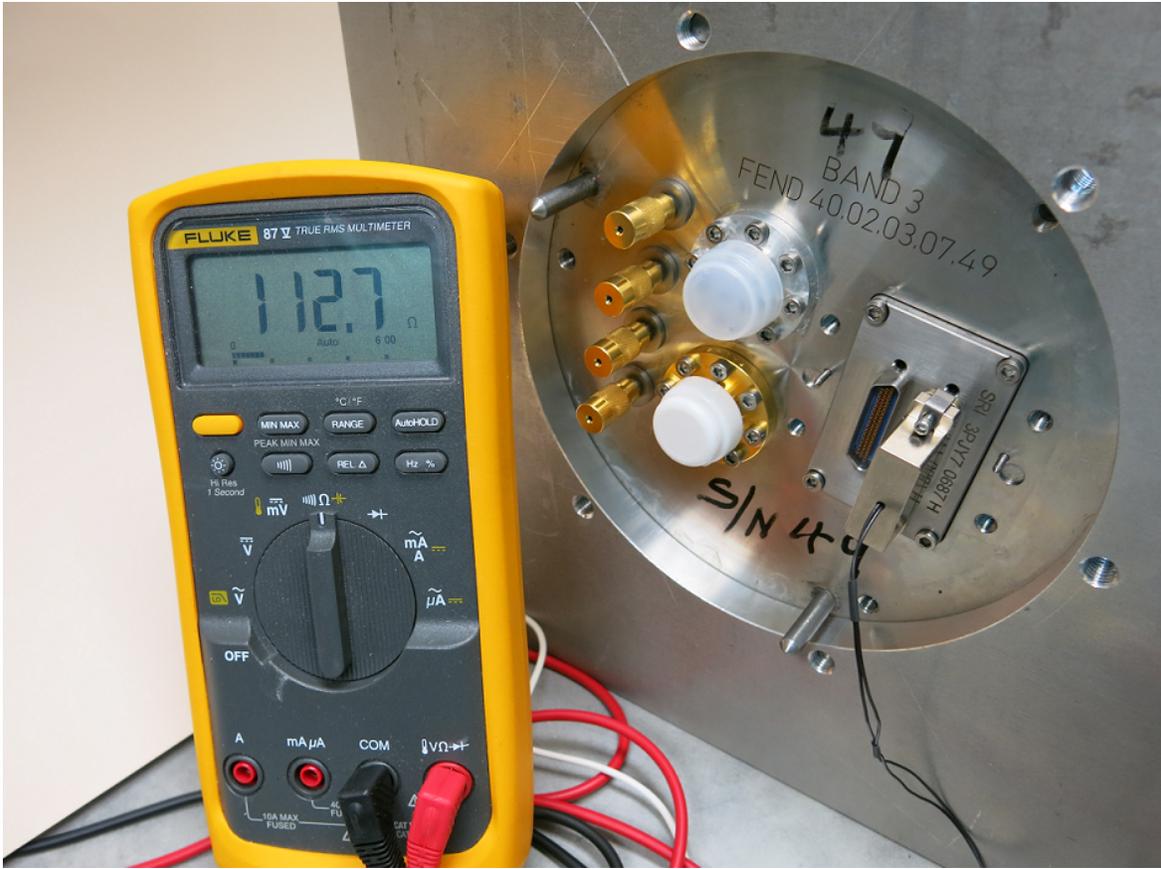
Lead resistance from 4K MDM to 300K MDM	= 4 ohm
Two 210 ohms in parallel	= 105 ohm
Lead resistance from 300K MDM to 4K MDM	= 4 ohm
Total (nominal)	= 4 + 105 + 4 = 113 ohm

Figure 42: Valid Reading (112.7 ohms)
