National Radio Astronomy Observatory
Socorro, NM

VLBA Antenna Memo Series #34

Brewster Maintenance Visit
July 23rd through 30th, 2001

Jim Ruff
8/2/01

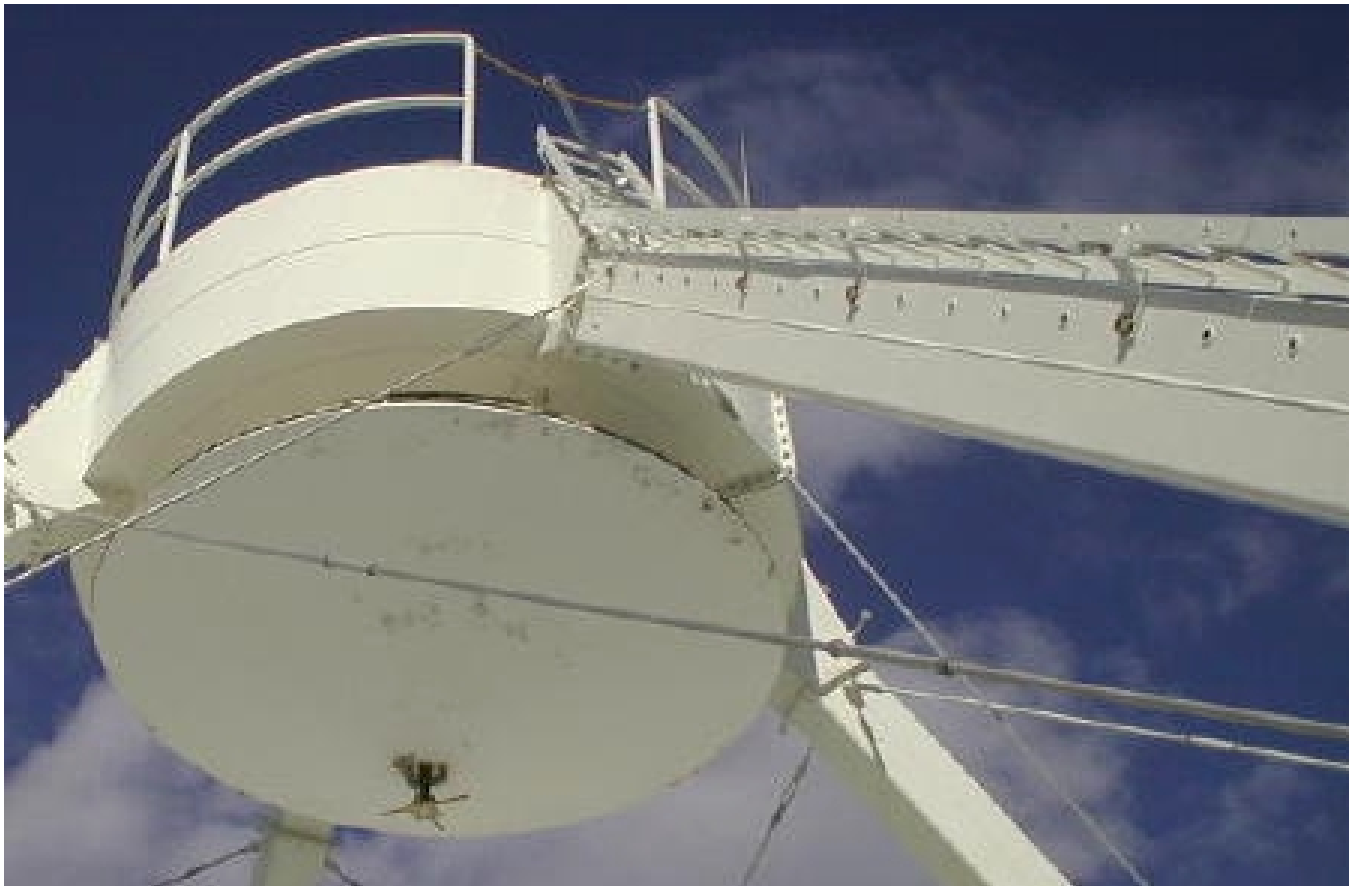
An apex handrail, quad leg ladder and Sellstrom fall arrest system were installed. The site techs were treated to a training session on use of the Sellstrom system and general fall protection.

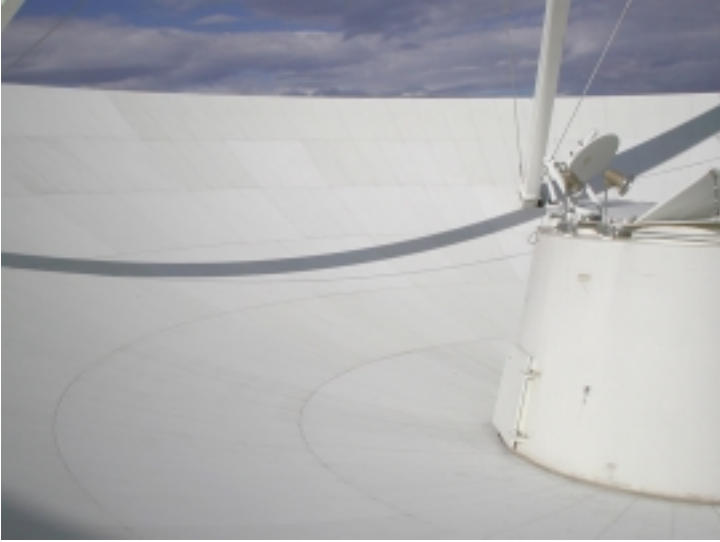
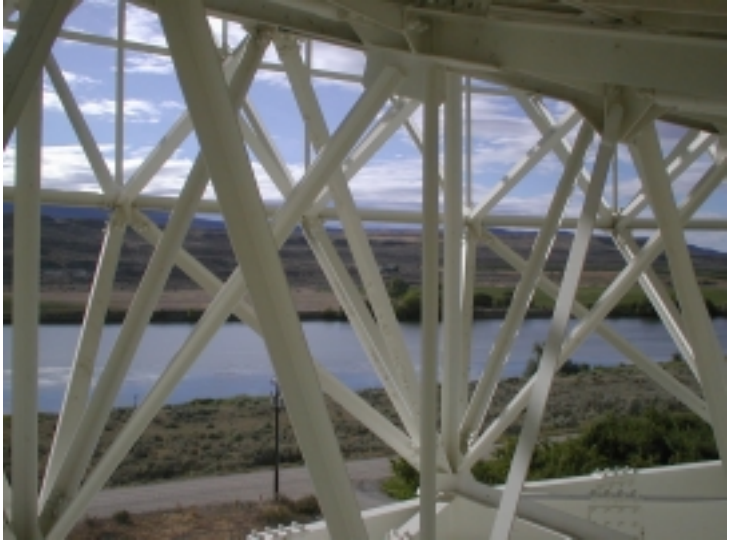
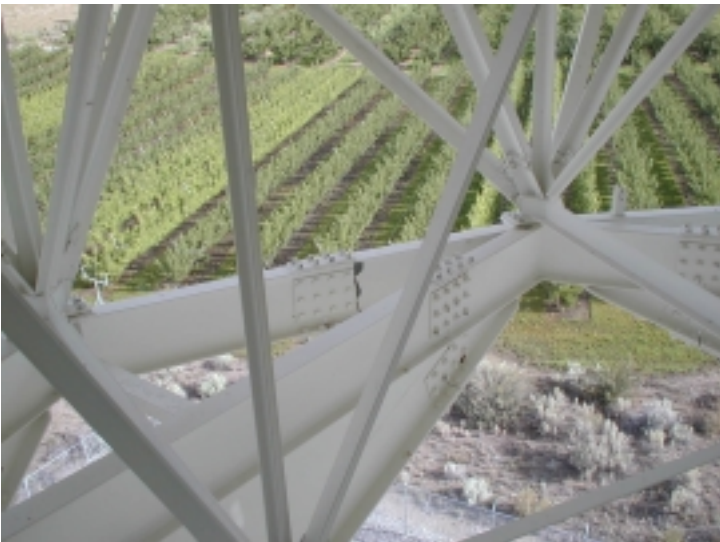
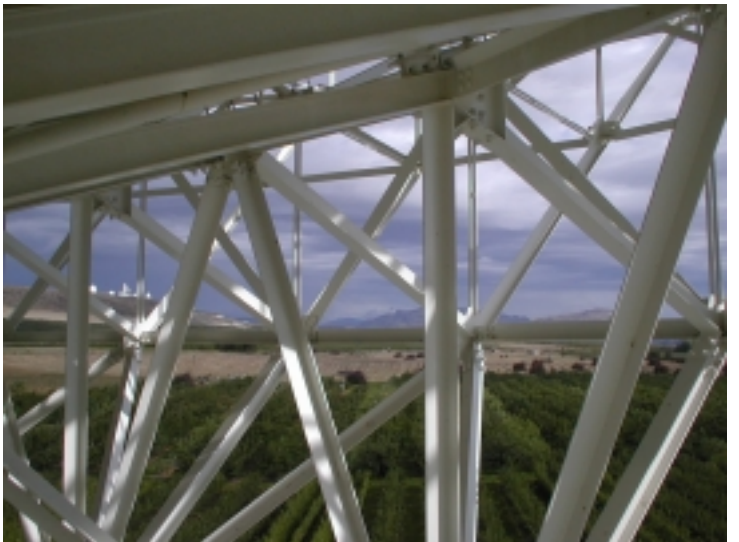
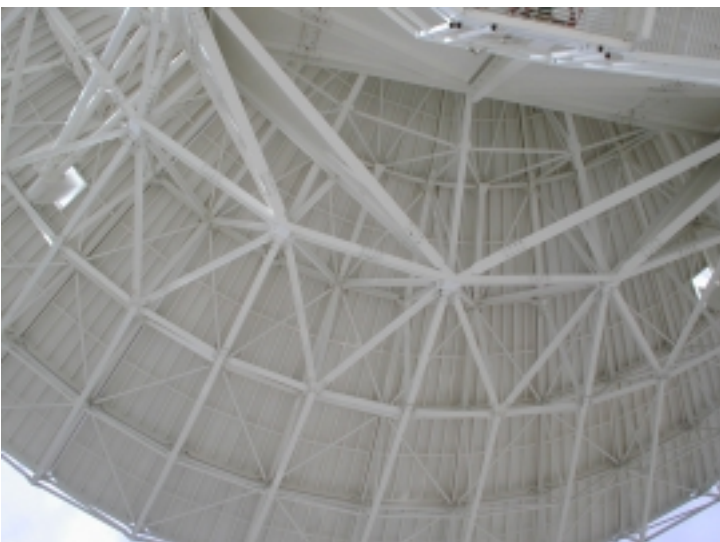
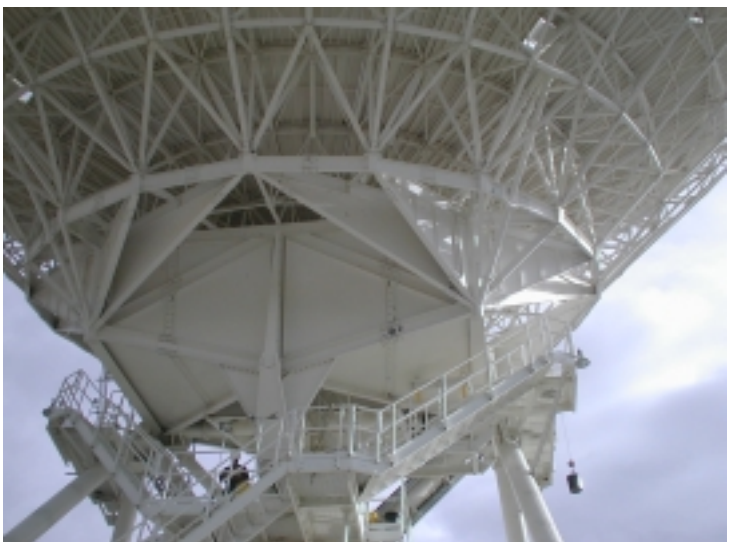
The rail at Brewster is very flat, with less than 0.030" deviation in elevation after the tilt is removed. The first order tilt is only 6 arcsec.

The paint on this antenna is in excellent condition.
